**State of California  
The Resources Agency  
DEPARTMENT OF WATER RESOURCES  
DIVISION OF FLOOD MANAGEMENT**

**2007  
PROJECT  
STRUCTURE REPORT**

**INSPECTION OF  
FLOOD CONTROL STRUCTURES ON THE  
SACRAMENTO AND SAN JOAQUIN RIVERS  
AND THEIR TRIBUTARIES**

**Prepared By  
The Flood Project Integrity & Inspection Branch**

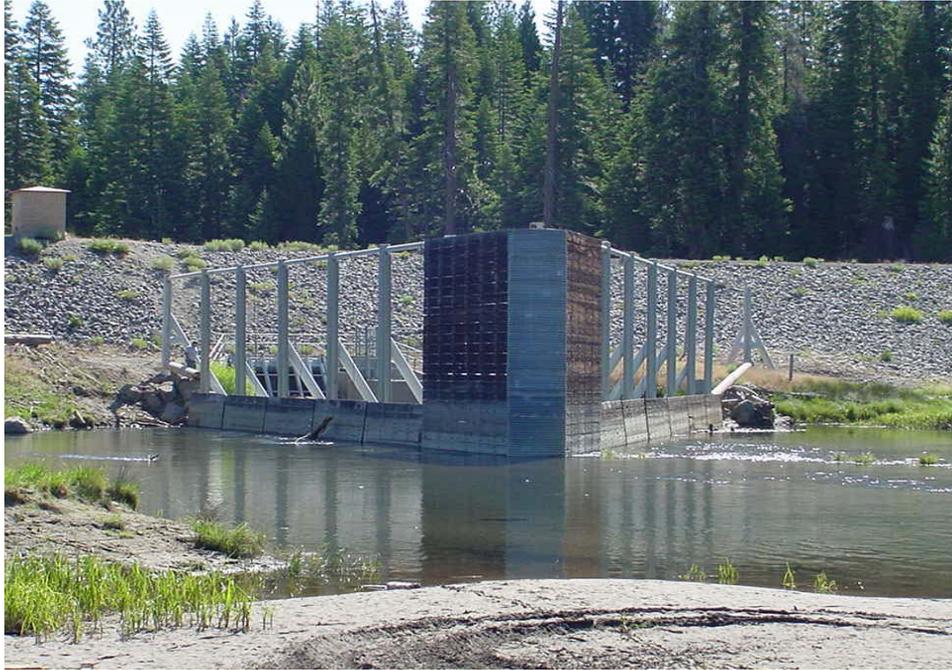
**The upstream side of the diversion structure at the inlet.**

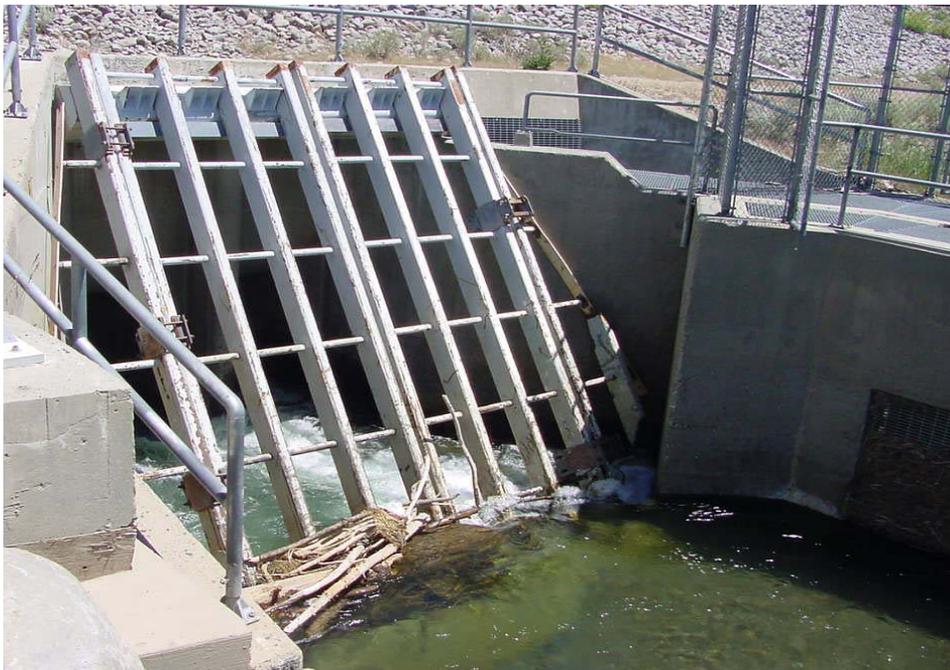
**Minimal amount of debris blocking the structure inlet.**

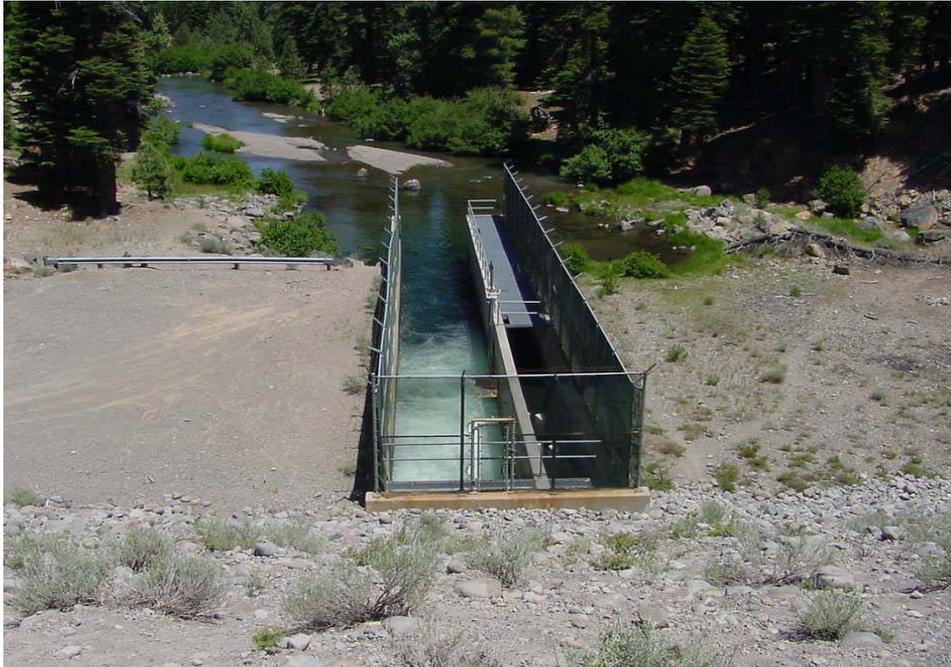
**The outlet works from the top of the dam.**

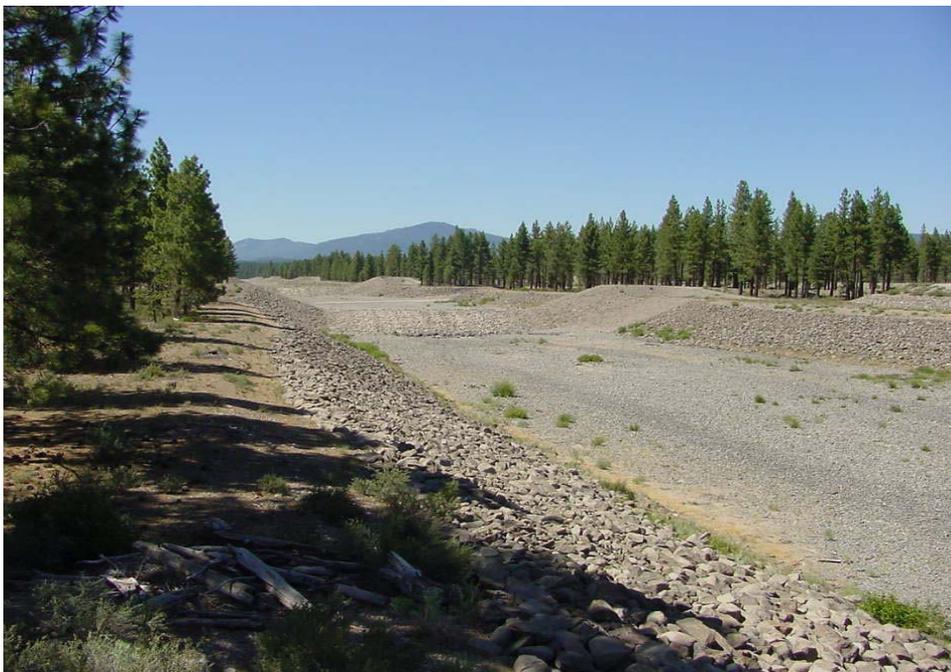
**Looking north from the Hwy 36 bridge at drop  
structures 3 through 7, note vegetation in the channel.**

1. **Condition of grouted rock revetment drop structures.**
  - a. **Acceptable.**
2. **Condition of channel banks upstream and downstream of the drop structures.**
  - a. **Acceptable.**
3. **Accumulation of trash and debris around the structures or in the channel.**
  - a. **None.**
4. **Vegetation around the structures, the channel banks or in the channel.**
  - a. **Minimal growth exists in the channel.**
5. **Comments:**
  - a. **Control vegetation in the channel.**
  - b. **Acceptable maintenance.**

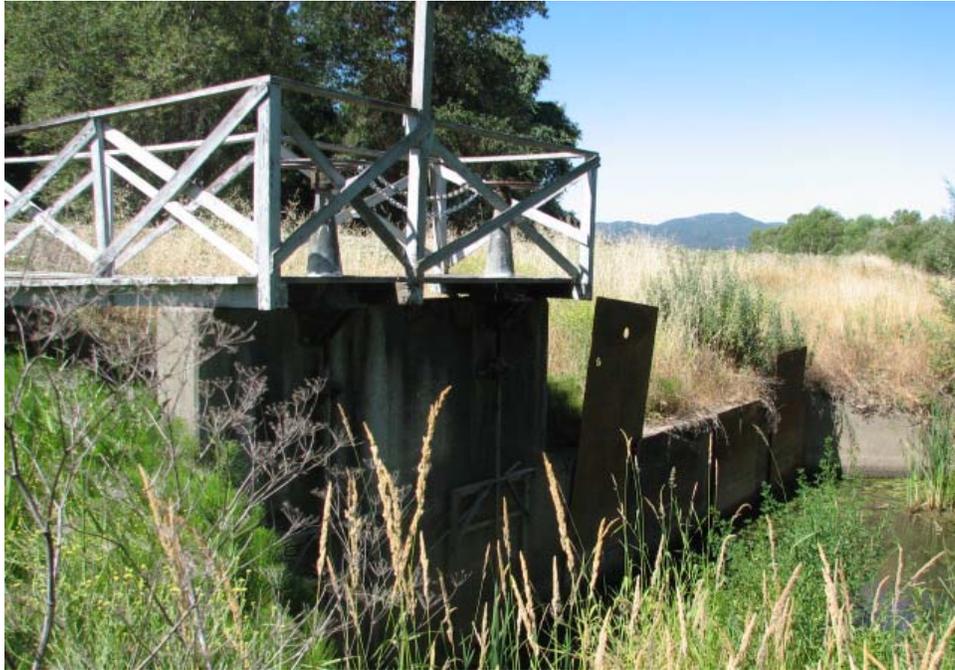
**View of the diversion structure gates at the intake.**

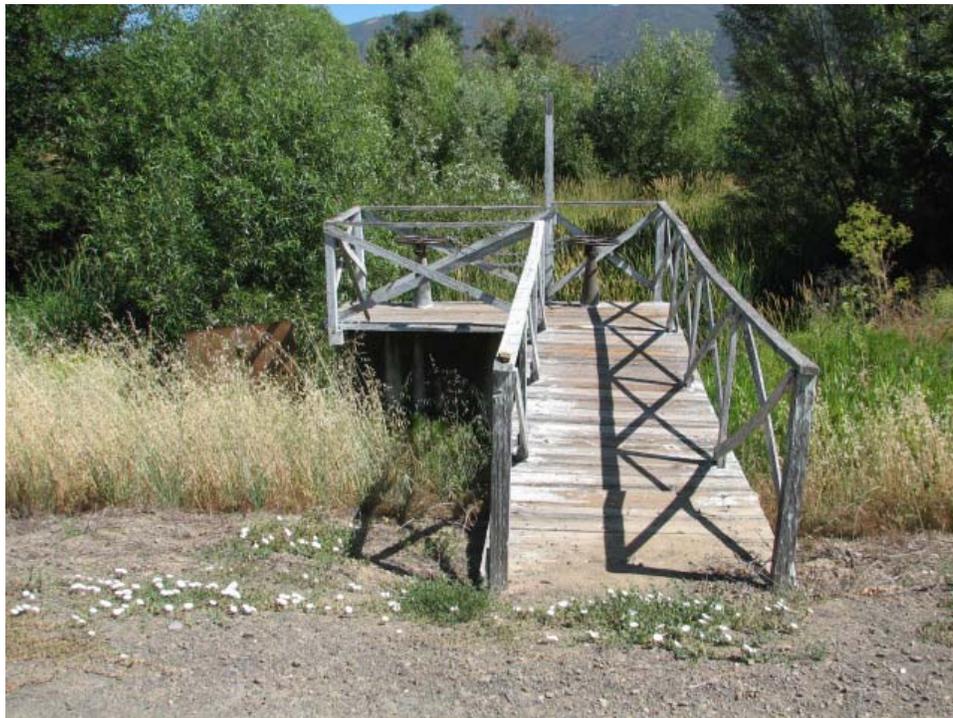
**Walkway and control gate mechanisms.**

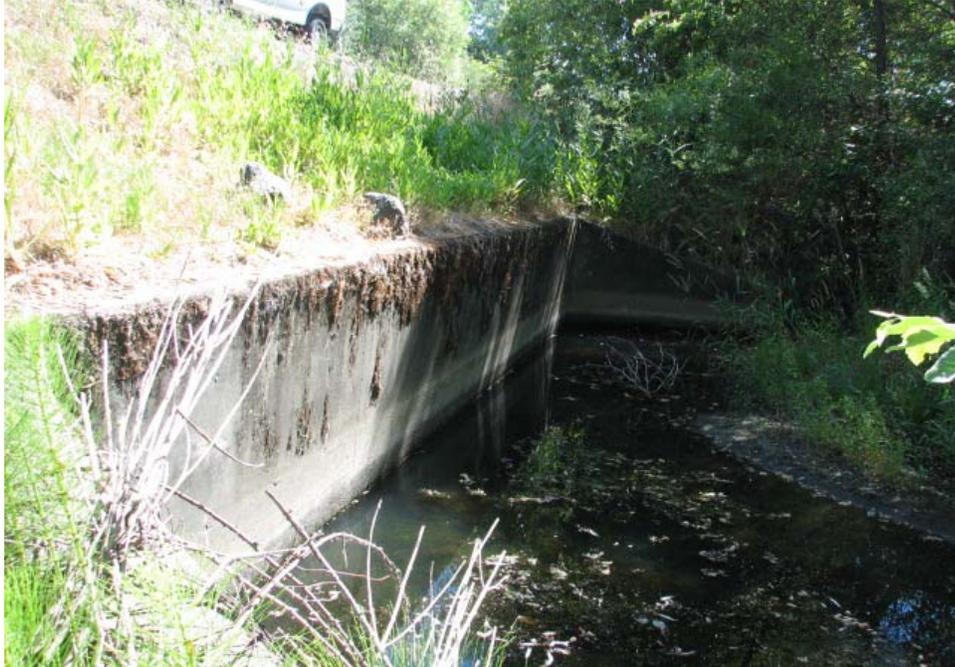
**View of the structure outlet.  
Gravel buildup has reduced flow.**

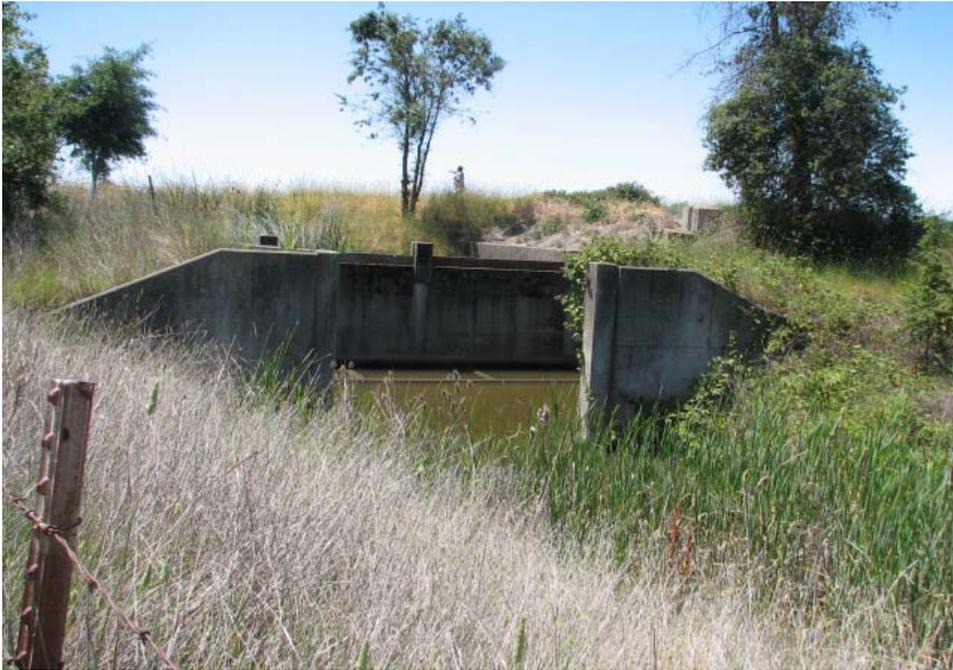
**The concrete weir and diversion pipe intake.**

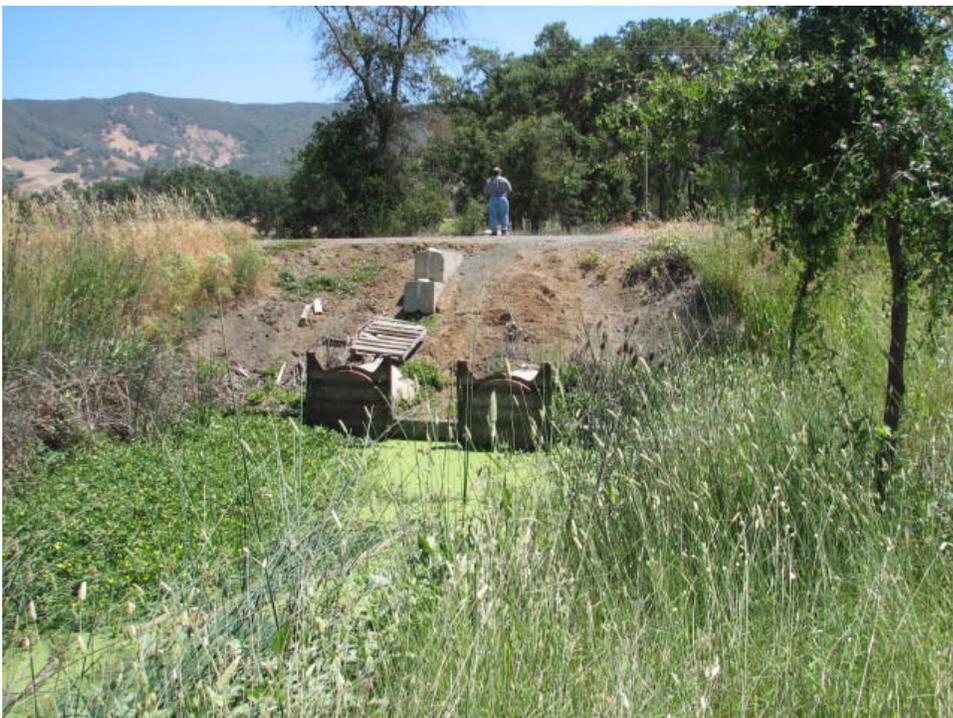
**View of the outlet pipes and channel.**

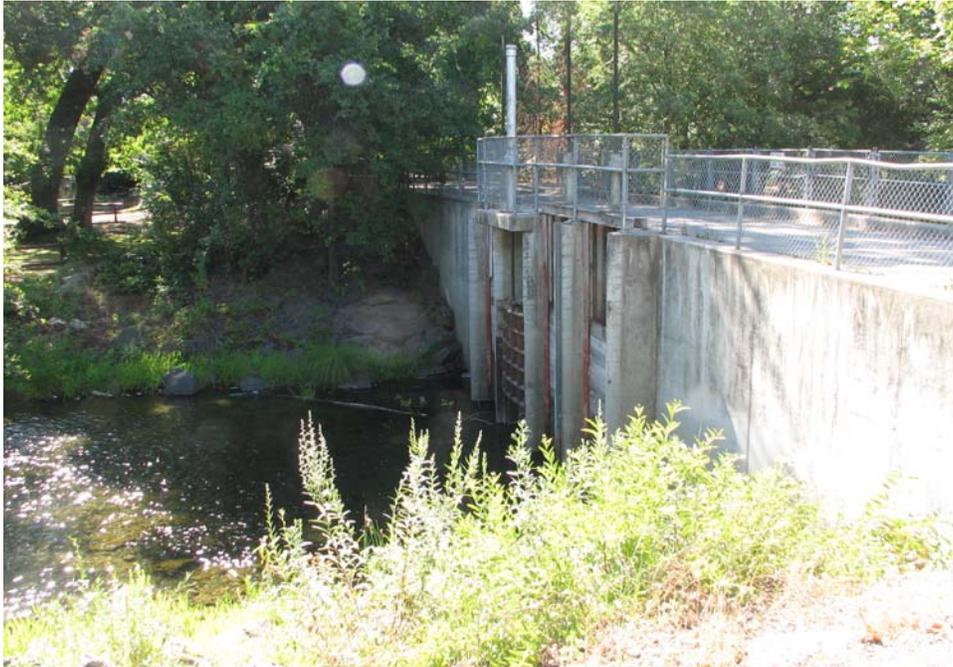
**View of the upstream side of the structure.**

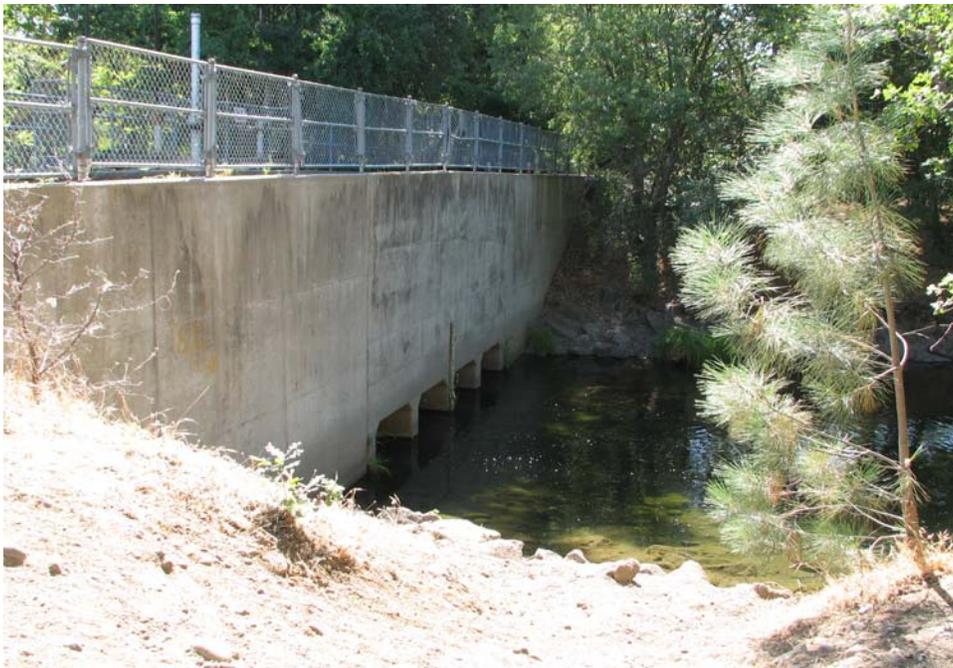
**Downstream at discharge end of structure from the right bank.**

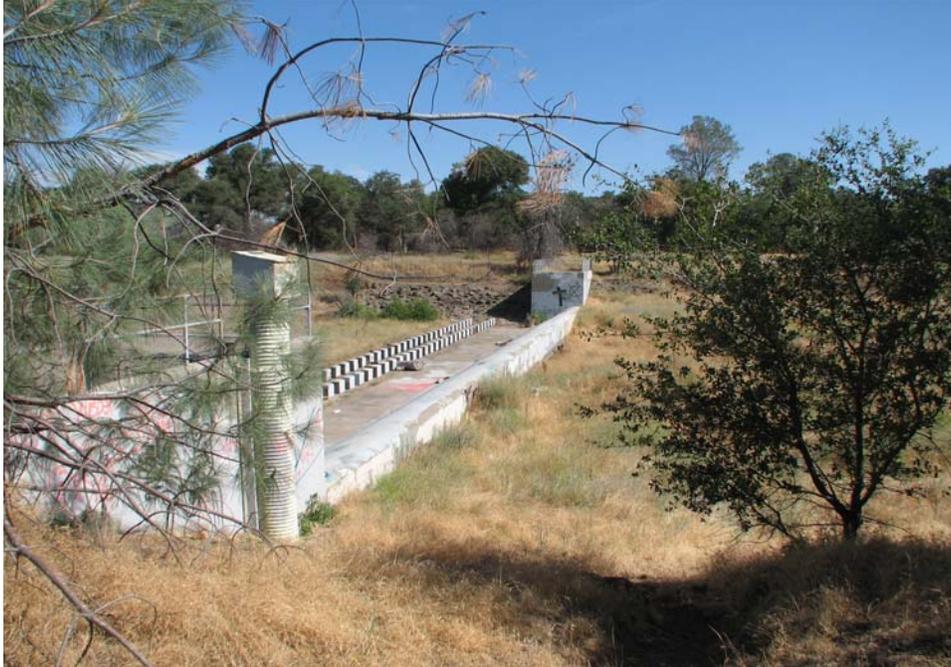
**Upstream side of the structure from the left bank.**

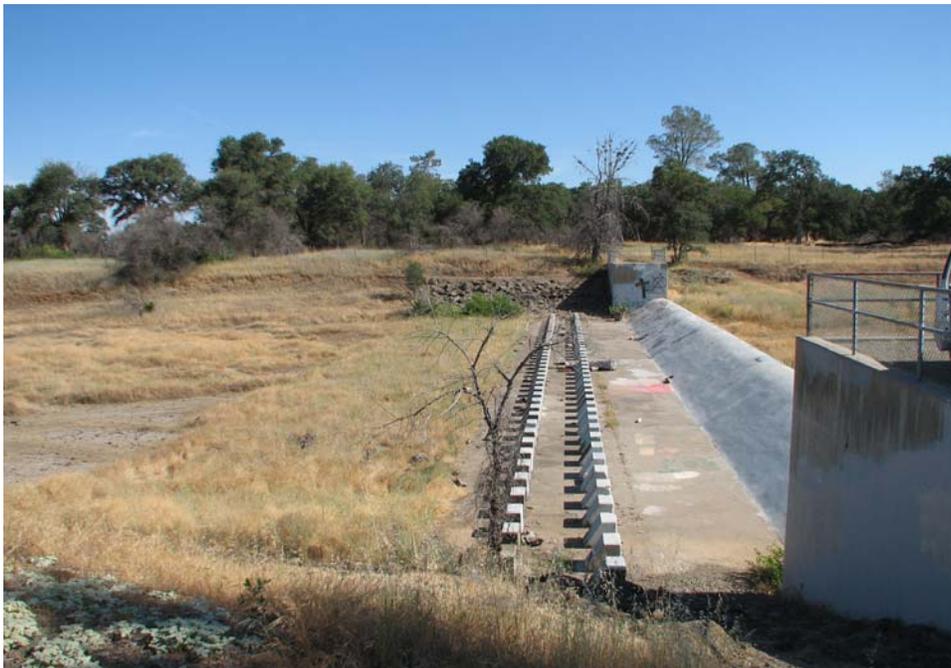
**The velocity dissipaters on the downstream side of structure from the left bank.**

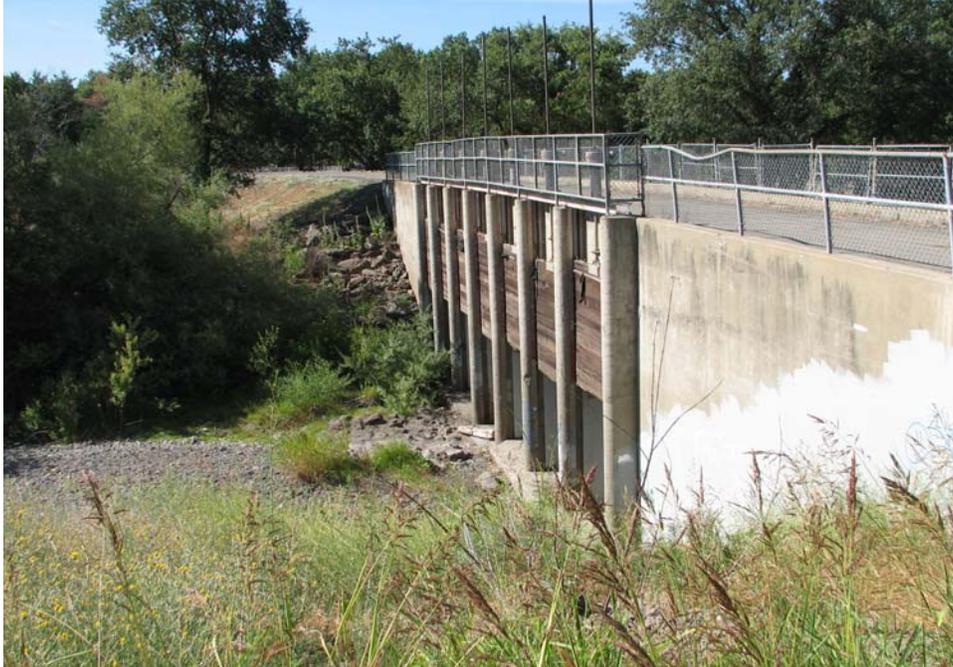
**View of the upstream side of structure.**

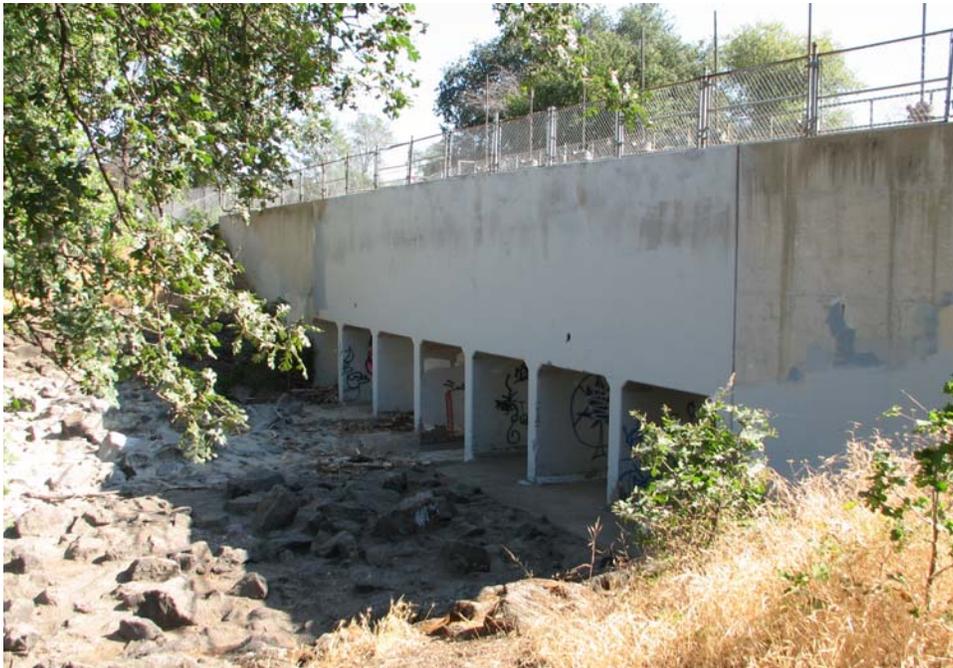
**View of the downstream side of structure.**

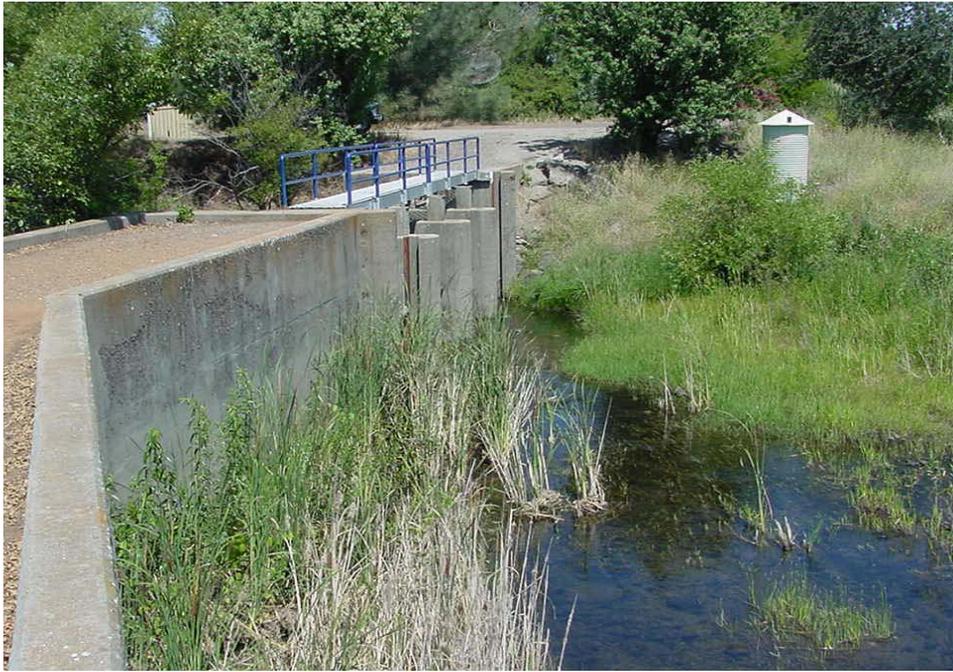
**View of the upstream side of the control structure and gauge.**

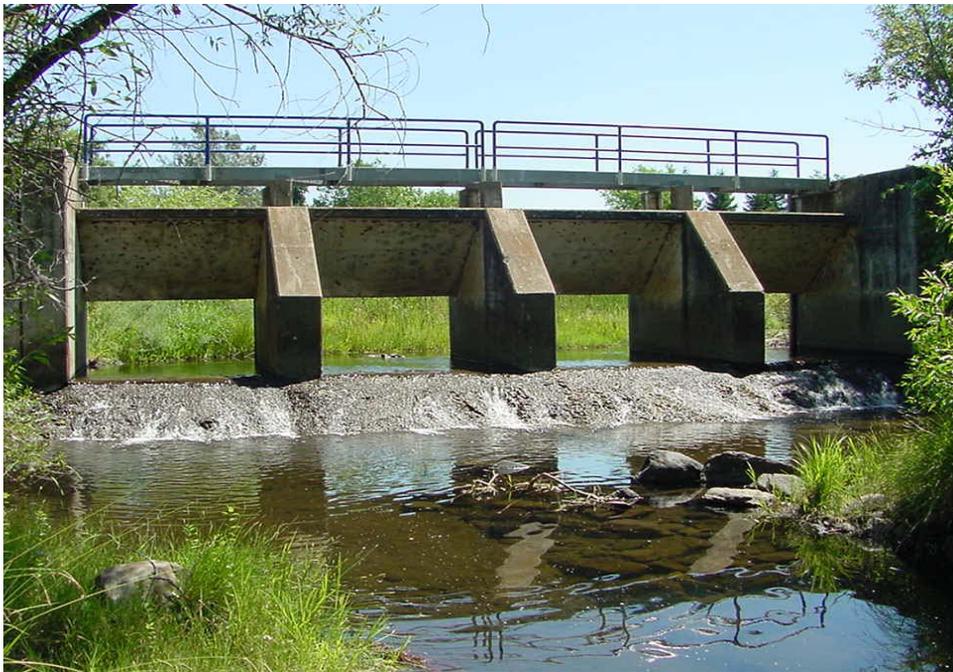
**View of the downstream side of the control structure.**

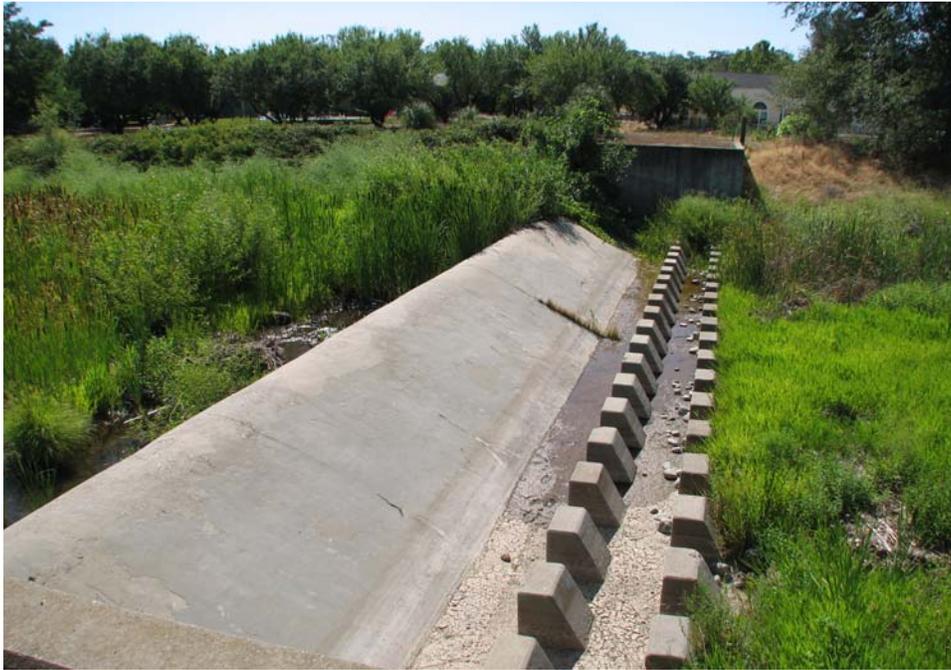
- 3. Condition of concrete weir, stilling basin, and velocity dissipaters.**
  - a. Minor cracks in the weir and minor spalling of concrete on the weir invert.**

**The weir and velocity dissipaters.**

- a. Previously reported undermining of the structure has been repaired.**
- b. Continue to monitor joint separation between the control structure and the abutments and repair as needed.**
- c. Sutter Maintenance Yard will remove vegetation upstream and downstream of the weir prior to flood season.**
- d. Remove debris from the stilling basin.**
- e. Acceptable maintenance.**

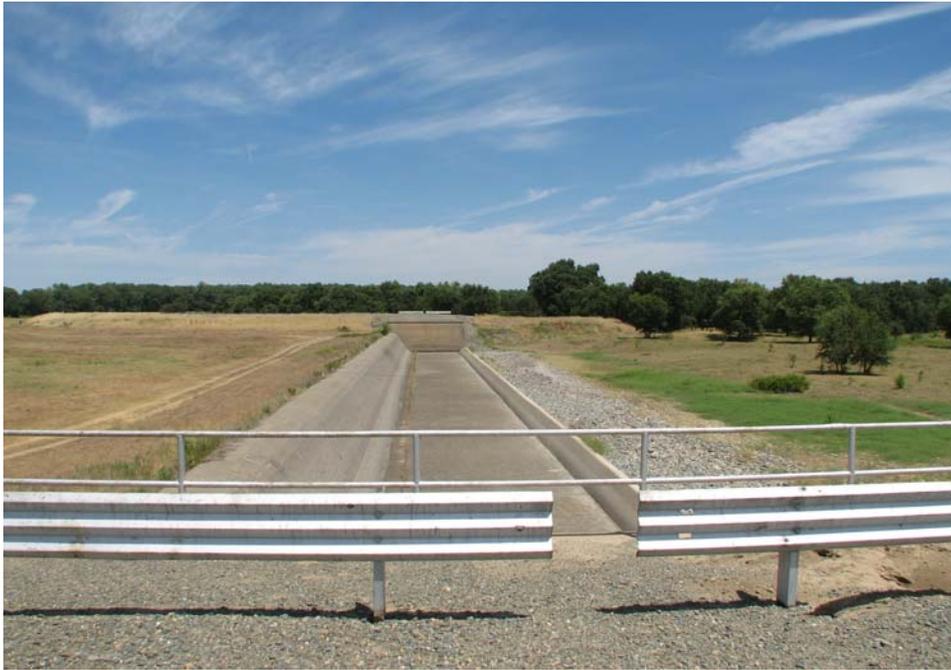
**The weir and stilling basin from the top of the south abutment.**

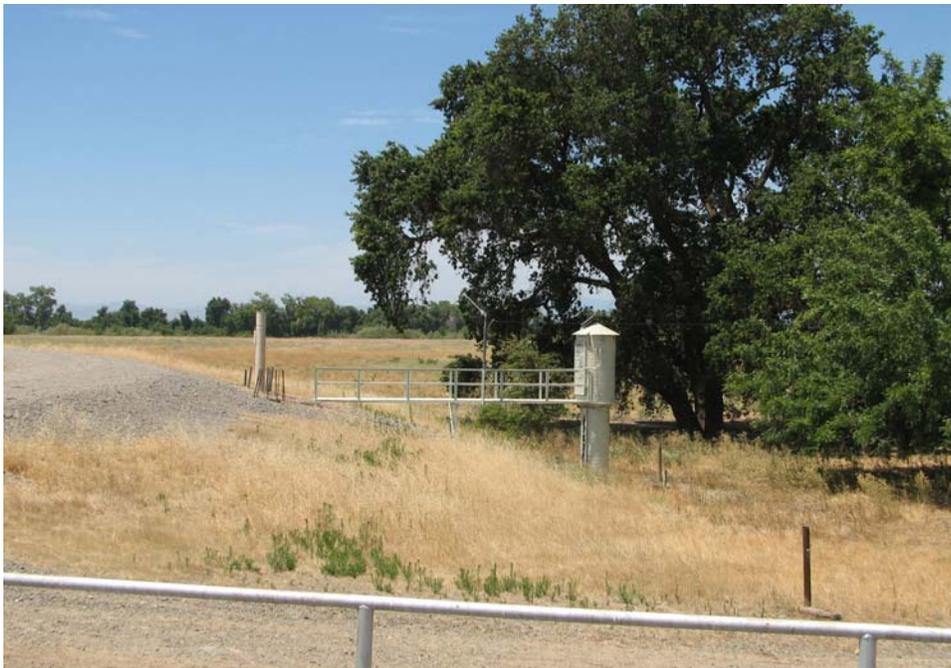
**View of the gauging house directly upstream of the weir.**

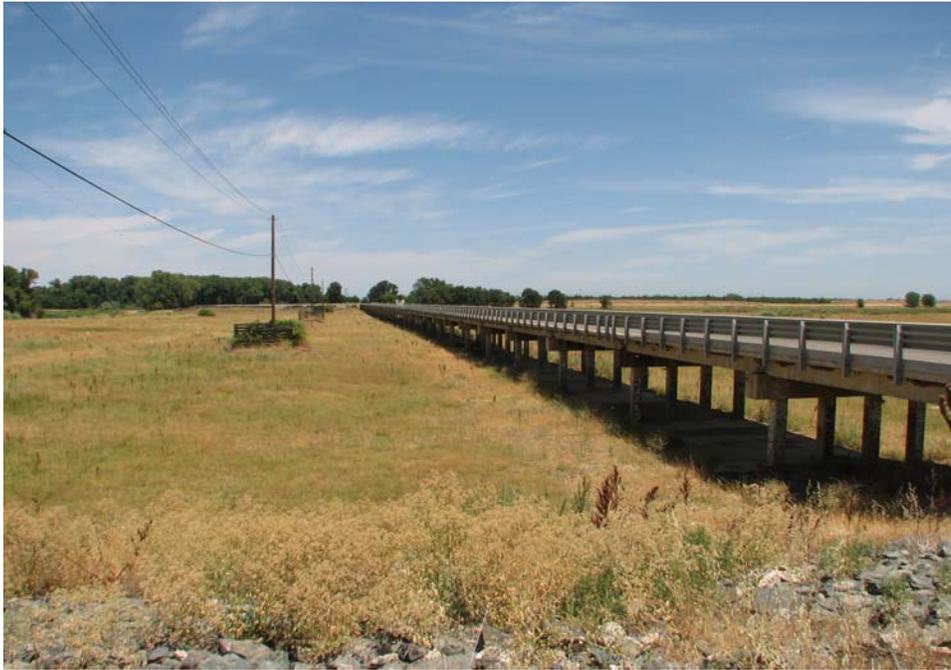
**The upstream side of weir from the south levee.**

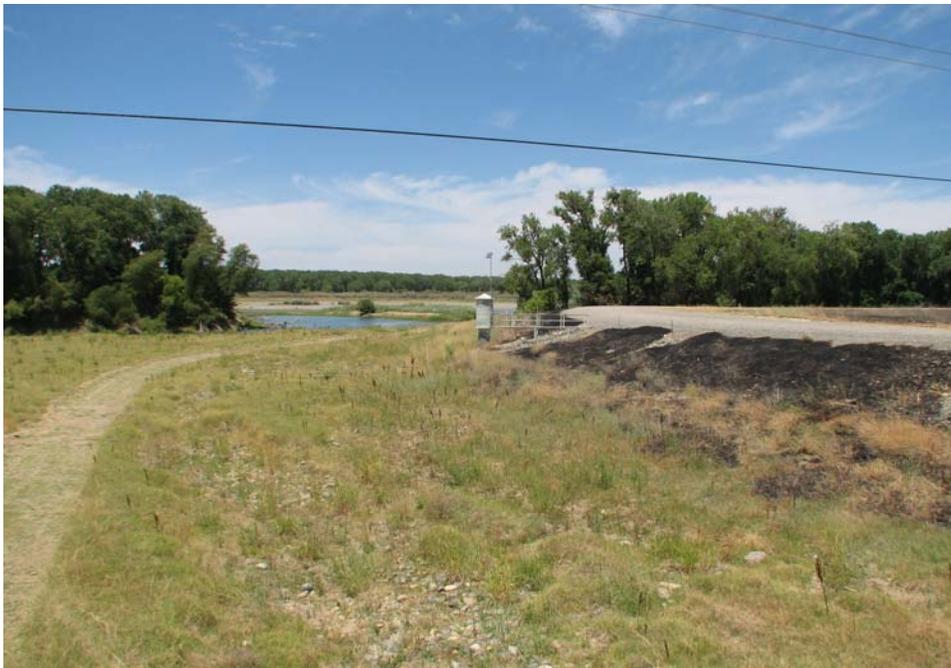
**View of the gauging house.**  
**Sacramento River is in the background.**

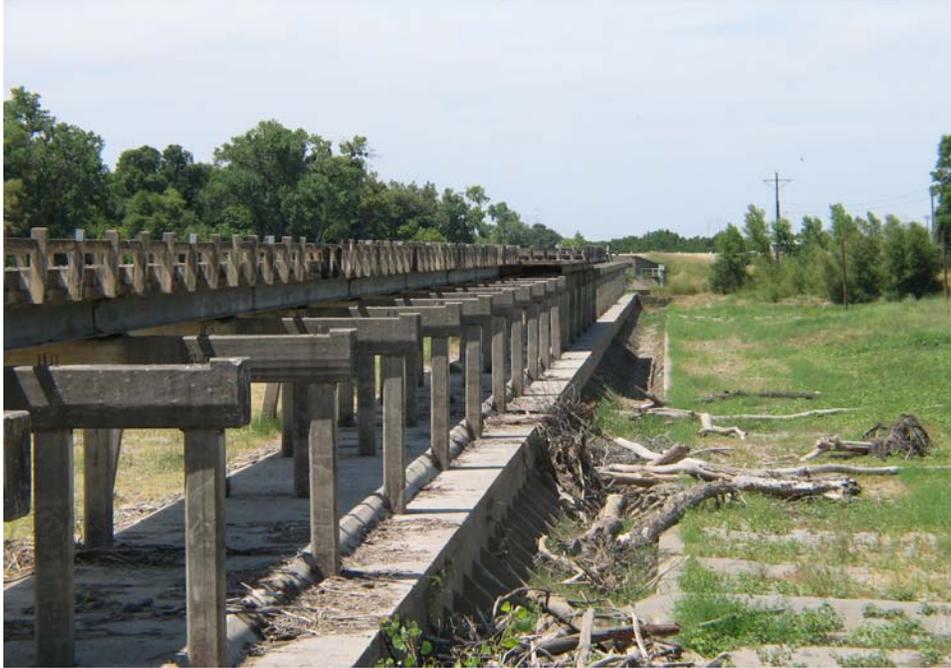
**Downstream side of the weir from the south end.**

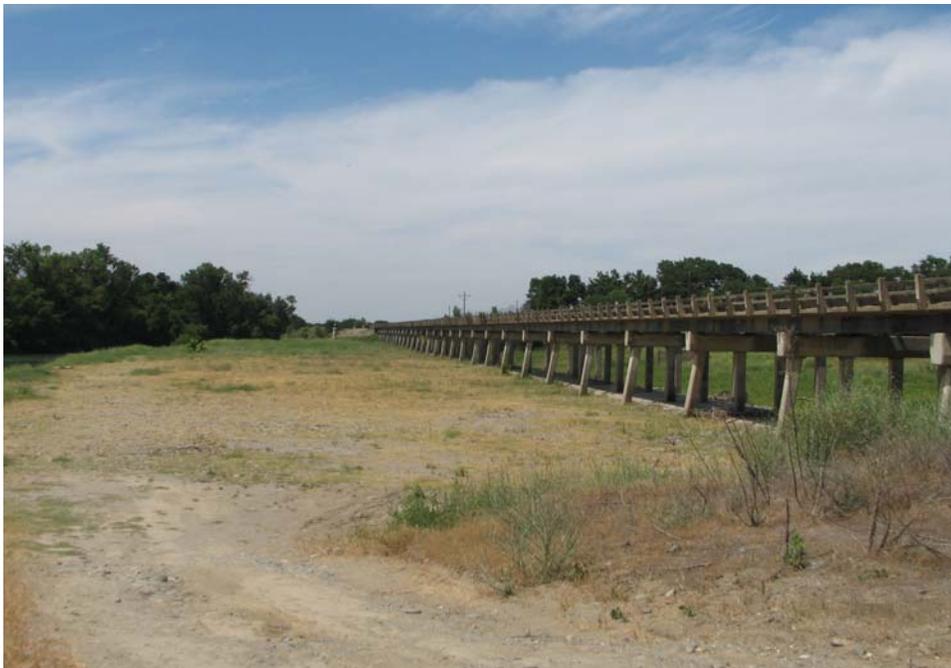
**Upstream side of the weir from the south end.**

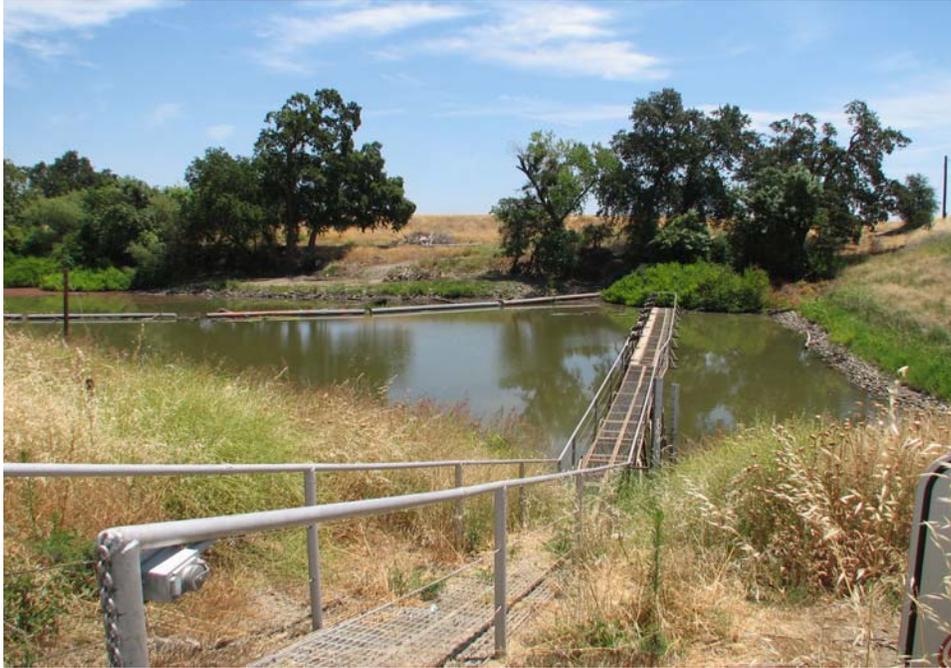
**The intake side of the structure.**

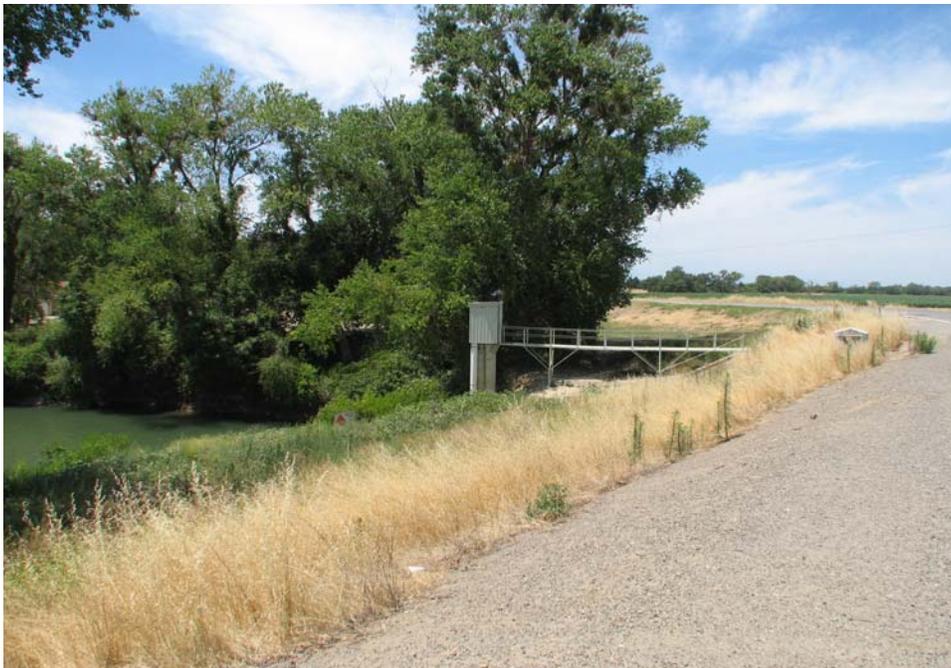
**View of the outlet channel and the gauge house.**

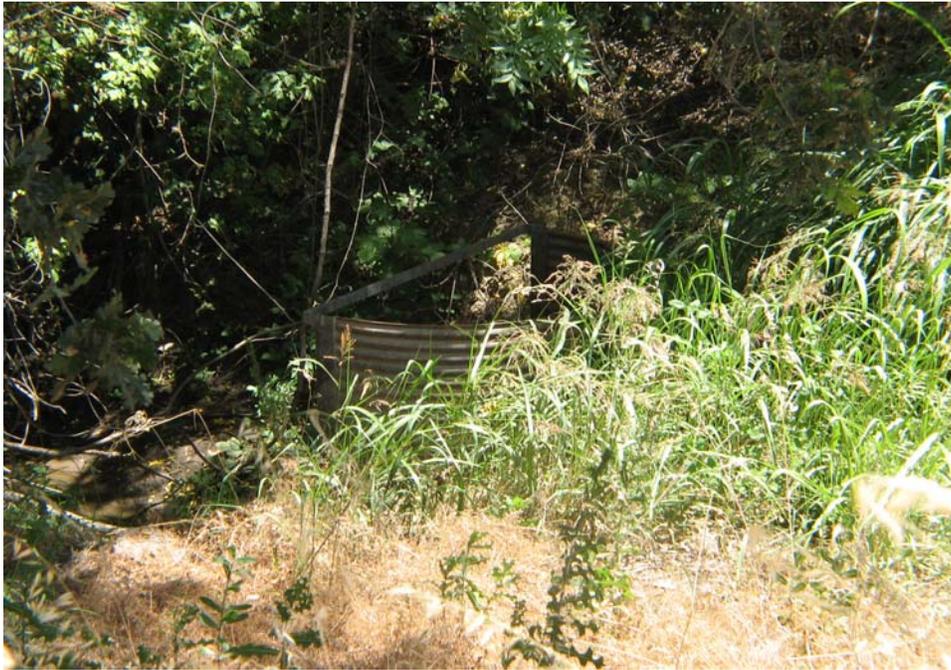
**Partial CMP stand pipe protects the inlet.**

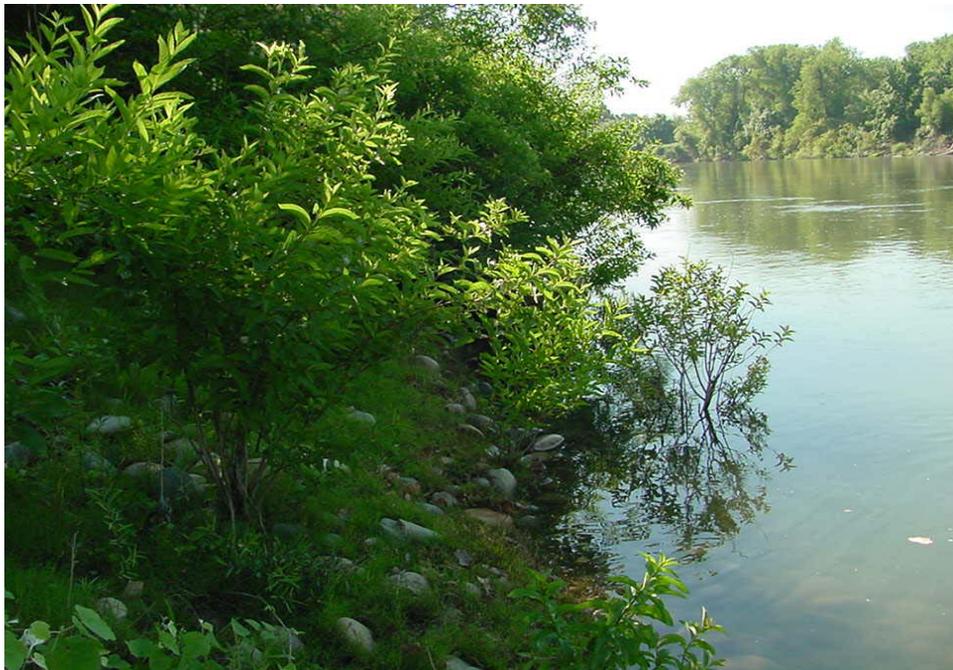
1. **Condition of the corrugated metal pipe (CMP) drainage structure.**
  - a. **Acceptable.**
2. **Condition of the control gate, mechanisms, and flap gates.**
  - a. **Acceptable**
3. **Condition of the revetment.**
  - a. **Acceptable.**
4. **Accumulation of trash and debris around the inlet, in the pipe or in the channel.**
  - a. **Minimal.**
5. **Vegetation around the structure or in the channel.**
  - a. **The vegetation immediately around the in-take needs sprayed. Growth is so dense that discharge end of structure cannot be seen.**
6. **Comments:**
  - a. **Remove vegetation from discharge end of structure. If growth is not removed, the drainage structure could become non-functional.**
  - b. **Minimally Acceptable maintenance.**

**View of the dense vegetation at the outlet.  
Outlet pipes are not visible.**

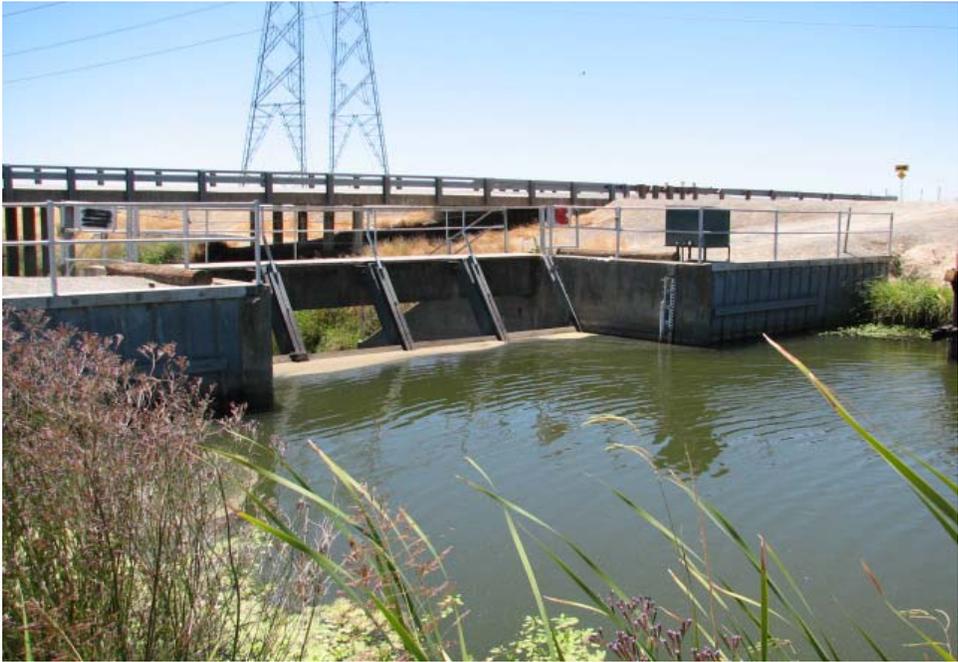
**Upstream side of structure from the left bank levee.**

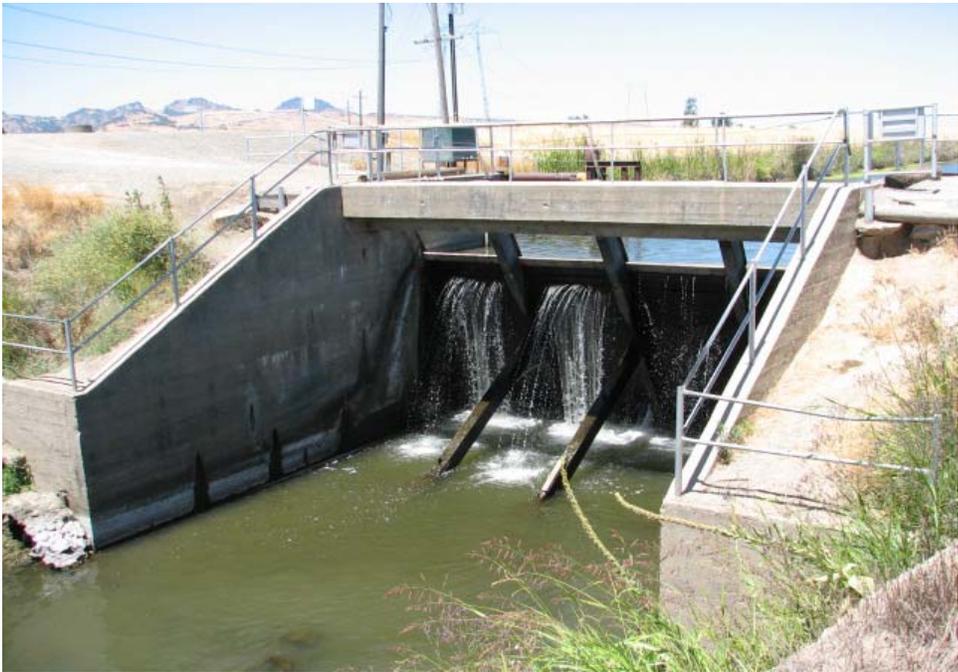
**View of the downstream side of structure.**

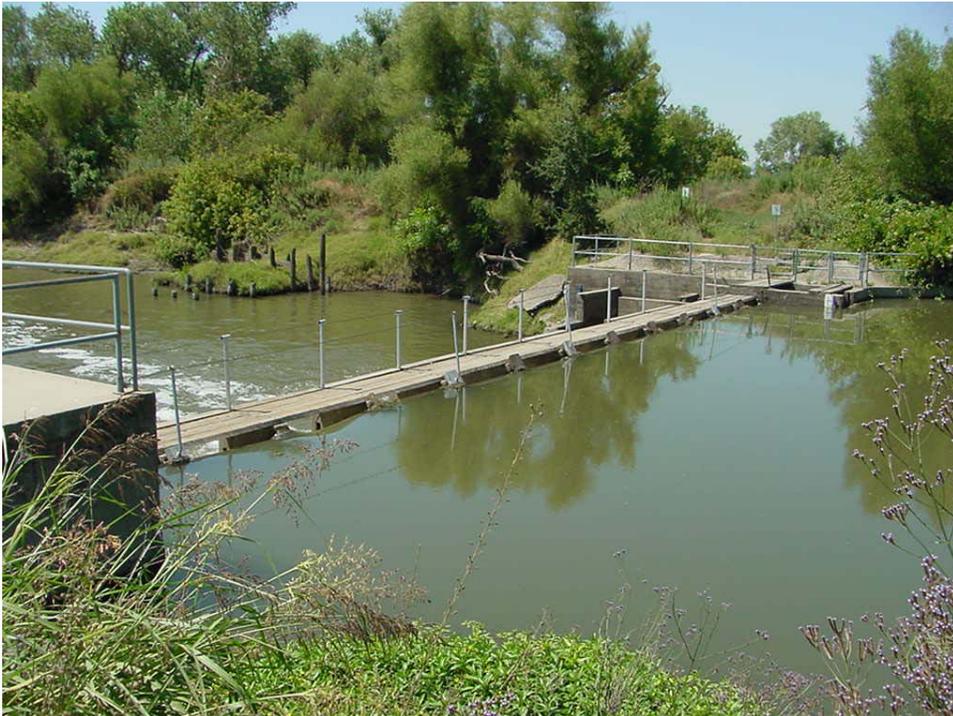
**Upstream side of the structure.**

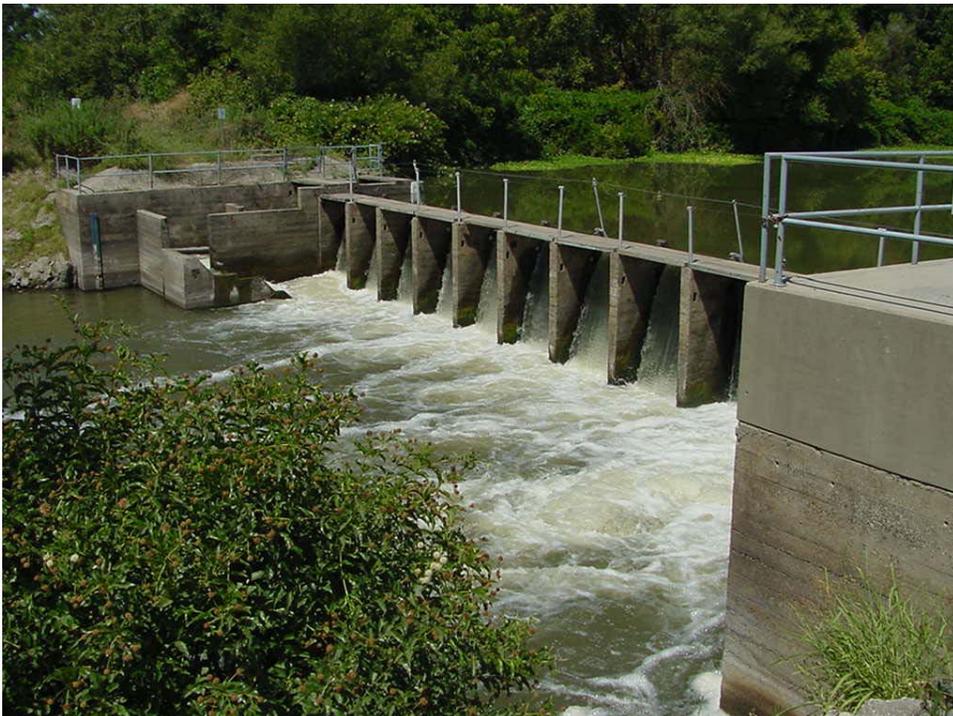
**Downstream side of the structure**

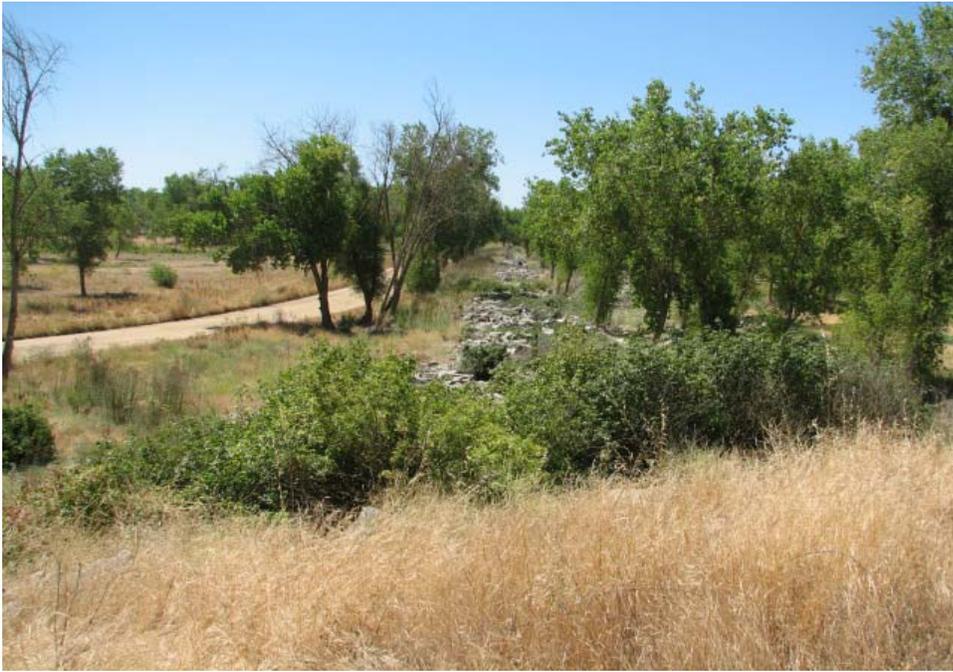
**View of the weir from the north/east end.**

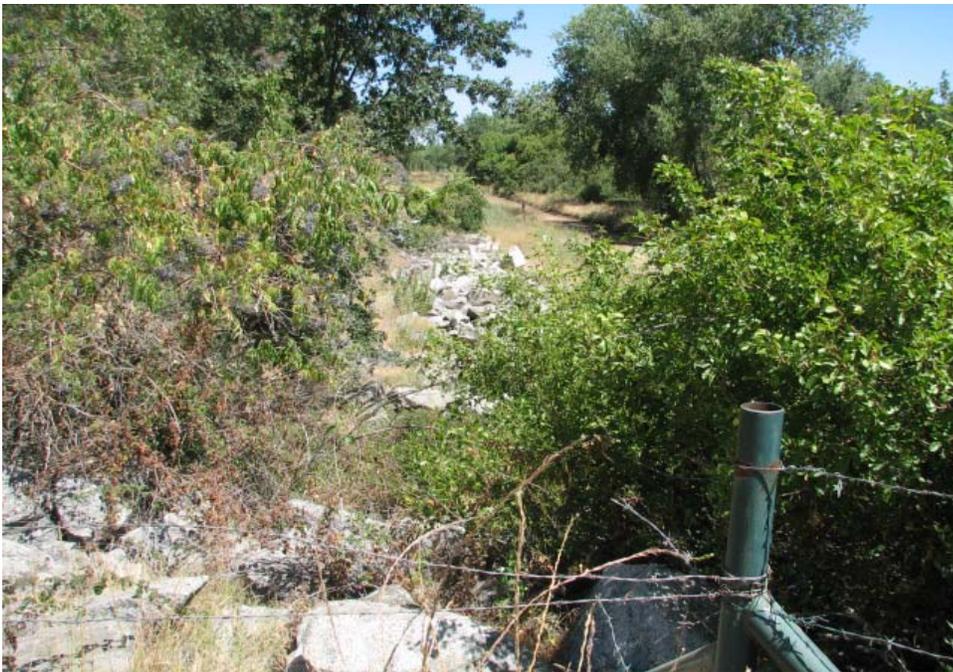
**View of the weir from the south/west end.**
