**State of California  
The Resources Agency  
DEPARTMENT OF WATER RESOURCES  
DIVISION OF FLOOD MANAGEMENT**

**2007  
PROJECT  
STRUCTURE REPORT**

**INSPECTION OF  
FLOOD CONTROL STRUCTURES ON THE  
SACRAMENTO AND SAN JOAQUIN RIVERS  
AND THEIR TRIBUTARIES**

**Prepared By  
The Flood Project Integrity & Inspection Branch**

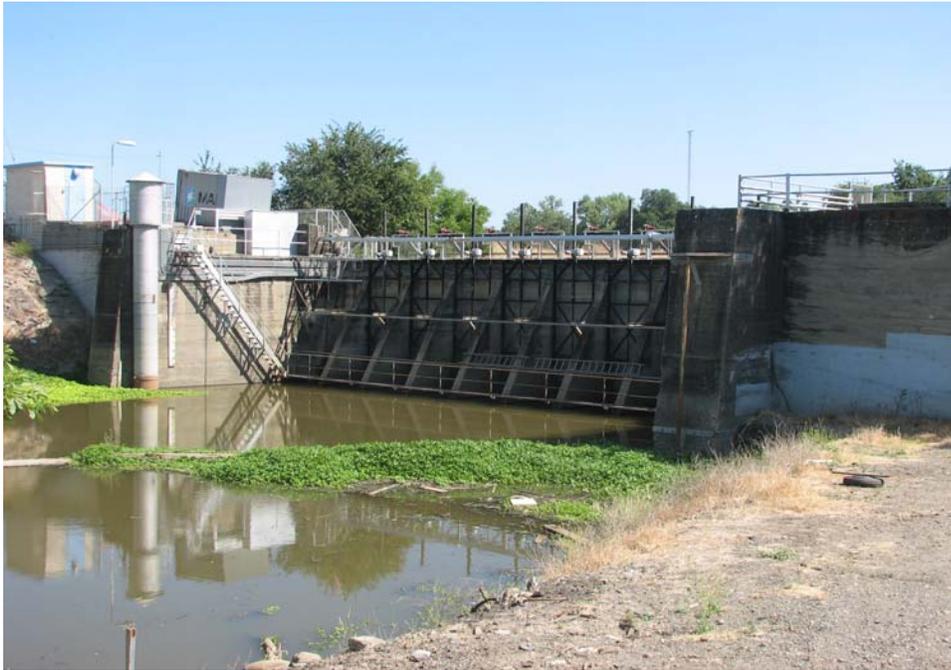
**Upstream side of structure from the left bank.**

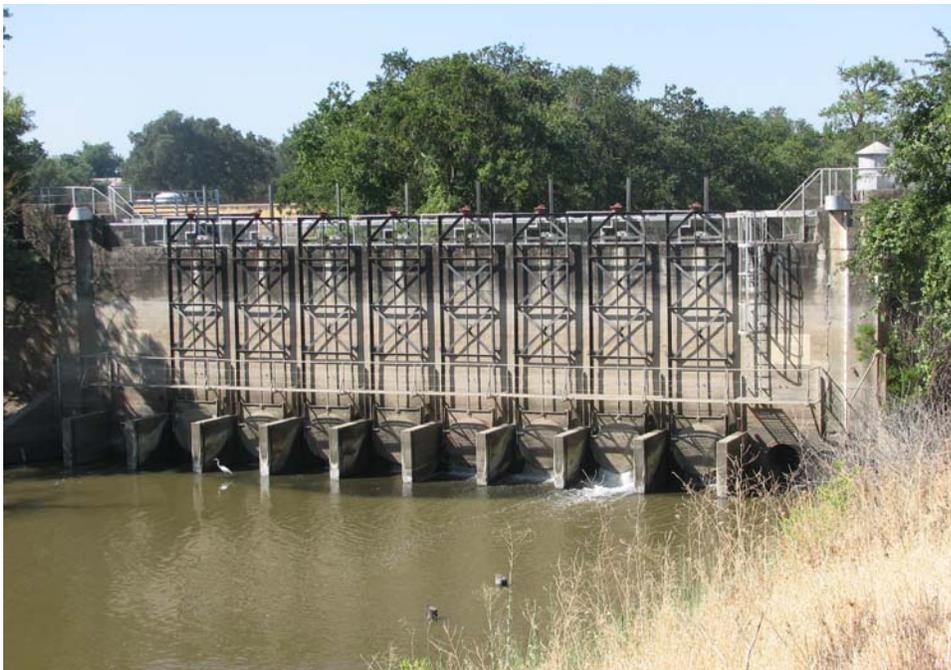
- 1. Condition of outfall structure.**
  - a. Acceptable.**
- 2. Condition of bulkheads.**
  - a. Minimally Acceptable. The large vertical crack and displacement on the downstream side, left bank, has not changed in several years. The crack is not accessible for measurement, but the overall width is estimated to be 1 inch.**

**Downstream side of the structure from the left bank.**

9. **Accumulation of trash and debris around the structure or in the channel.**
  - a. **Minimal.**
10. **Comments:**
  - a. **Structure is inspected and maintained daily.**
  - b. **The seepage through the structure should be monitored during high water stages.**
  - c. **Sacramento Maintenance Facility performs a yearly pre-season inspection of the structure and its components.**
  - c. **Clear vegetation on and around log boom.**
  - e. **Acceptable maintenance.**
11. a. **Center of gates N 38.79950, W 121.72501**

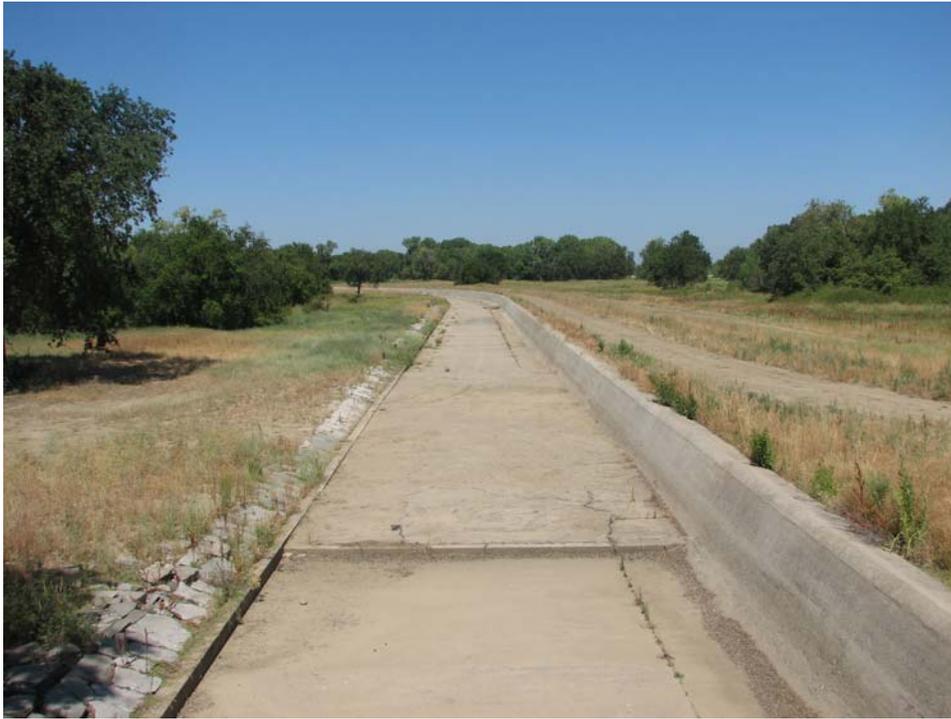
1. **Condition of concrete weir and stilling basin.**
  - a. **Some cracks and spalling exist on the weir and in the stilling basin as previously reported.**

**View of the weir and stilling basin from the south abutment.**

6. **Condition of gauging house and equipment.**
  - a. **Acceptable.**
7. **Comments:**
  - a. **Monitor the cracks and spalling and repair as needed.**
  - b. **Remove debris from the stilling basin prior to flood season.**

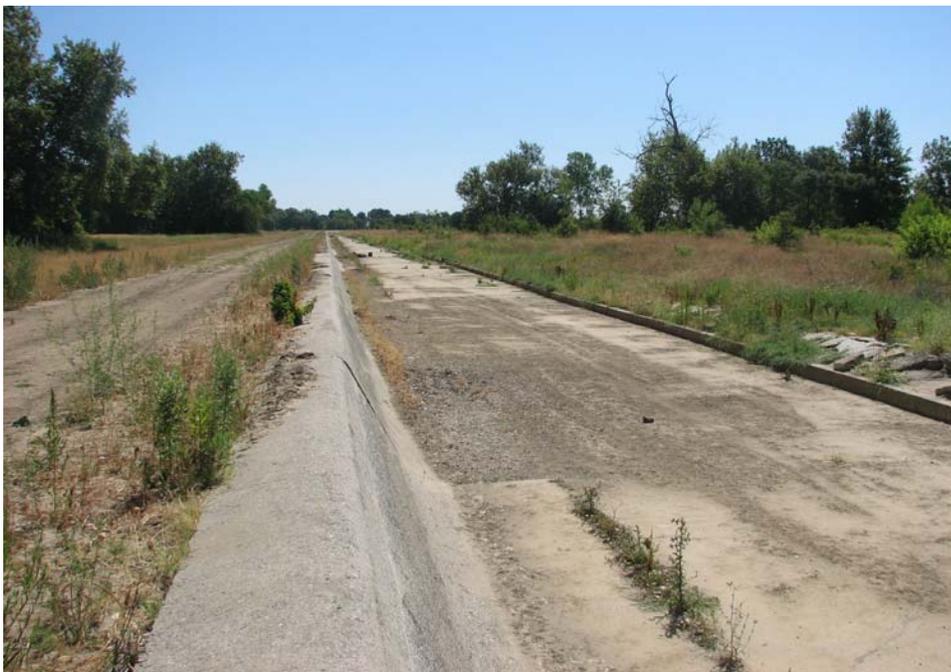
**View of the weir, looking east from fish ladder**

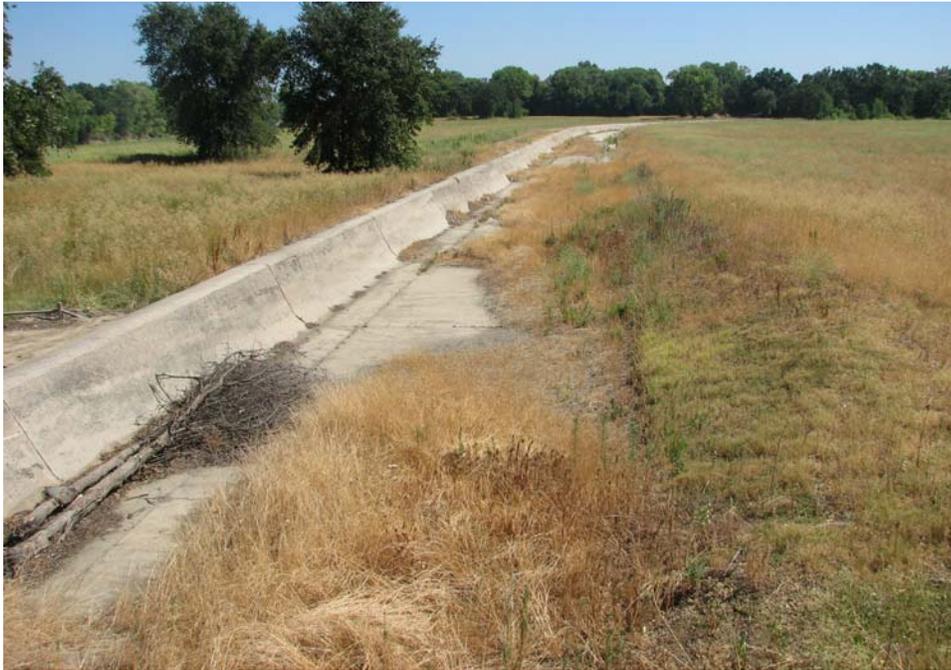
2. **Condition of concrete abutment.**
  - a. **Acceptable.**
  - b. **The crack on the downstream side of the right (south) abutment, and the two cracks on the right abutment at Rattlesnake Island, have not enlarged.**

- c. **North abutment has large cracks on east side.**
3. **Condition of revetment.**
  - a. **Acceptable.**
4. **Accumulation of trash and debris around the structure or in the channel.**

**View of the weir and stilling basin from the north abutment.**

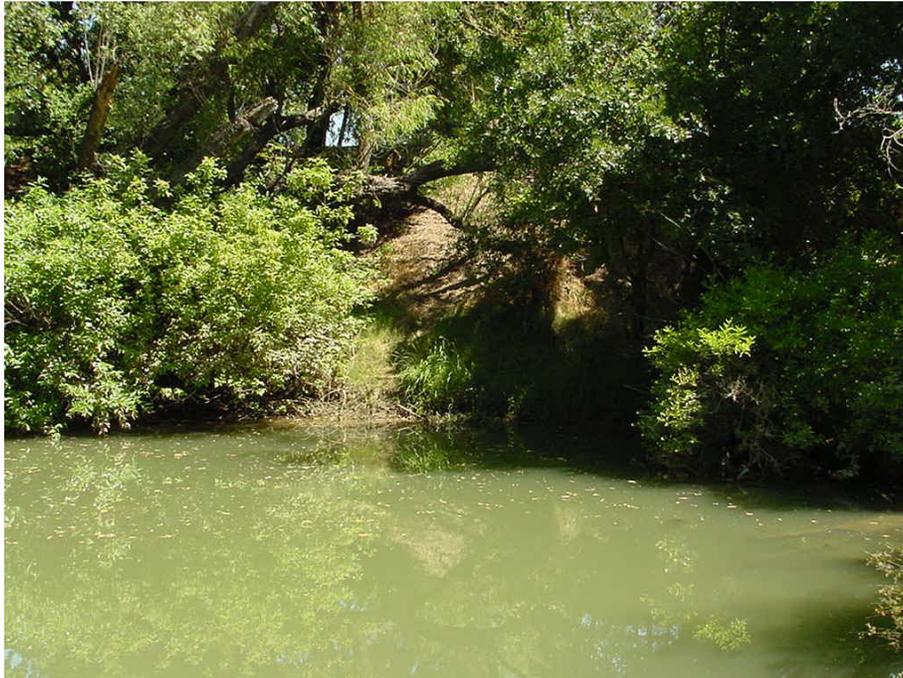
**ELK SLOUGH INLET STRUCTURE**  
**Maintained by Reclamation District No. 999**

**View of the discharge side into Elk Slough.  
The structure is under water.**

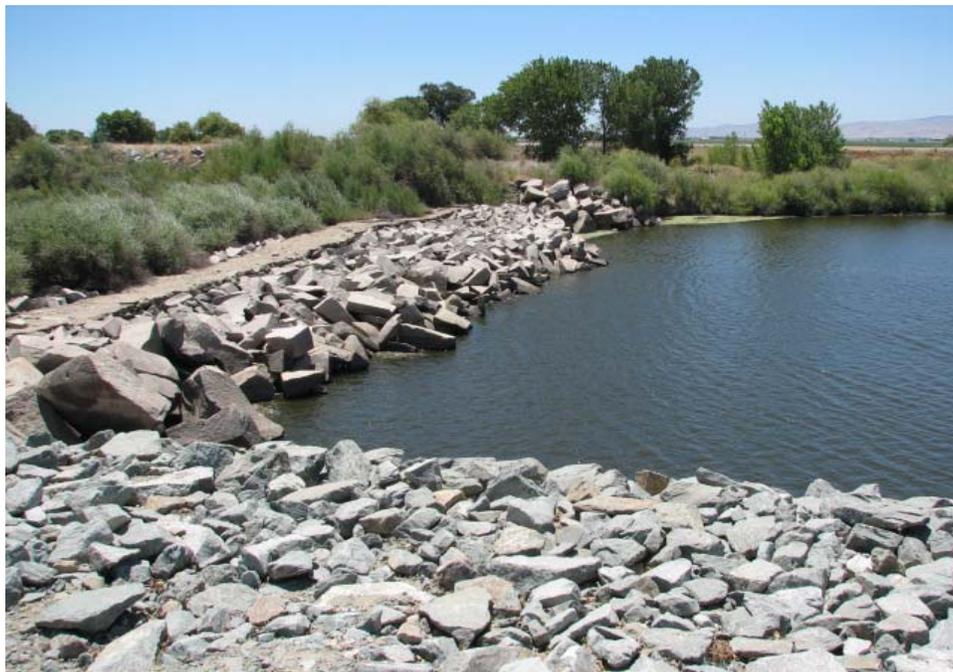
**Looking southeast at the downstream side of the structure.  
The San Joaquin river is in the background.**

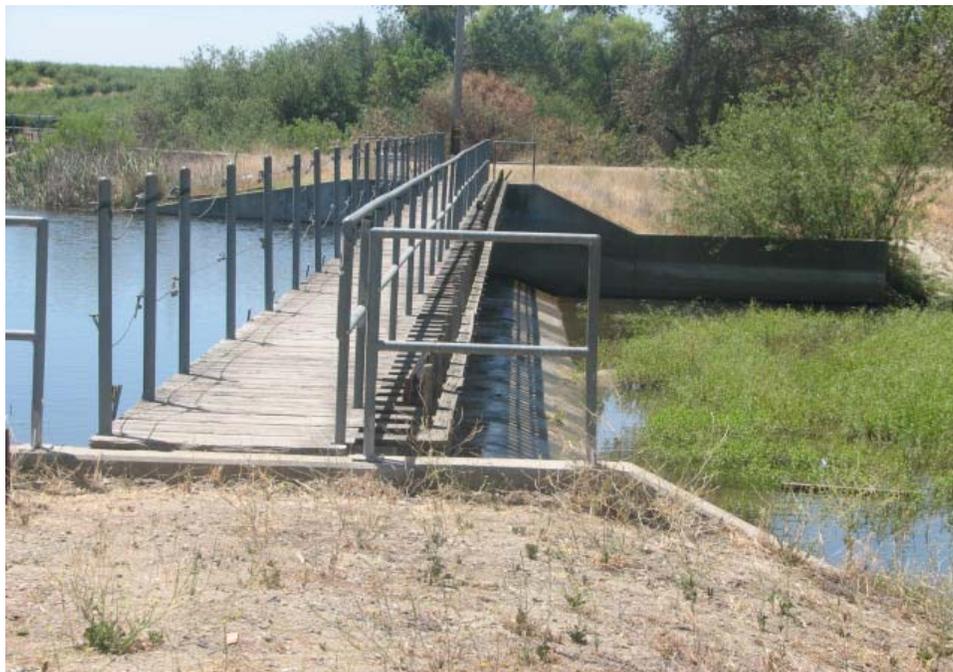
**ASH AND BERENDA SLOUGH CONTROL STRUCTURE**  
Maintained by Madera County F.C. & W.C.A.

**The downstream side of the Ash structure.  
Note the dense vegetation.**

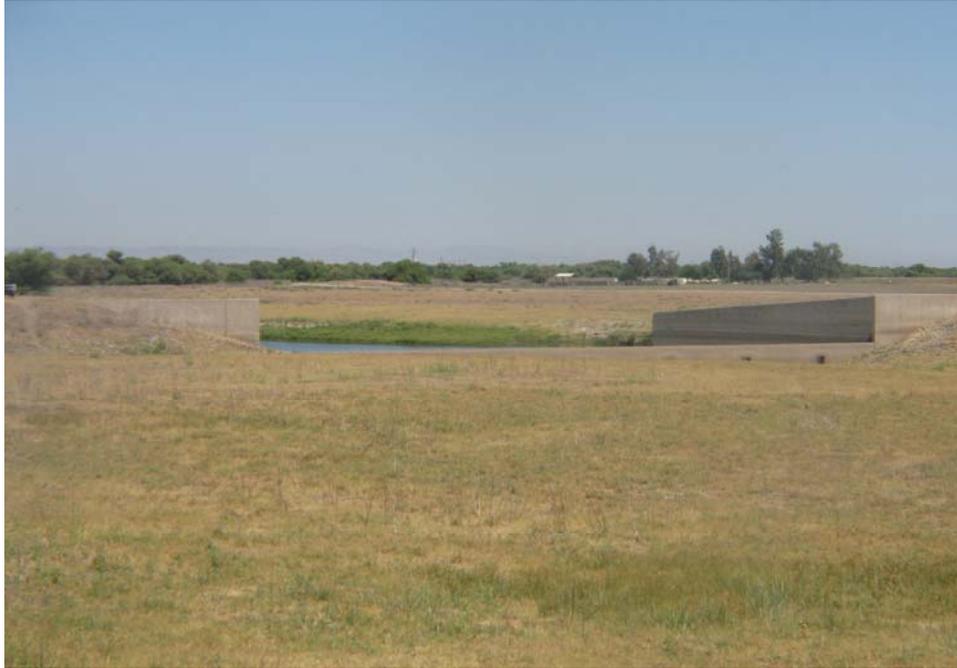
**MARIPOSA BYPASS DROP STRUCTURE**  
Maintained by Lower San Joaquin Levee District

1. **Condition of concrete drop structure, stilling basin, and velocity dissipaters.**
  - a. **Acceptable.**
2. **Condition of concrete abutments and wing walls.**
  - a. **The left wing wall has a 3 inch separation at the joint and is not stable.**
3. **Condition of revetment.**
  - a. **Acceptable.**
4. **Accumulation of trash and debris around the structure or in the channel.**
  - a. **None.**
5. **Vegetation around the structure or in the channel.**
  - a. **None.**
6. **Comments:**
  - a. **Monitor the left wing wall during high water.**
  - b. **Acceptable maintenance.**

**The upstream side of the structure**

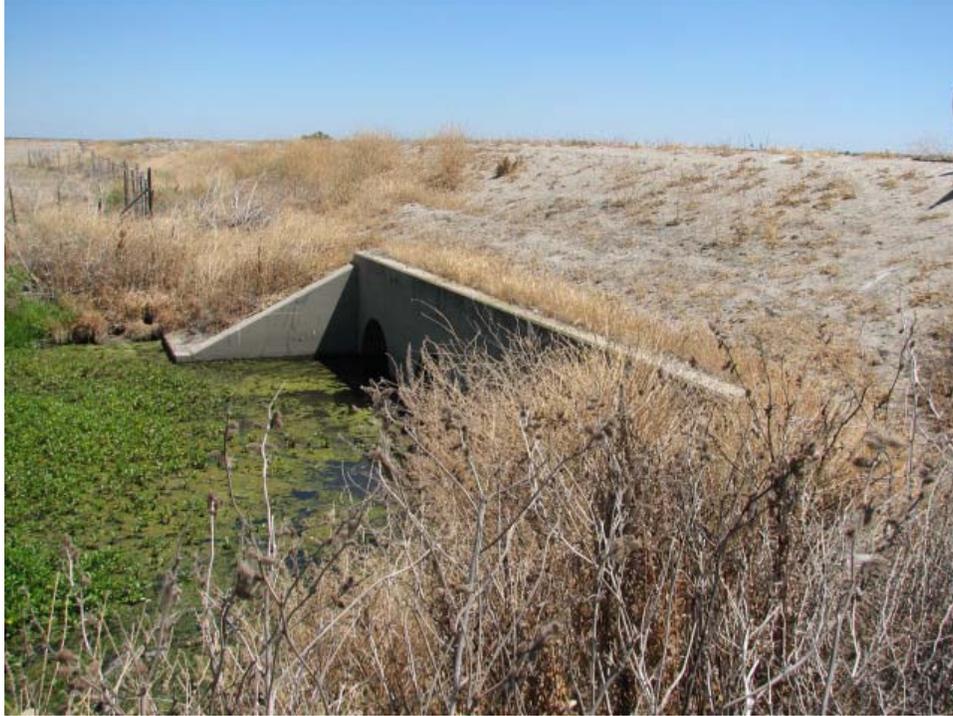
**FRESNO RIVER DRAINAGE STRUCTURE**  
Maintained by Lower San Joaquin Levee District

1. **Condition of concrete drainage structure.**
  - a. **Acceptable.**
2. **Condition of abutments and wing walls.**
  - a. **Acceptable.**
3. **Condition of control gate, mechanism, and flap gate.**
  - a. **The control gate mechanism is bent.**
4. **Condition of revetment.**
  - a. **Acceptable.**
5. **Accumulation of trash and debris around the structure or in the channel.**
  - a. **Acceptable.**
6. **Vegetation around the structure or in the channel.**
  - a. **Moderate.**
7. **Comments:**
  - a. **Repair the control gate mechanism.**
  - b. **Minimally Acceptable maintenance.**

**The intake side of the structure.**

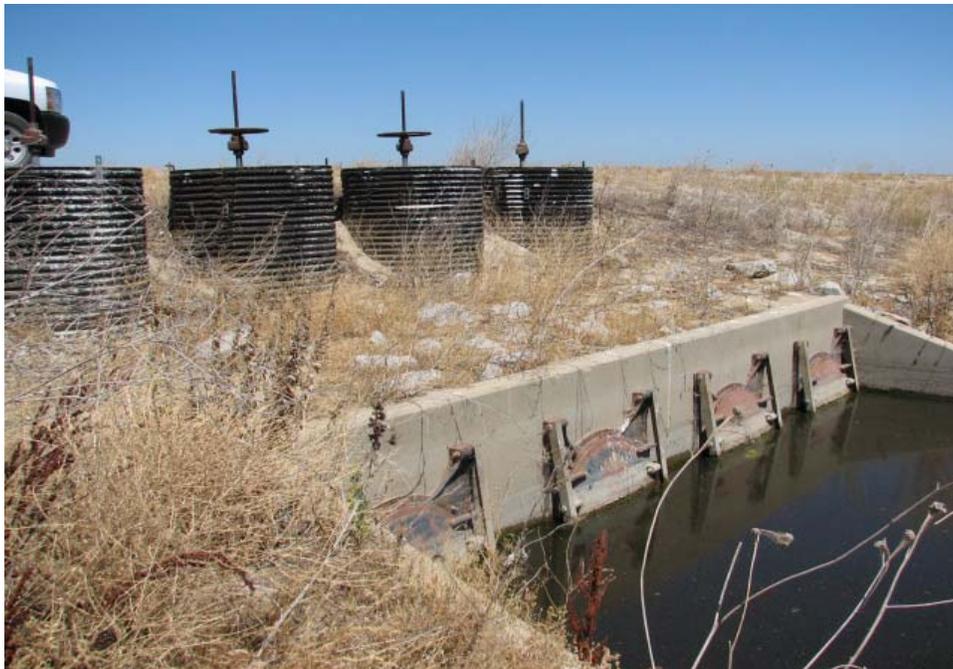
**The discharge side of the  
Structure and the control mechanism.**

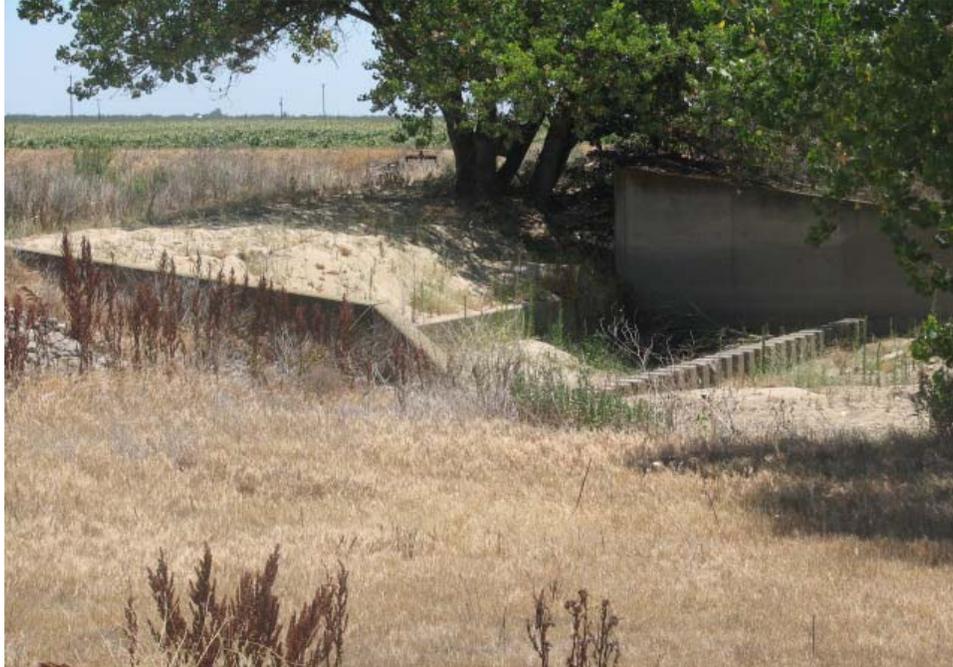
**ASH SLOUGH DROP STRUCTURE NO. 4**  
**Maintained by Lower San Joaquin Levee District**

1. **Condition of concrete drop structure, stilling basin, and velocity dissipaters.**
  - a. **What can be seen is in Acceptable condition, but a seasonal sand dam is backing up water for irrigation purposes on the upstream side.**

- a. **None.**
5. **Vegetation around the structure or in the channel.**
  - a. **Minimal.**
6. **Condition of the gauging house and equipment.**
  - a. **The gauging house is completely non-functional. A placard on the damaged door indicates that this is a DWR gauging station.**

**The downstream side of the drop structure and the seasonal sand dam.**

- b. **Remove bamboo.**
  - c. **Determine the status of the gauging house and report findings to the Flood Project Inspection Section.**
  - d. **Unable to perform an adequate inspection of the structure due to the sand dam.**

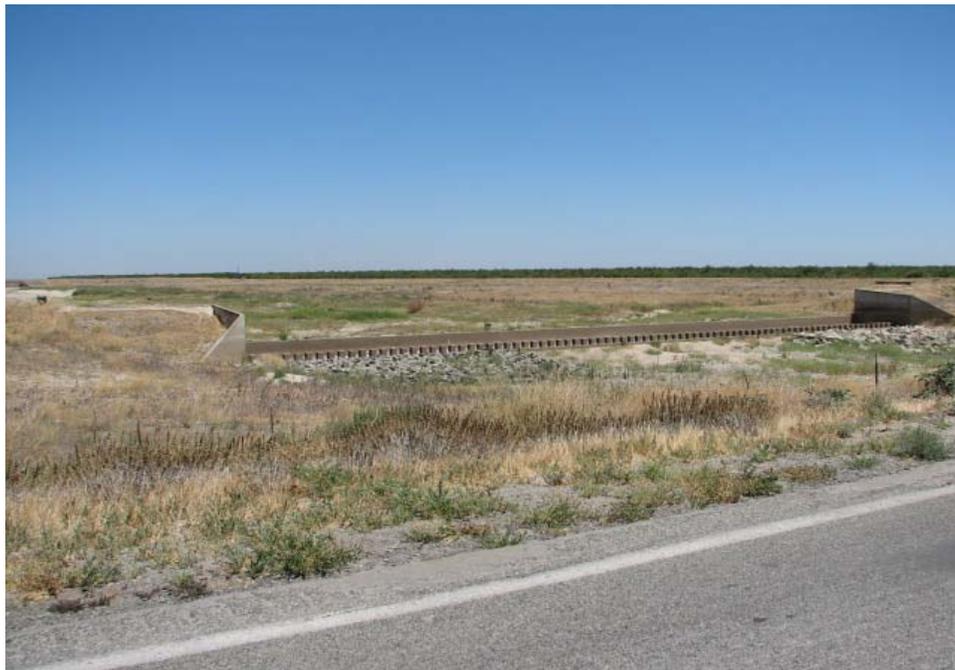
**Looking northeast at the drop structure.**

1. **Condition of concrete structure, stilling basin, and velocity dissipaters.**
  - a. **Acceptable.**
2. **Condition of concrete abutments and wing walls.**
  - a. **Acceptable.**
3. **Condition of revetment.**
  - a. **Acceptable.**
4. **Accumulation of trash and debris around the structure or in the channel.**
  - a. **Minimal.**
5. **Vegetation and debris around the structure or in the channel.**
  - a. **None.**
6. **Comments:**
  - a. **Acceptable maintenance.**

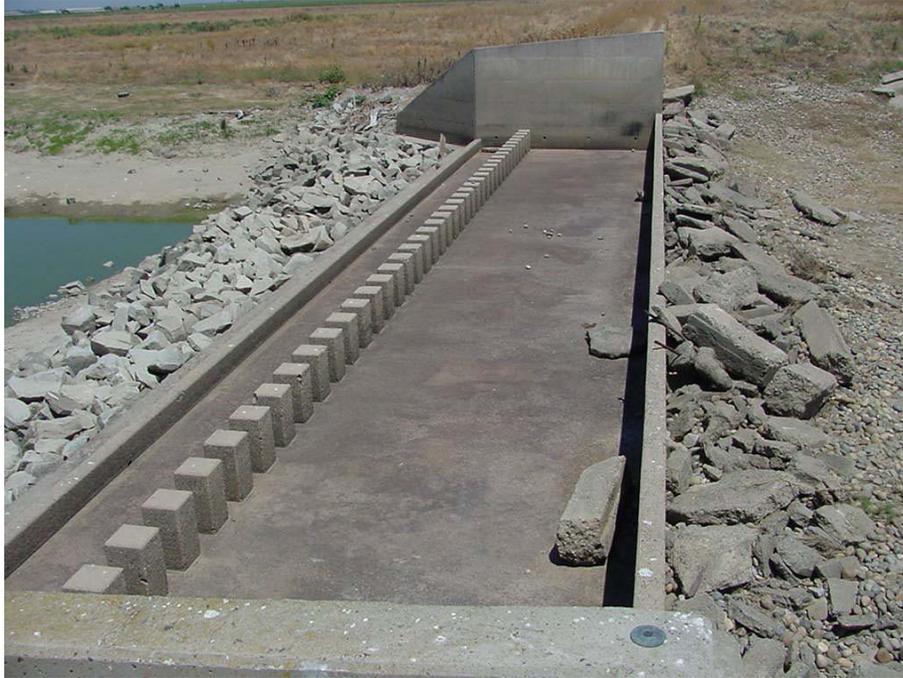
**Overview of the stilling basin, velocity dissipaters and revetment.**

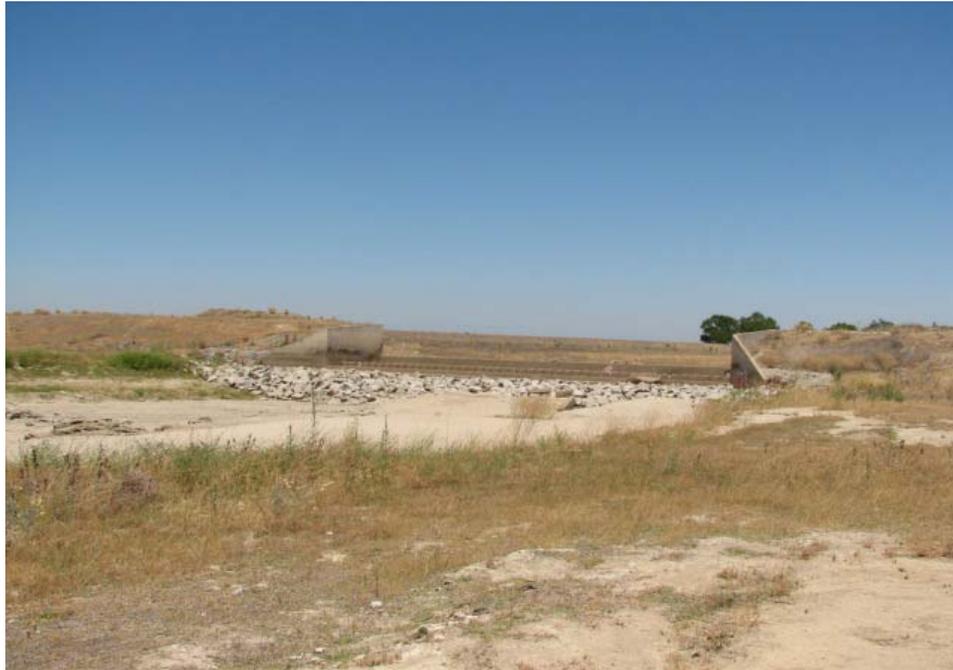
**Looking east at the drop structure.**

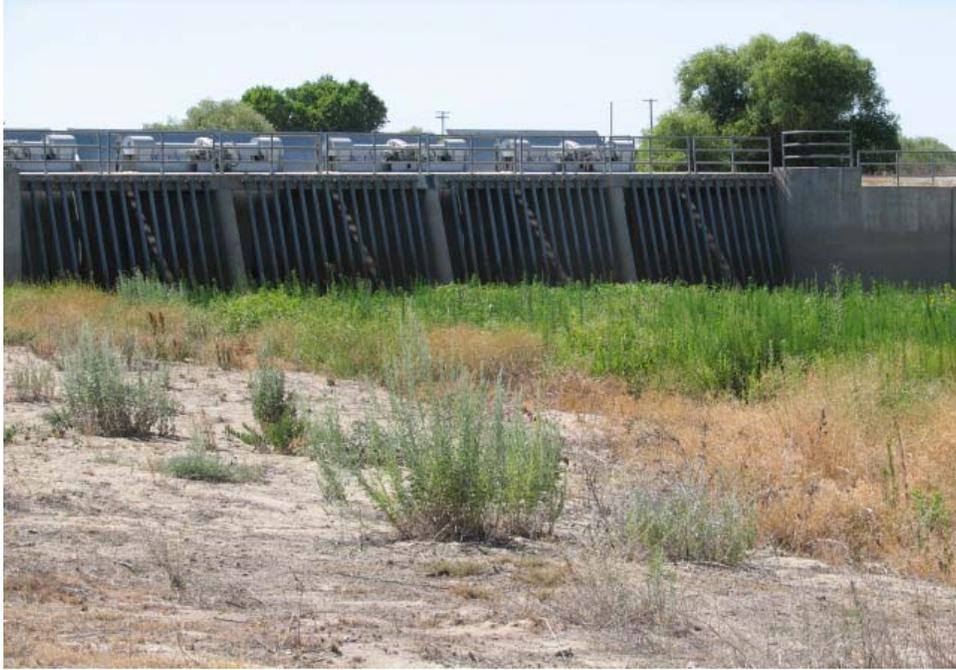
1. **Condition of the San Joaquin River Control Structure.**
  - a. **Acceptable.**
2. **Condition of the Chowchilla Canal Bypass Structure.**
  - a. **Acceptable.**
3. **Condition of the abutments and wing walls.**
  - a. **Acceptable.**
4. **Condition of the radial gates and mechanisms.**
  - a. **Acceptable.**
5. **Condition of the gate hoist equipment.**
  - a. **Acceptable.**
6. **Condition of the engine generator set.**
  - a. **Acceptable.**
7. **Condition of the float wells and equipment.**
  - a. **Acceptable.**
8. **Accumulation of trash and debris around the structures or in the channel.**
  - a. **None.**
9. **Vegetation around the structures or in the channel.**
  - a. **Minimal.**
10. **Comments:**
  - a. **All the equipment is tested and serviced prior to flood season each year**
  - b. **Acceptable maintenance.**

**The upstream side of the San Joaquin River structure.**

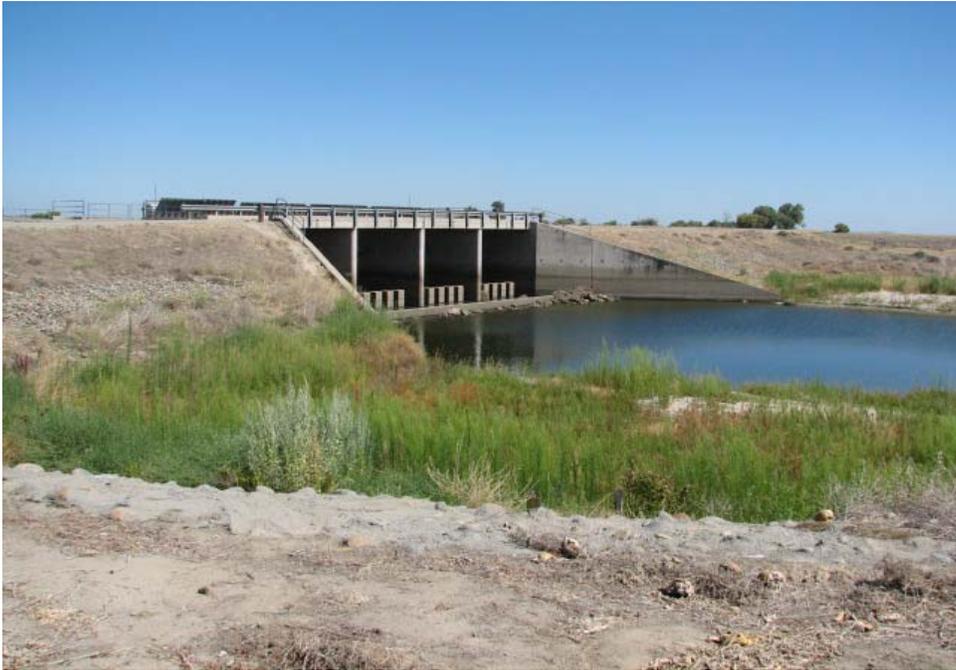
**The downstream side of the San Joaquin River structure.**

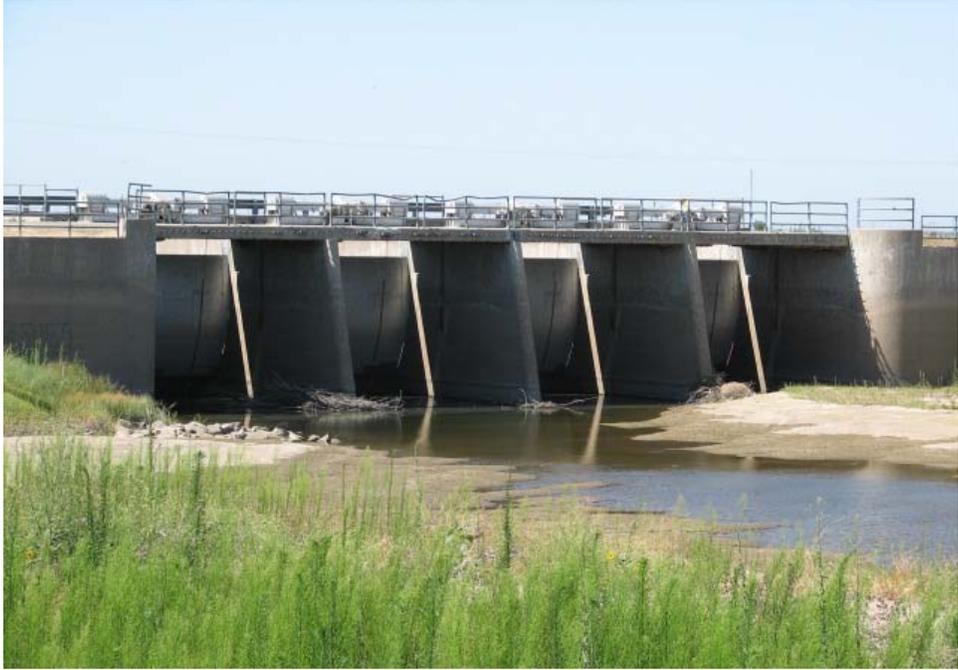
**The upstream side of the Chowchilla Canal Bypass structure.**

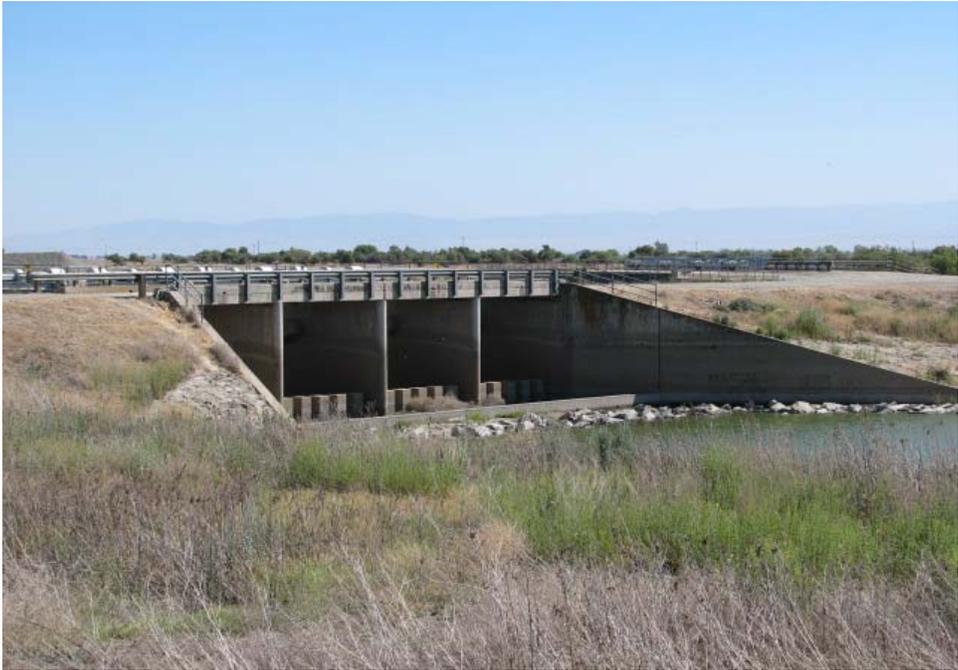
**The downstream side of the structure  
into the Chowchilla Canal bypass.**

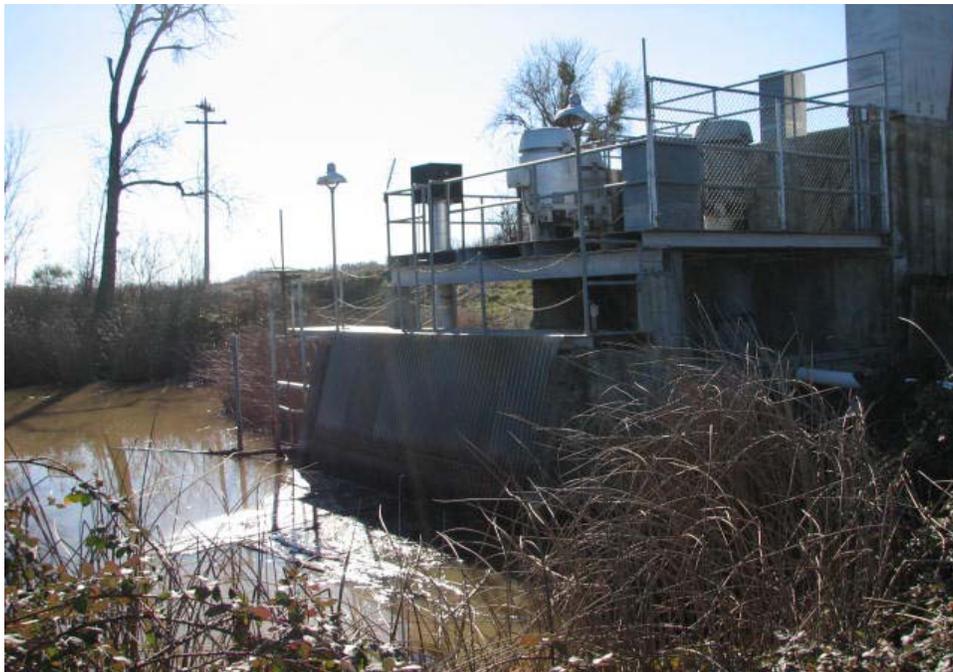
**View of the pumping plant, sump and trash racks.**

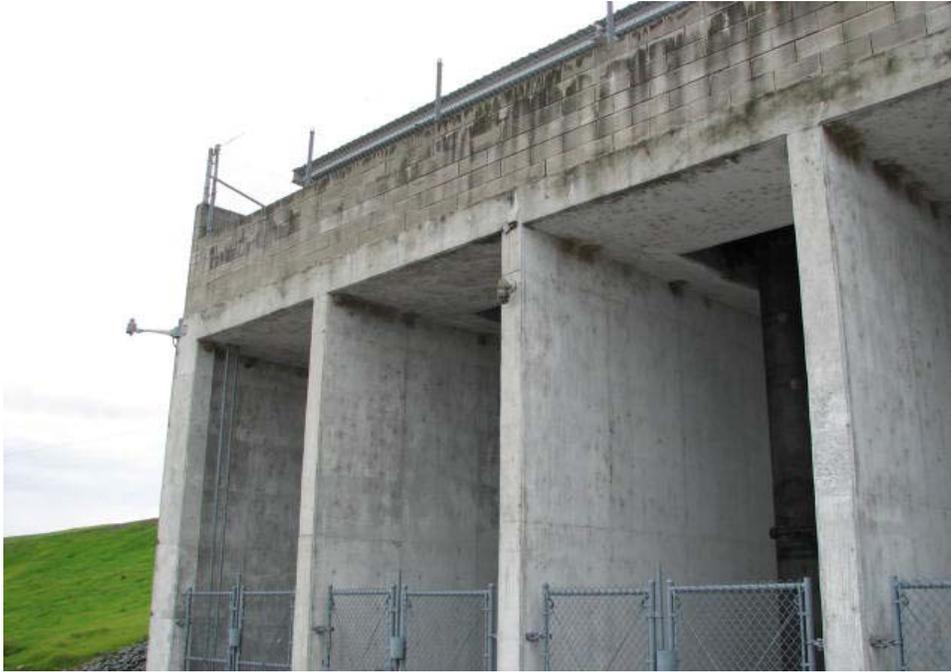
1. **Overall Facility Maintenance Rating**
  - a. **Acceptable**
2. **Operating Log and Maintenance Manual**
  - a. **Acceptable, Copy received**
  - b. **Acceptable, Manual available.**
3. **Building and Structure**
  - a. **Acceptable**
4. **Life Safety and Security Fencing**
  - a. **Acceptable**
  - b. **Acceptable**
5. **Sumps or Wet wells and Trash Racks**
  - a. **Acceptable**
  - b. **Acceptable**
6. **Slide and Flap Gates**
  - a. **Acceptable**
  - b. **Acceptable**
7. **Manual and Electric Gate Operators**
  - a. **Acceptable**
  - b. **Acceptable**
8. **Pump and Pump Control system**
  - a. **Minimally Acceptable, Unit 3 scheduled for repair**
  - b. **Acceptable**
9. **Metallic Elements**
  - a. **Acceptable**

**The intake side of the pumping plant.**

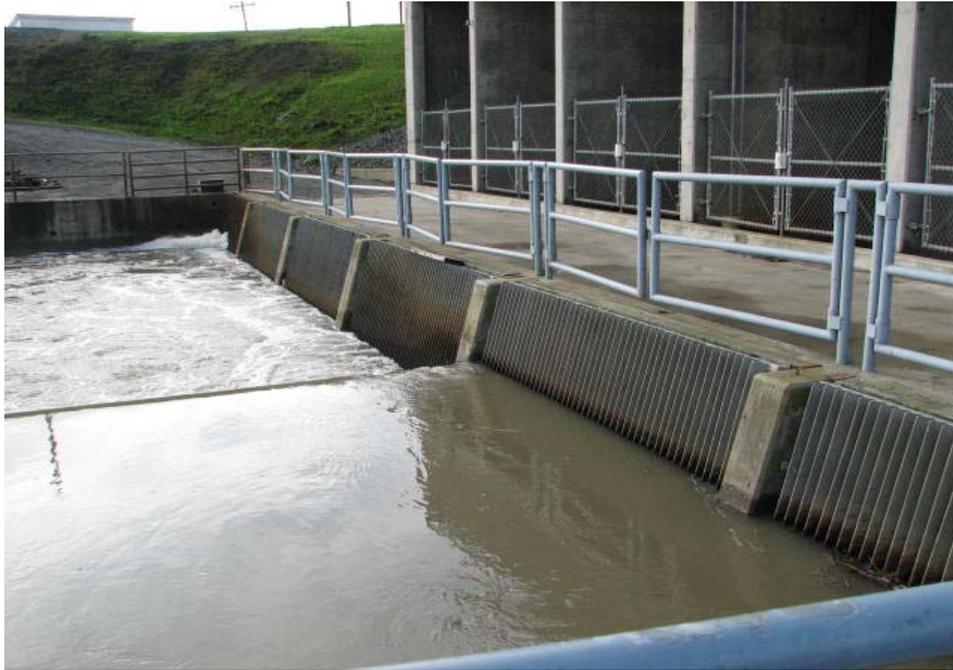
- 1. Overall Facility Maintenance Rating**
  - a. **Acceptable**
- 2. Operating Log and Maintenance Manual**
  - a. **Acceptable, Copy received**
  - b. **Acceptable, Manual available.**
- 3. Building and Structure**
  - a. **Acceptable**
- 4. Life Safety and Security Fencing**
  - a. **Acceptable, concrete landing step cracked**
  - b. **Minimally Acceptable, main corrugated metal gate damaged**
- 5. Sumps or Wet wells and Trash Racks**
  - a. **Minimally Acceptable, small amount of debris accumulation in sump 4**
  - b. **Acceptable**
- 6. Slide and Flap Gates**
  - a. **Acceptable**
  - b. **Acceptable**
- 7. Manual and Electric Gate Operators**
  - a. **Acceptable**
  - b. **Acceptable**
- 8. Pump and Pump Control system**
  - a. **Acceptable**
  - b. **Acceptable**
- 9. Metallic Elements**
  - a. **Acceptable, protective coating on repaired intake patchy**

**The pumping plant, sump and trash racks from the intake side.**

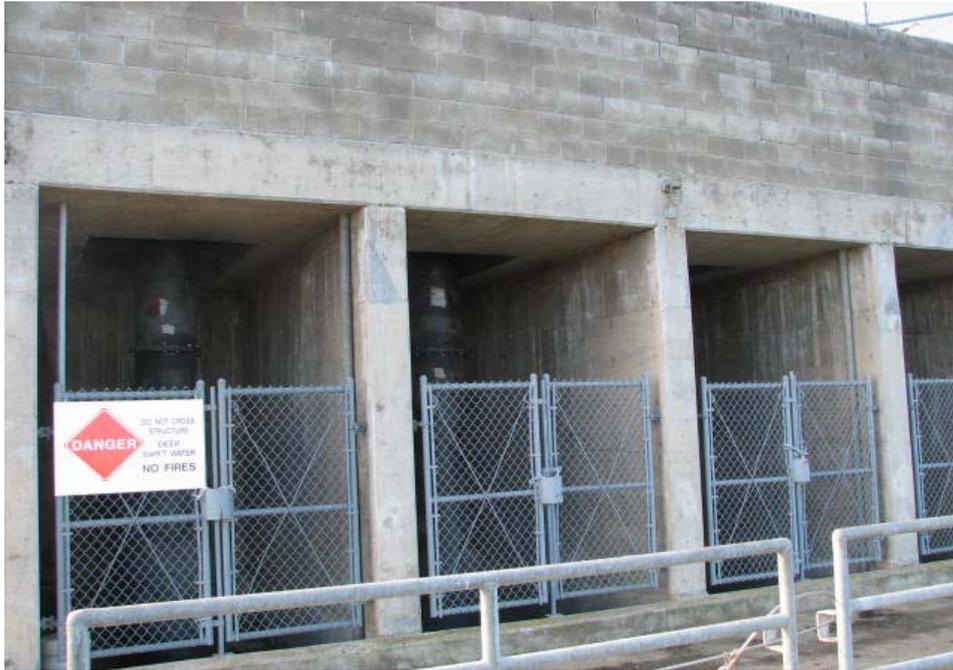
- 1. Overall Facility Maintenance Rating**
  - a. Acceptable**
- 2. Operating Log and Maintenance Manual**
  - a. Acceptable, Copy received**
  - b. Acceptable, Manual available.**
- 3. Building and Structure**
  - a. Acceptable**
- 4. Life Safety and Security Fencing**
  - a. Acceptable**
  - b. Acceptable**
- 5. Sumps or Wet wells and Trash Racks**
  - a. Acceptable**
  - b. Acceptable**
- 6. Slide and Flap Gates**
  - a. Acceptable**
  - b. Acceptable**
- 7. Manual and Electric Gate Operators**
  - a. Acceptable**
  - b. Acceptable**
- 8. Pump and Pump Control system**
  - a. Acceptable, Units 3 & 4 newly replaced and tested**
  - b. Acceptable**
- 9. Metallic Elements**
  - a. Acceptable**

**The inlet side of the pumping plant.**

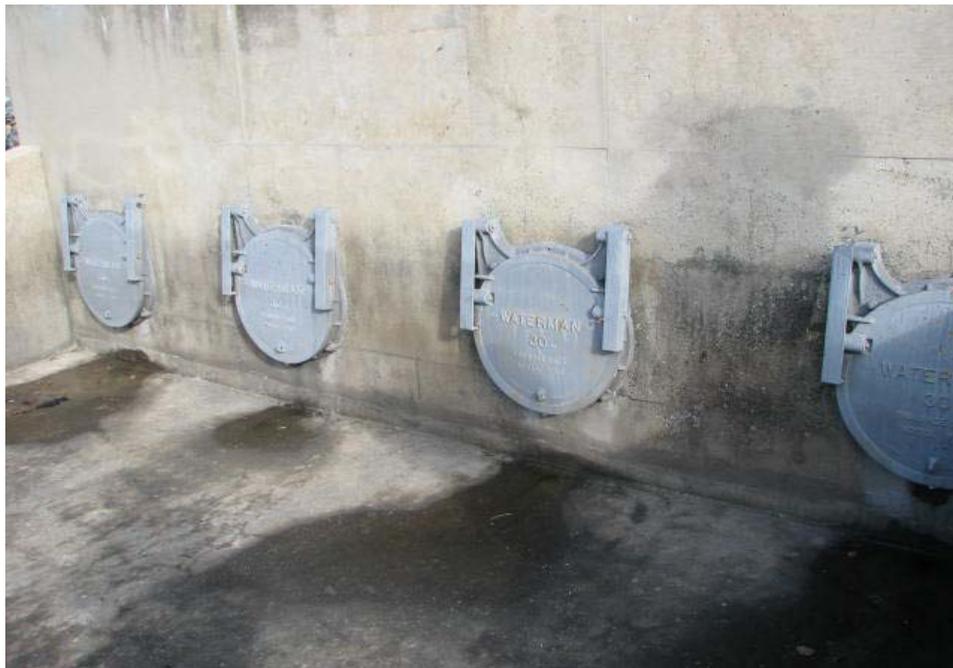
**The discharge side of the pumping plant.**

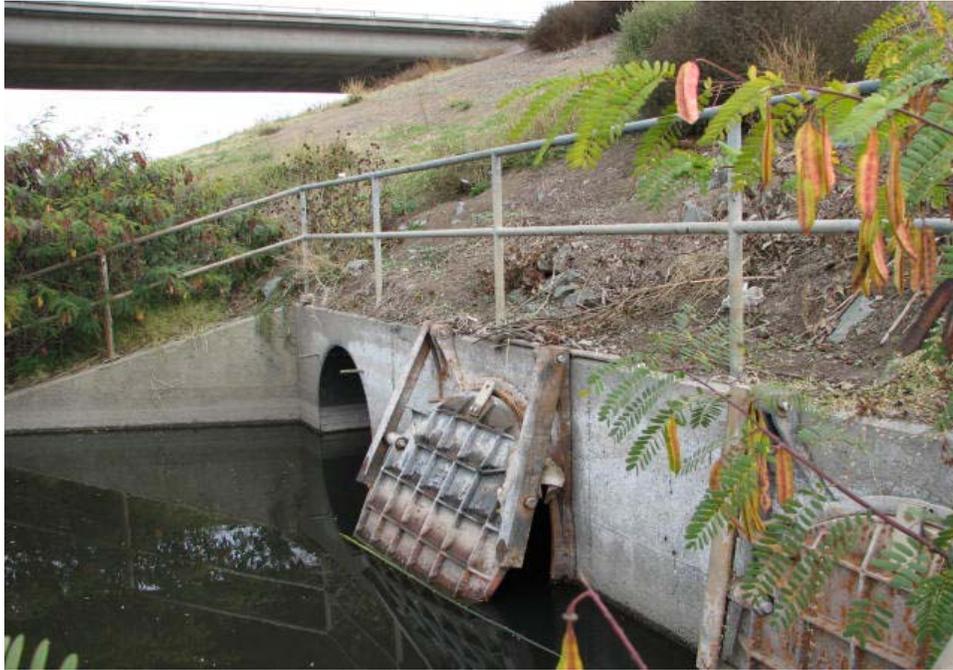
- a. **Acceptable, Unit 1 removed, intake and outlet welded shut**
  - b. **Acceptable**
9. **Metallic Elements**
  - a. **Acceptable**

**Unit 1 Discharge Flap Gate Removed  
Unit 2 Discharge Flap Gate will not fully close**

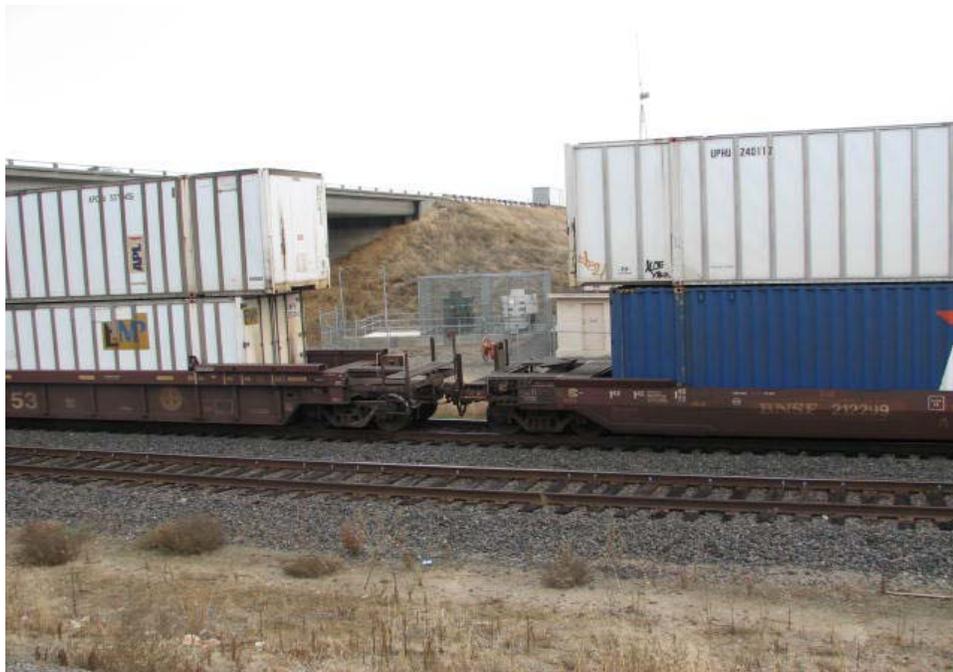
**Discharge Outlet looking back at Pumping Plant**

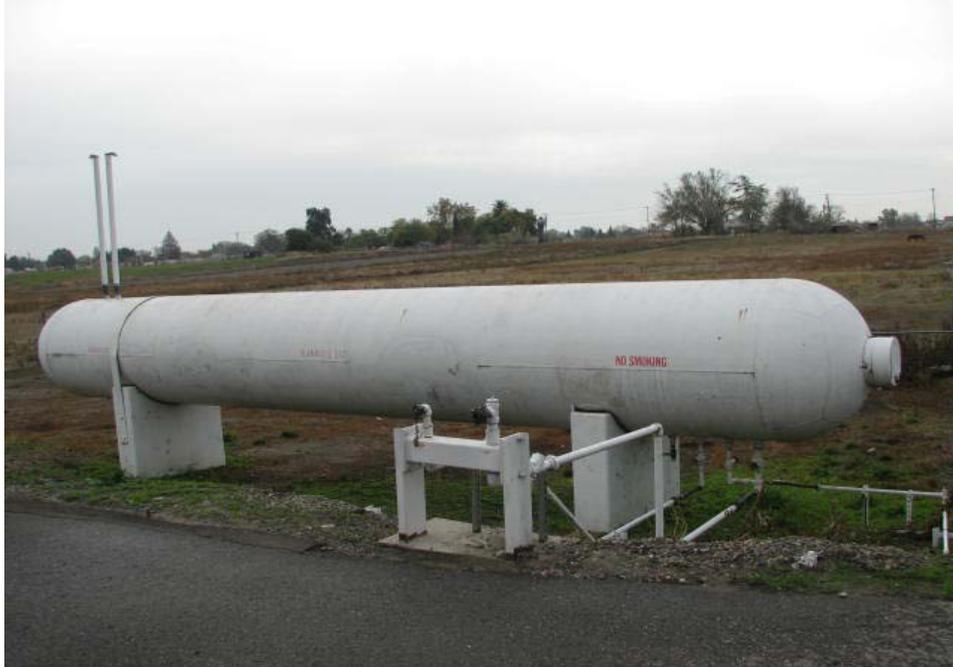
**Propane Tank located along driveway next to Pumping Plant**

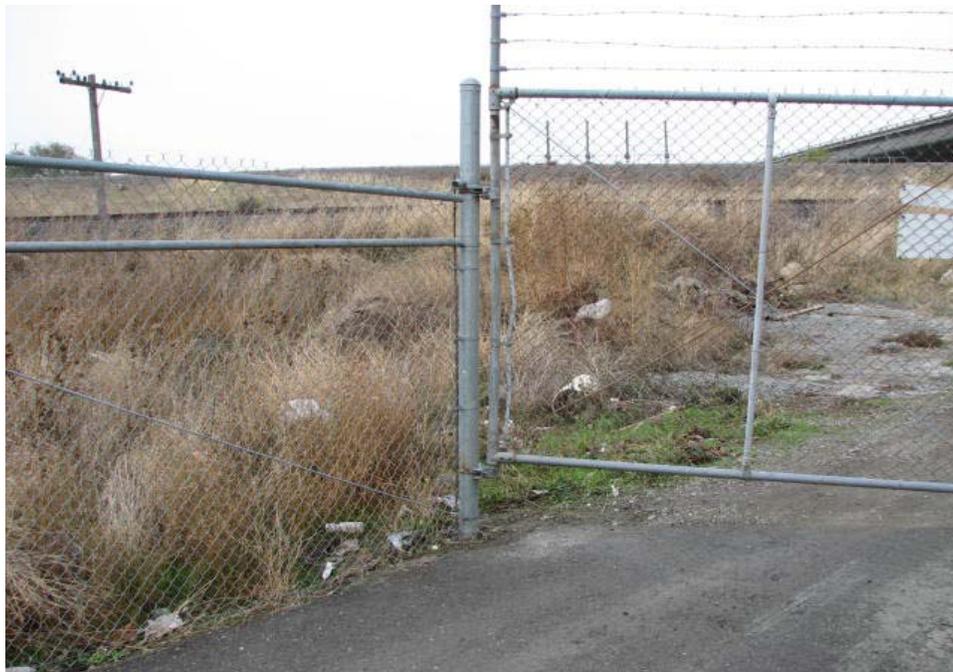
**Rear Access Gate**

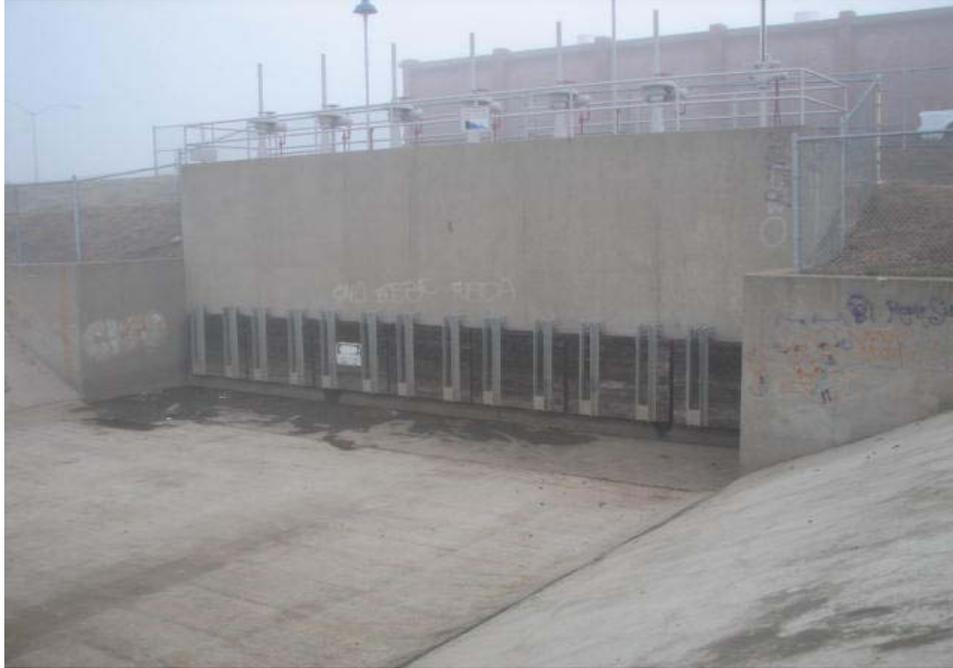
- 1. Overall Facility Maintenance Rating**
  - a. Acceptable**
- 2. Operating Log and Maintenance Manual**
  - a. Acceptable, Copy received**
  - b. Acceptable, Manual available.**
- 3. Building and Structure**
  - a. Acceptable, monitor cracking of right outlet wing wall**
- 4. Life Safety and Security Fencing**
  - a. Acceptable, Stairs have settled 1 inch and may be a tripping hazard**
  - b. Acceptable**
- 5. Sumps or Wet wells and Trash Racks**
  - a. Acceptable**
  - b. Acceptable**
- 6. Slide and Flap Gates**
  - a. Acceptable**
  - b. Acceptable**
- 7. Manual and Automatic Gate Operators**
  - a. Acceptable**
  - b. Acceptable**
- 8. Pump and Pump Control system**
  - a. Acceptable**
  - b. Acceptable**
- 9. Metallic Elements**
  - a. Acceptable**

**Gates and controls at the discharge side of the pumping plant.**

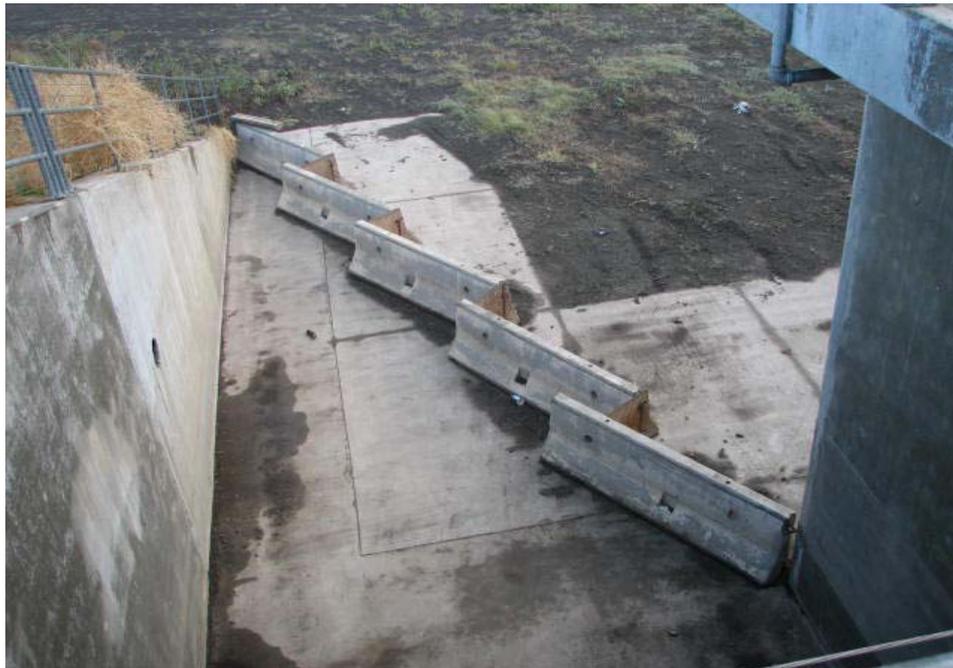
**Traffic barriers used to divert low flow to main sump**

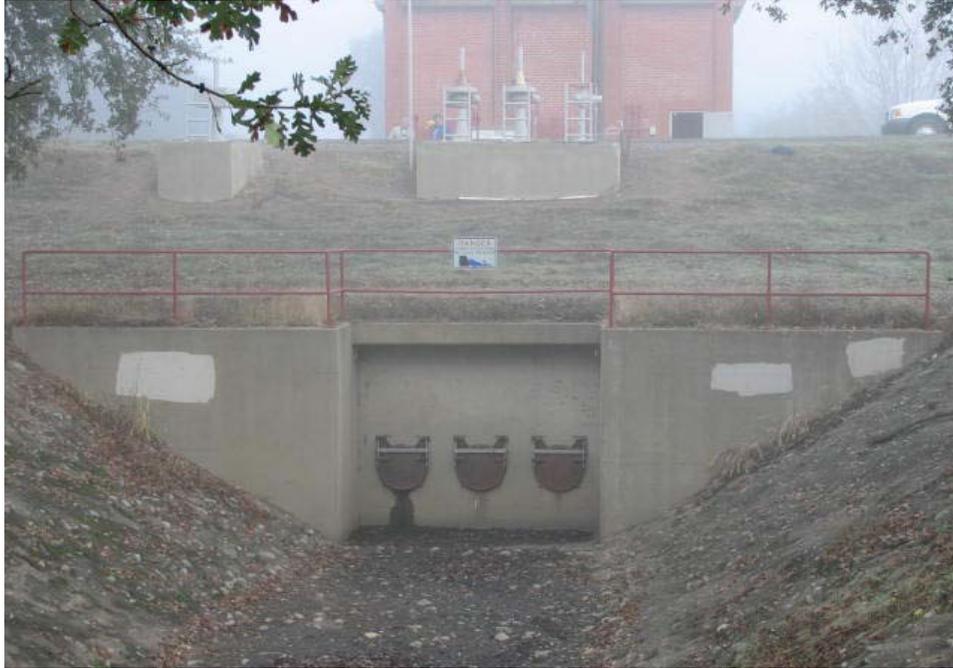
**Gate controls and flap gates on the discharge side of the pumping plant.**
