**State of California  
The Resources Agency  
DEPARTMENT OF WATER RESOURCES  
DIVISION OF FLOOD MANAGEMENT**

**2007  
PROJECT  
STRUCTURE REPORT**

**INSPECTION OF  
FLOOD CONTROL STRUCTURES ON THE  
SACRAMENTO AND SAN JOAQUIN RIVERS  
AND THEIR TRIBUTARIES**

**Prepared By  
The Flood Project Integrity & Inspection Branch**

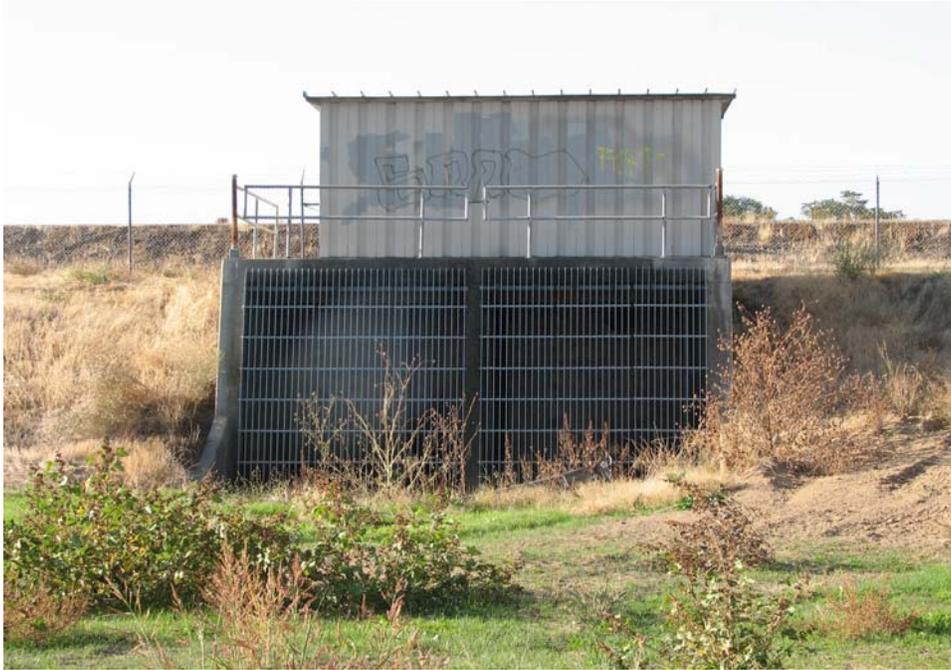
- 3. Building and Structure**
  - a. **Acceptable, bullet holes seen through out building**
- 4. Life Safety and Security Fencing**
  - a. **Acceptable, main sidewalk is crack, security lighting non-functional**

- b. **Minimally Acceptable, security gate (Back) and security fence (3 locations) damaged by trespassers**
- 5. Sumps or Wet wells and Trash Racks**
  - a. **Acceptable**

- a. **Acceptable**
  - b. **Acceptable**
- 9. Metallic Elements**
  - a. **Minimally Acceptable, Pump house hand rails show signs of corrosion**

**View of the pumping plant, sump and trash racks.**

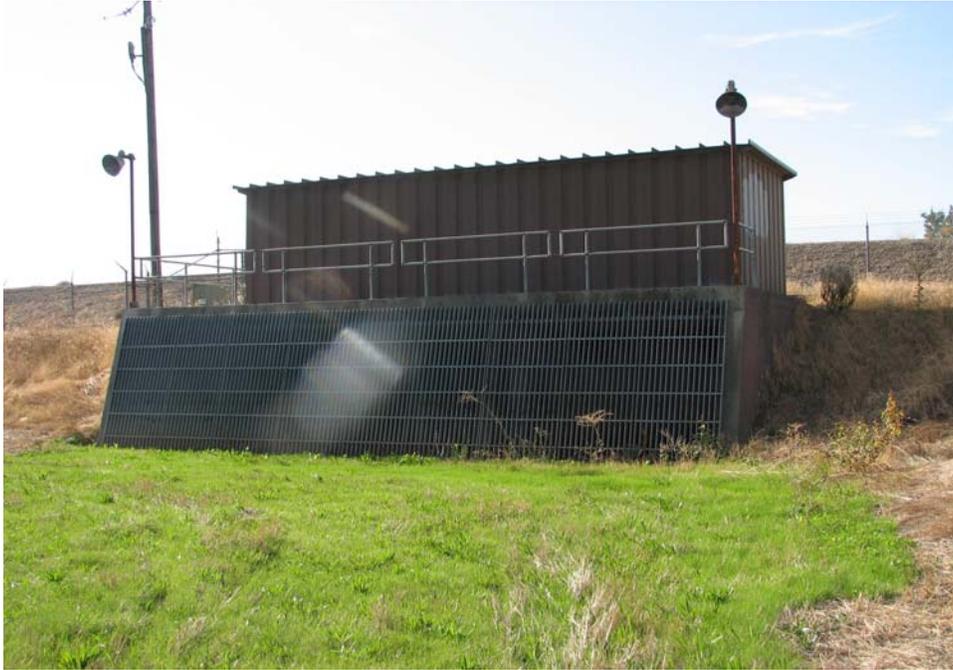
- 1. Overall Facility Maintenance Rating**
  - a. **Acceptable**
- 2. Operating Log and Maintenance Manual**
  - a. **Unacceptable, Copy not received**
  - b. **Unacceptable, Manual unavailable.**
- 3. Building and Structure**
  - a. **Acceptable**
- 4. Life Safety and Security Fencing**
  - a. **Acceptable, main sidewalk is crack, security lighting non-functional**
  - b. **Minimally Acceptable, security fence damaged by trespassers**
- 5. Sumps or Wet wells and Trash Racks**
  - a. **Acceptable**
  - b. **Acceptable**
- 6. Slide and Flap Gates**
  - a. **Acceptable**
  - b. **Acceptable**
- 7. Manual Gate Operators**
  - a. **Acceptable**
- 8. Pump and Pump Control system**
  - a. **Acceptable**
  - b. **Acceptable**
- 9. Metallic Elements**
  - a. **Minimally Acceptable, light posts are corroded**

**View of the pumping plant, sump and trash racks at the intake.**

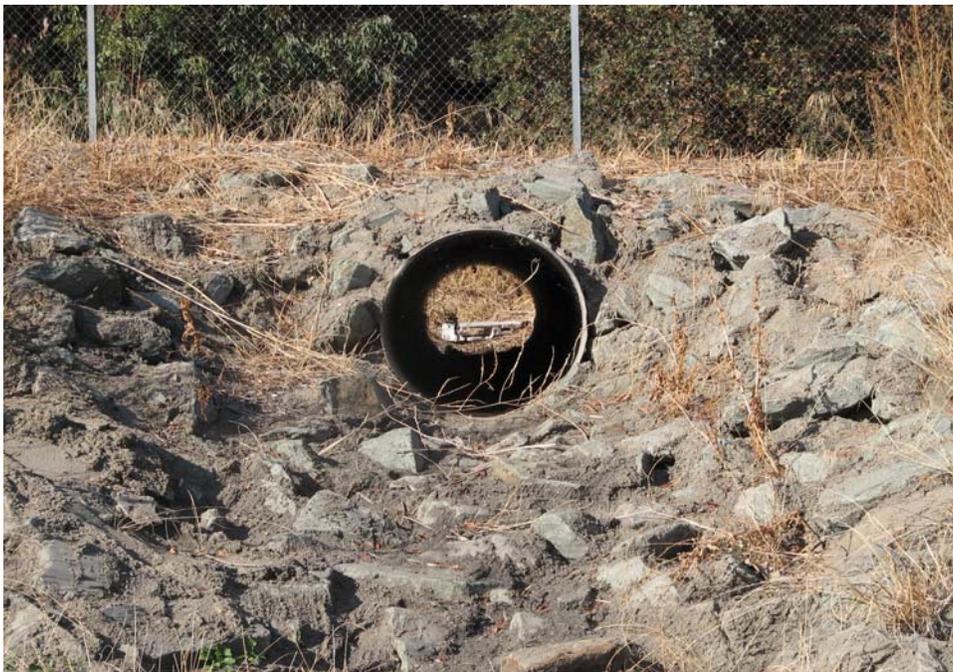
**New inlet drainage pipe**  
**Note: Security Grate needed over pipe openings**

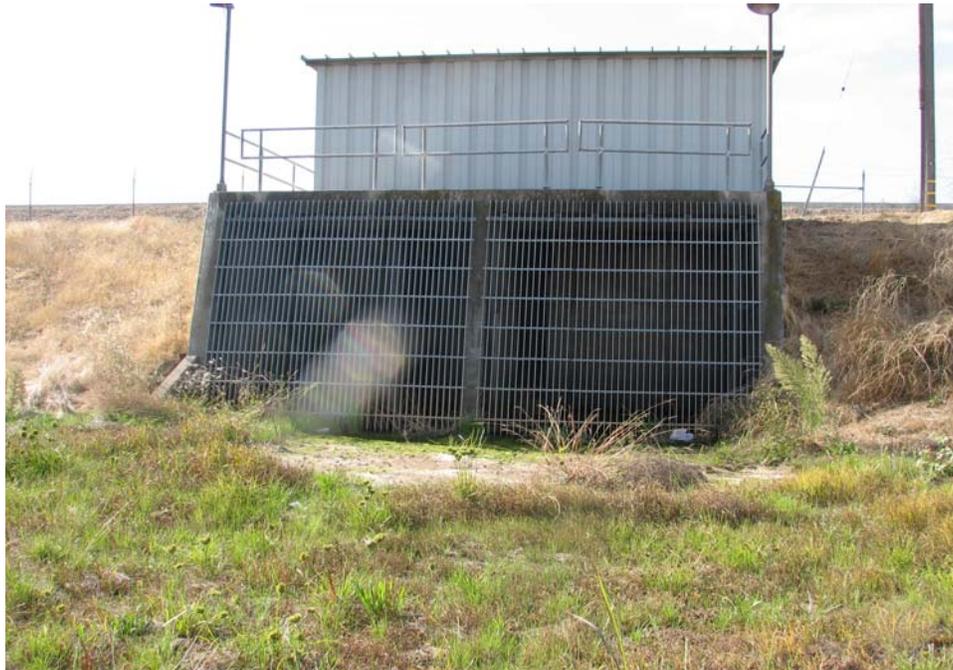
- 1. Overall Facility Maintenance Rating**
  - a. **Acceptable**
- 2. Operating Log and Maintenance Manual**
  - a. **Unacceptable, Copy not received**
  - b. **Unacceptable, Manual unavailable.**
- 3. Building and Structure**
  - a. **Acceptable**
- 4. Life Safety and Security Fencing**
  - a. **Acceptable, main sidewalk foundation is undermined due to erosion, security lighting non-functional**
  - b. **Minimally Acceptable, new concrete drain provides access under security fence**
- 5. Sumps or Wet wells and Trash Racks**
  - a. **Acceptable**
  - b. **Acceptable**
- 6. Slide and Flap Gates**
  - a. **Acceptable**
  - b. **Acceptable**
- 7. Manual Gate Operators**
  - a. **Acceptable**
- 8. Pump and Pump Control system**
  - a. **Acceptable**
  - b. **Acceptable**
- 9. Metallic Elements**
  - a. **Acceptable**

**The pumping plant, sump and trash racks at the intake.**

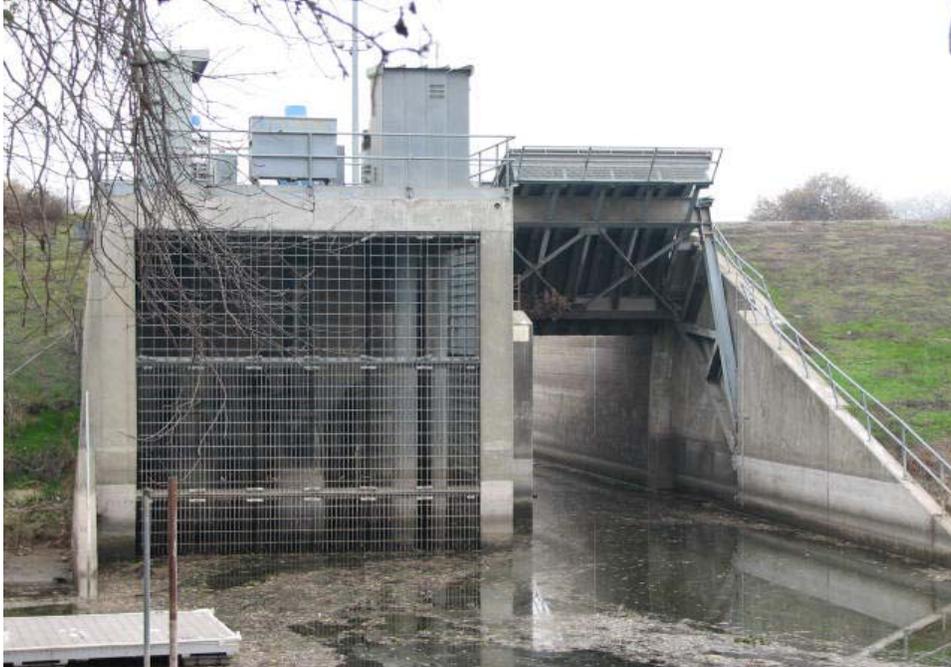
1. **Overall Facility Maintenance Rating**
  - a. **Acceptable**
2. **Operating Log and Maintenance Manual**
  - a. **Unacceptable, Copy not received**
  - b. **Unacceptable, Manual unavailable.**
3. **Building and Structure**
  - a. **Acceptable**
4. **Life Safety and Security Fencing**
  - a. **Acceptable**
  - b. **Minimally Acceptable, security fence has been cut away along down stream slope near trailer park office**
5. **Sumps or Wet wells and Trash Racks**
  - a. **Acceptable**
  - b. **Acceptable**
6. **Slide and Flap Gates**
  - a. **Acceptable**
  - b. **Acceptable**
7. **Manual Gate Operators**
  - a. **Acceptable**
8. **Pump and Pump Control system**
  - a. **Acceptable**
  - b. **Acceptable**
9. **Metallic Elements**
  - a. **Acceptable**

**View of the pump house intake and the radial gate.**

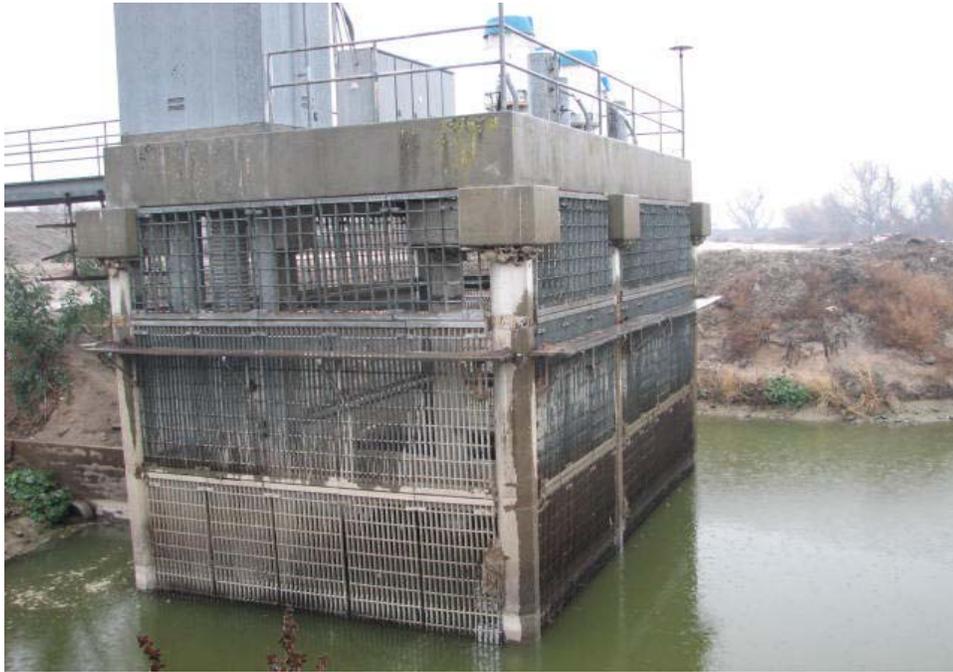
- 1. Overall Facility Maintenance Rating**
  - a. **Acceptable**
- 2. Operating Log and Maintenance Manual**
  - a. **Unacceptable, Copy not received**
  - b. **Unacceptable, Manual unavailable.**
- 3. Building and Structure**
  - a. **Acceptable**
- 4. Life Safety and Security Fencing**
  - a. **Acceptable**
  - b. **Acceptable**
- 5. Sumps or Wet wells and Trash Racks**
  - a. **Acceptable**
  - b. **Acceptable**
- 6. Slide and Flap Gates**
  - a. **Acceptable**
  - b. **Acceptable**
- 7. Manual Gate Operators**
  - a. **Acceptable**
- 8. Pump and Pump Control system**
  - a. **Acceptable**
  - b. **Acceptable**
- 9. Metallic Elements**
  - a. **Acceptable**

**View of the pumping plant, sump and trash racks.**

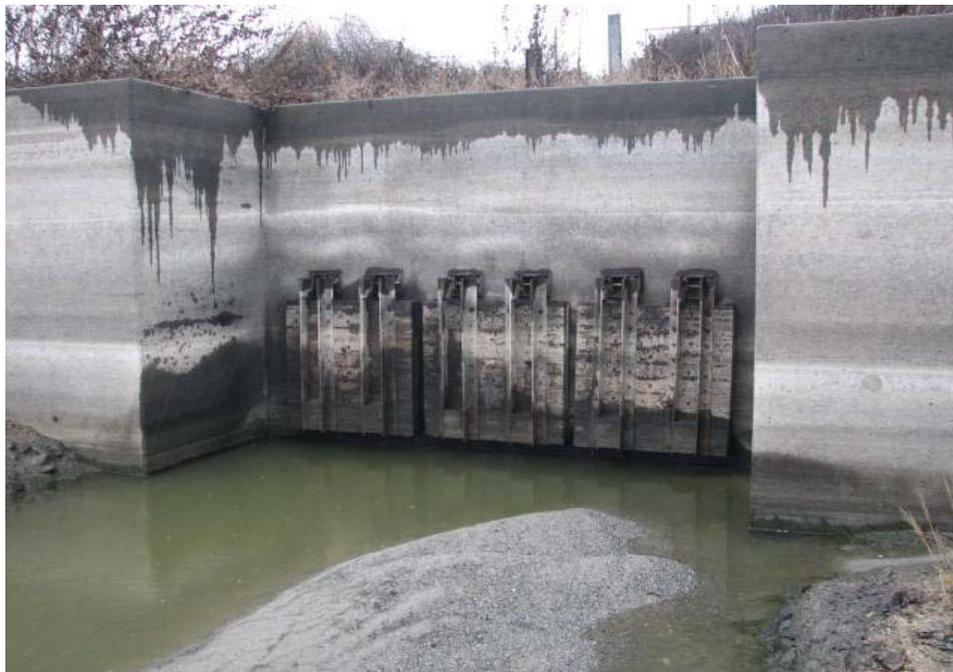
**The pumping plant outlet**

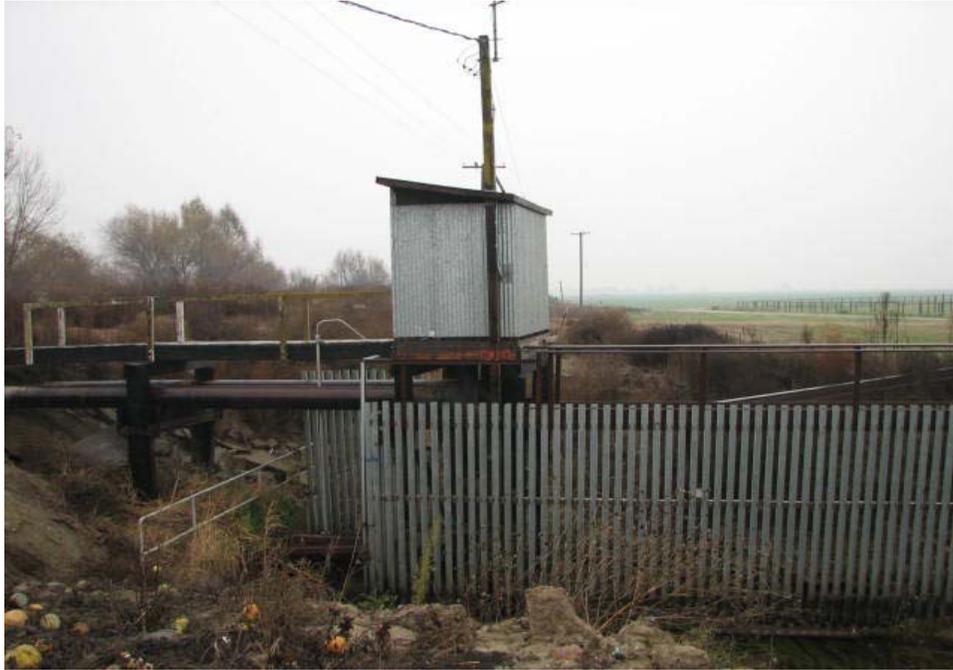
- 1. Overall Facility Maintenance Rating**
  - a. Minimally Acceptable, outlet pipe broken within levee**
- 2. Operating Log and Maintenance Manual**
  - a. Unacceptable, Copy not received**
  - b. Unacceptable, Manual unavailable.**
- 3. Building and Structure**
  - a. Acceptable**
- 4. Life Safety and Security Fencing**
  - a. Acceptable**
  - b. Unacceptable, no security fencing**
- 5. Sumps or Wet wells and Trash Racks**
  - a. Acceptable**
  - b. Acceptable**
- 6. Slide and Flap Gates**
  - a. Acceptable**
  - b. Acceptable**
- 7. Manual Gate Operators**
  - a. Acceptable**
- 8. Pump and Pump Control system**
  - a. Acceptable**
  - b. Acceptable**
- 9. Metallic Elements**
  - a. Acceptable**

**The pumping plant intake and trash racks.**

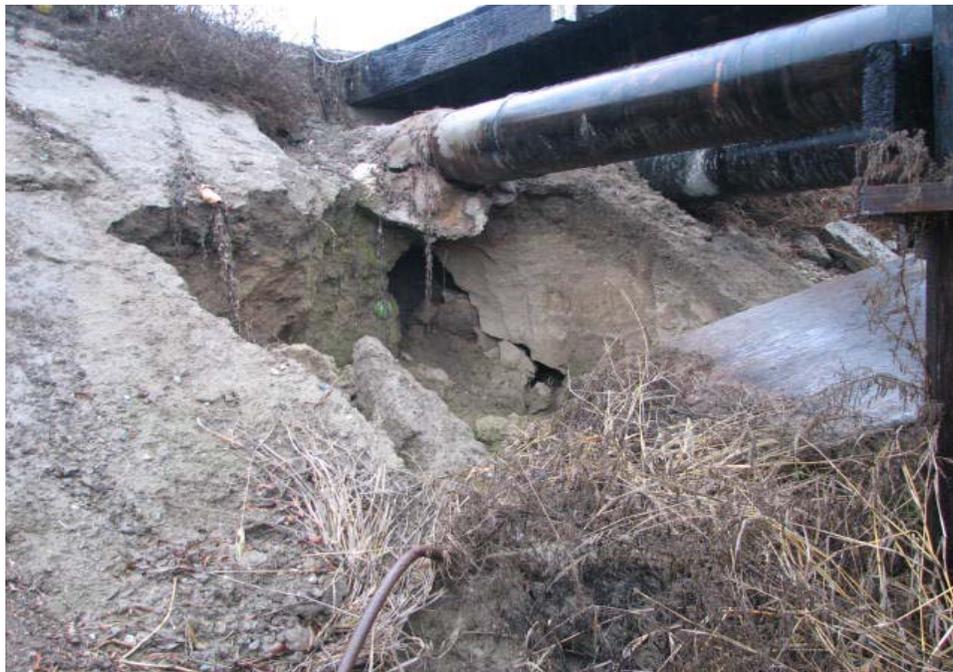
**Plant discharge pipes**

**Note: repair or replace cracked pipe and recompact levee slope**
