**Flood Control Project Maintenance  
Levee Inspections**  
**LMA District Cover Sheet**  
**Spring 2020 Levee Inspection Results**

**Reclamation District No. 2063 Crows Landing**

**Spring 2020 Levee Inspection Results**

Waterway	Bank	Unit Miles
Unit No. 01 San Joaquin River	Right	10.44

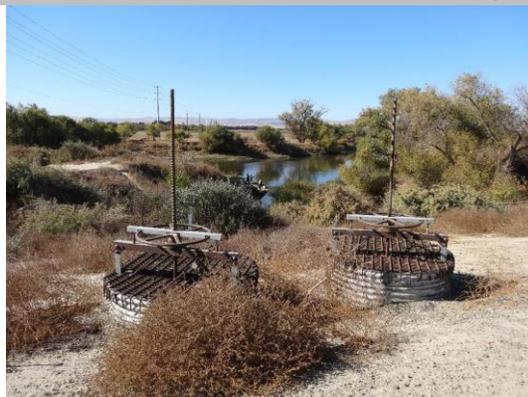
Photo 3 of 3 : UCIP\_SP\_2020\_50218\_43202.jpg

WS view: two slide gates in CMP risers on levee slope.

Comment Code					
Inspector Comment					
DS_ID:22119 FS_ID:50217 EP_NO: N/A Repair Type: No Action Needed Crossing Status: Found UCIP Comments: 08/23/2016: WS flapgates were held open by a piece of wood. Pipes may be used temporarily for irrigation. (K. Fazel - UCIP)11/05/2013: working during field inspection. (P. Amatya - DWR) FIELD_STRUCT_DESC: [Lateral Drain No. 5] 2 of 2: 48-inch corrugated metal gravity drainage pipe through the levee, 25.5 feet below the crown. Slide gate in a corrugated metal pipe (CMP) riser on the waterside (WS) slope. Flap gate on the WS end. 70-foot-long cobble spillway to river. Installed by USACE in 1961. [Additional Reference(s): DWR Levee Log, 1992. USACE San Joaquin O&M Manual 6, September 1961, (HLM 1.35)]. FS Date: 11/5/2013

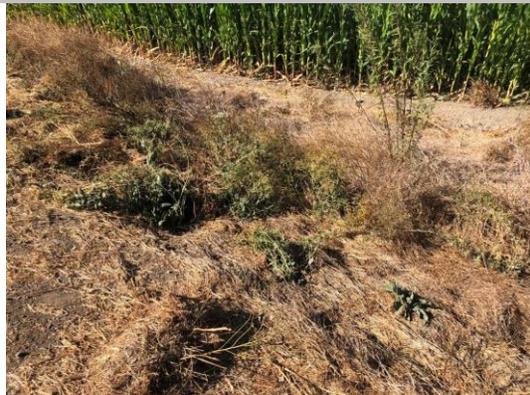
Photo 1 of 3 : SP\_2020\_RD2063\_112\_38\_20200225\_00008.jpg

LM Start	<b>1.82</b>	Rating **	M	Issue No.	<b>38</b>
LM End	<b>1.84</b>	Issue Type +	Ma	Location *	
Category	Supplemental		GPS Latitude/Longitude		
			Start	End	
Item	DWR Erosion Survey		37.457653 °	37.457653 °	
			-121.033728 °	-121.033728 °	
DWR ID	RD2063U01RM100.79				
Comment Code					
Inspector Comment					
Site ID: RD2063U01RM100.79 09/12/2019: Erosion has developed into the lower levee slope.

Looking down at the erosion pocket.

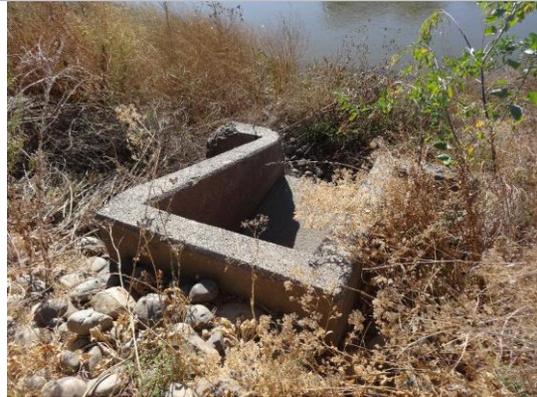
Photo 1 of 3 : UCIP\_SP\_2020\_25023\_45102.jpg

LM Start	<b>2.68</b>	Rating **	A/W	Issue No.	<b>64</b>
LM End	<b>2.68</b>	Issue Type +	Ma	Location *	
Category	Supplemental		GPS Latitude/Longitude		
			Start	End	
Item	DWR UCIP LMA Responsibility		37.447475 °	37.447475 °	
			-121.026017 °	-121.026017 °	
DWR ID	22087				
Comment Code					
Inspector Comment					
DS_ID:22087 FS_ID:25023 EP_NO: N/A Repair Type: No Action Needed Crossing Status: Found UCIP Comments: 11/05/2013 Both pipe ends about 85 feet off the levee center. (P. Amatya - DWR UCIP) FIELD_STRUCT_DESC: 24-inch corrugated metal gravity drainage pipe through the levee, 20.3 feet below the crown. Flap gate on the waterside (WS) end. Concrete headwall on each end. Installed by USACE in 1961. [Additional Reference(s): DWR Levee Log, 1992. USACE San Joaquin O&M Manual 6, September 1961, (HLM 2.71)]. FS Date: 11/5/2013

WS view: U typed concrete headwall on river bank.

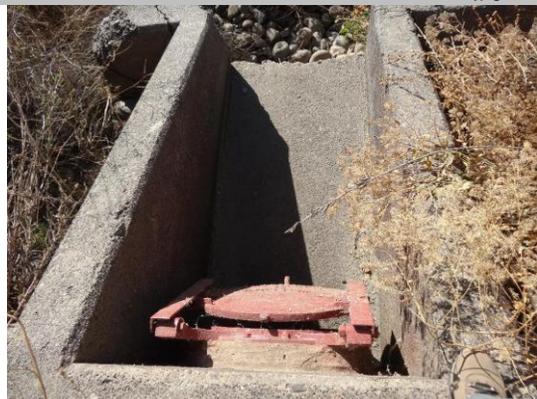
Photo 2 of 3 : UCIP\_SP\_2020\_25023\_45101.jpg

WS view: pipe, flap gate, and concrete headwall on river bank.

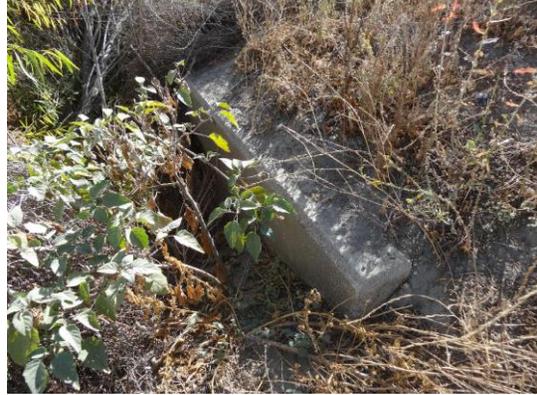
Photo 3 of 3 : UCIP\_SP\_2020\_25023\_45100.jpg

LS view: pipe and concrete headwall off the levee toe.

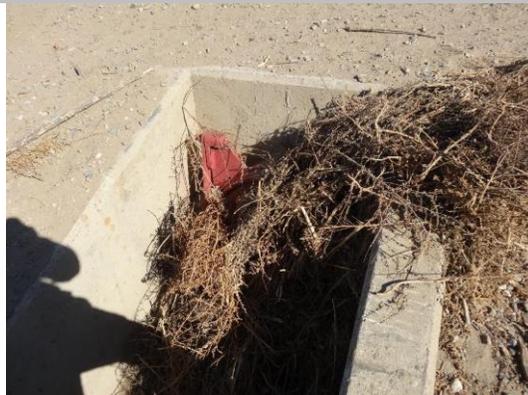
Photo 2 of 3 : UCIP\_SP\_2020\_24443\_43521.jpg

Comment Code					
Inspector Comment					
DS_ID:22088 FS_ID:24443 EP_NO: N/A Repair Type: Non-Urgent Crossing Status: Found UCIP Comments: 11/05/2013 - clear and clean debris (P. Amatya - DWR UCIP) FIELD_STRUCT_DESC: *ABANDONED* 24-inch corrugated metal gravity drainage pipe through the levee, 9.5 feet below the crown. Flap gate on the waterside (WS) end. Pipe open on the landside (LS) end. Concrete headwall on each end. [Additional Reference(s): DWR Levee Log, 1992. USACE San Joaquin O&M Manual 6, September 1961, (HLM 2.97)]. FS Date: 11/5/2013

WS view: pipe, flap gate, and concrete headwall with debris blocking the outlet.

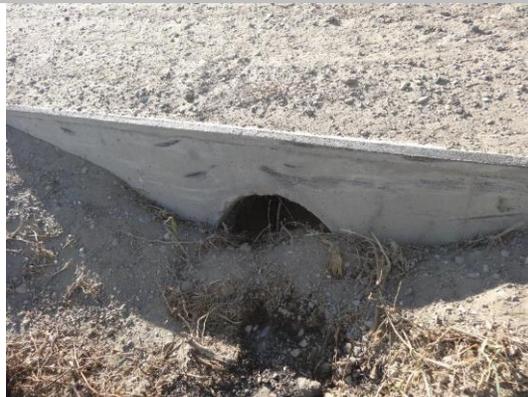
Photo 3 of 3 : UCIP\_SP\_2020\_24443\_43520.jpg

WS view: pipe, flap concrete headwall with soil debris blocking the inlet.

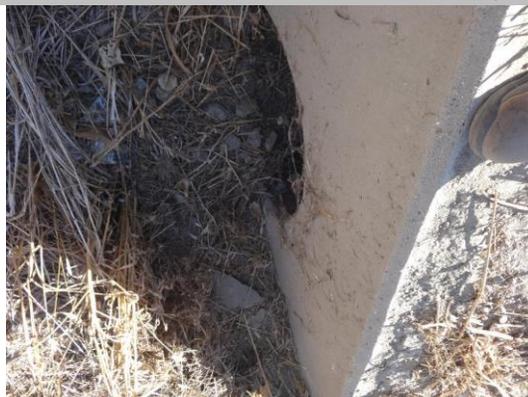
Photo 3 of 3 : UCIP\_SP\_2020\_24469\_43643.jpg

LS view: CM pipe and concrete headwall on levee slope. Debris blocking inlet pipe.

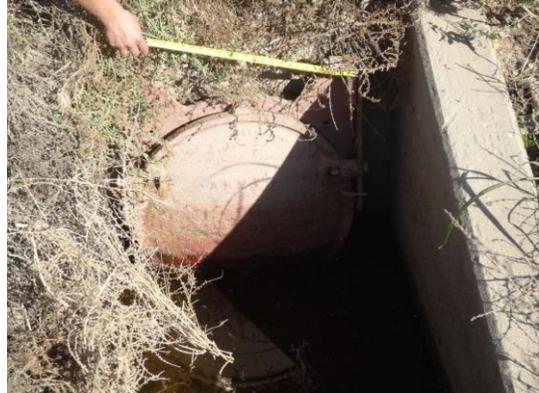
Photo 1 of 3 : UCIP\_SP\_2020\_51821\_43842.jpg

Item	DWR UCIP LMA Responsibility		37.432813 °	37.432813 °	
			-121.013419 °	-121.013419 °	
DWR ID	22096				
Comment Code					
Inspector Comment					
DS_ID:22096 FS_ID:51821 EP_NO: N/A Repair Type: No Action Needed Crossing Status: Found UCIP Comments: 05/11/2017 Review of photos indicate less than 1/4 of the inlet is silted in. Since the pipe is in good condition, it has been downgraded from Non-Urgent to No Action Needed. (K. Fazel - UCIP)11/05/2013:- new flap gate on waterside.- cleaning of outlet and inlet pipes required. (P. Amatya - DWR) FIELD_STRUCT_DESC: 24-inch corrugated metal gravity drainage pipe through the levee, 12 feet below the crown. Flap gate on the waterside (WS) end. Concrete headwall on each end. Installed by USACE in 1961. [Additional Reference(s): DWR Levee Log, 1992. USACE San Joaquin O&M Manual 6, September 1961, (HLM 4.08)]. FS Date: 11/5/2013

WS view: pipe, flap gate, and concrete headwall on drainage ditch.

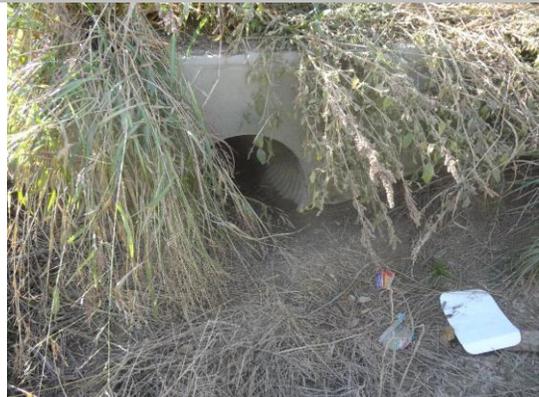
Photo 2 of 3 : UCIP\_SP\_2020\_51821\_43841.jpg

LS view: CM pipe and concrete headwall on levee toe.

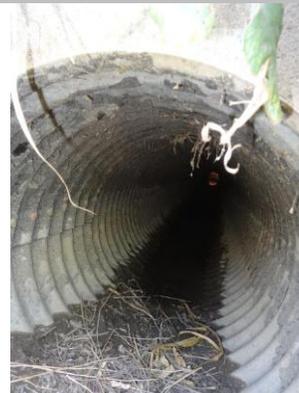
Photo 3 of 3 : UCIP\_SP\_2020\_51821\_43840.jpg

LS view: inside view of the CM pipe on levee toe.

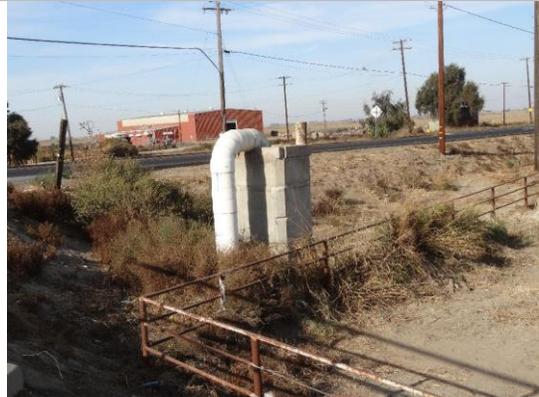
Photo 3 of 3 : UCIP\_SP\_2020\_41746\_43848.jpg

DS\_ID:22099  
 FS\_ID:41746  
 EP\_NO: N/A  
 Repair Type: Non-Urgent  
 Crossing Status: Found  
 UCIP Comments: 11/05/2013 Need to determine if annular space has been grouted or if repair/sleeving was done in accordance with a permit or Title 23. Slide gate not found in CM pipe riser on the waterward slope. Dense vegetation on waterside. Pipe only visible in CMP riser on waterside slope. (P. Amatya - DWR UCIP)  
 FIELD\_STRUCT\_DESC: 24-inch corrugated metal irrigation discharge pipe through the levee, 10 feet below the crown. Smaller pipe sleeved through the 24-inch pipe. Slide gate in a corrugated metal pipe (CMP) riser on the waterside (WS) slope. Connects to a concrete pipe irrigation system. Installed by USACE in 1961. [Additional Reference(s): DWR Levee Log, 1992. USACE San Joaquin O&M Manual 6, September 1961, (HLM 4.16)].  
 FS Date: 11/5/2013

LS view: discharge pipe and concrete distribution box on levee toe.

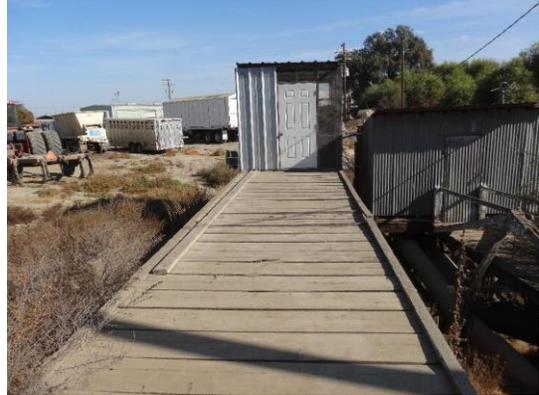
Photo 3 of 3 : UCIP\_SP\_2020\_25025\_45108.jpg

LS view: walkway to pump and pump house on levee slope.

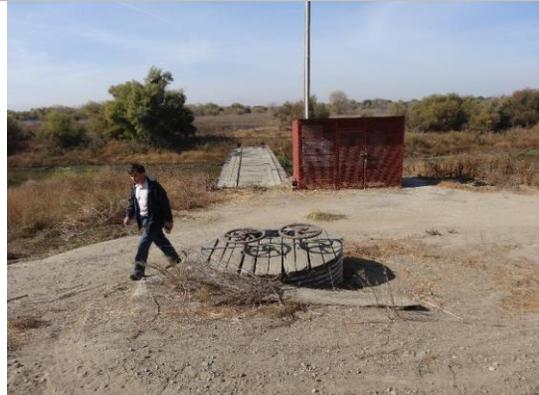
Photo 1 of 3 : UCIP\_SP\_2020\_41670\_43905.jpg

Item	DWR UCIP Field Study		37.427143 °	37.427143 °	
			-120.999374 °	-120.999374 °	
DWR ID	22123				
Comment Code					
Inspector Comment					
DS_ID:22123 FS_ID:41670 EP_NO: N/A Repair Type: Non-Urgent Crossing Status: Found UCIP Comments: 11/06/2013 Any abandoned pipes should be verified as having been abandoned properly. - abandoned walkway, pile structure and steel pipe.- concrete standpipe on landside toe.- overhead power line. (P. Amatya - DWR UCIP) FIELD_STRUCT_DESC: 2 of 2: 12-inch concrete encased steel irrigation discharge pipe through the levee, 9 feet below the crown. Two pumps on a floating structure in the river. Two slide gates in a 72-inch corrugated metal pipe (CMP) riser on the waterside (WS) slope. Pipe discharges into a concrete distribution box on the landside (LS) toe. Installed by USACE in 1961. [Additional Reference(s): DWR Levee Log, 1992, 14-inch and 16-inch pipes referenced. USACE San Joaquin O&M Manual 6, September 1961, (HLM 5.13), 14-inch and 16-inch pipes referenced]. FS Date: 11/6/2013

WS view: CMP riser, abandoned walkway, power pole on levee slope.

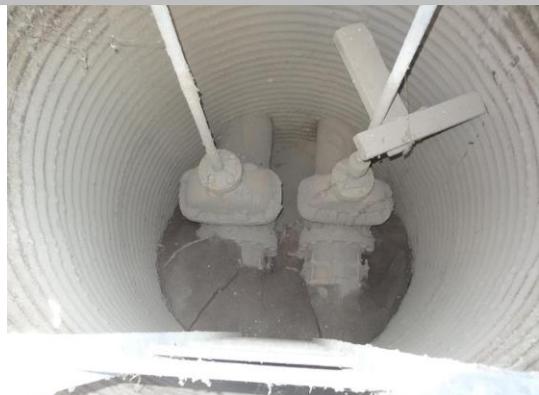
Photo 2 of 3 : UCIP\_SP\_2020\_41670\_43904.jpg

WS view: two gate valves inside CMP riser on levee slope.

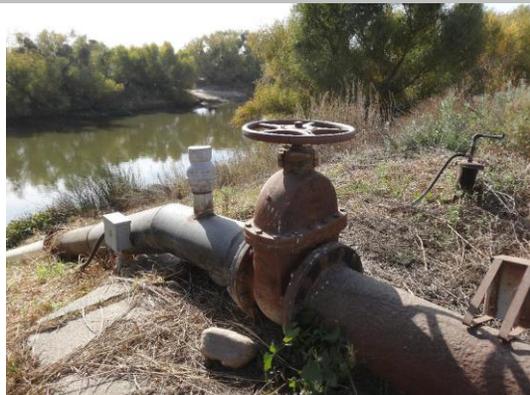
Photo 1 of 3 : UCIP\_SP\_2020\_24628\_43938.jpg

Item	DWR UCIP Field Study		37.411347 °	37.411347 °	
			-120.998063 °	-120.998063 °	
DWR ID	22108				
Comment Code					
Inspector Comment					
DS_ID:22108 FS_ID:24628 EP_NO: 4062 Repair Type: Non-Urgent Crossing Status: Found UCIP Comments: 11/06/2013 Abandoned pipe also found adjacent to this pipe. Needs proper abandonment. Soil erosion under pipe on waterside. No pipe visible on landside. Overhead powerline. (P. Amatya - DWR UCIP) FIELD_STRUCT_DESC: 12-inch polyvinyl chloride (PVC) irrigation discharge pipe through the levee, 3 feet below the crown. Floating pump in the river. Gate valve and air vent on the waterside (WS) berm. Service pole with overhead line on the WS shoulder. (pump with discharge pipe through the levee authorized under Permit No. 4062, 1962 - John W. Greer). [Additional Reference(s): DWR Levee Log, 1992]. FS Date: 11/6/2013

WS view: steel pipe, gate valve, air vent on levee berm.

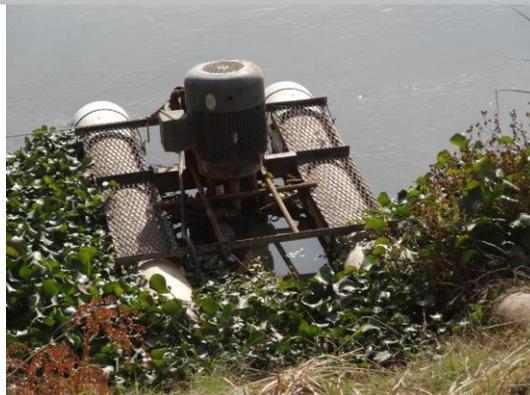
Photo 2 of 3 : UCIP\_SP\_2020\_24628\_43937.jpg

WS view: pump on floating structure in the stream.

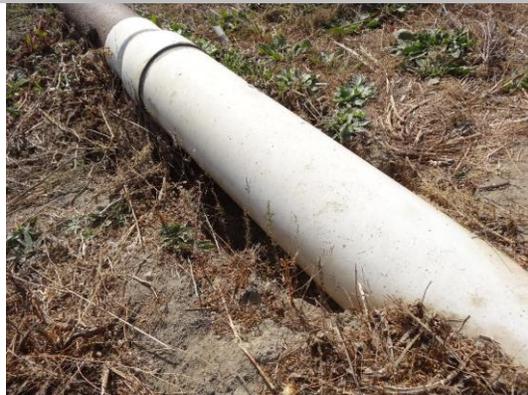
Photo 3 of 3 : UCIP\_SP\_2020\_24628\_43936.jpg

WS view: exposed pipe on levee slope. Erosion under the pipe.

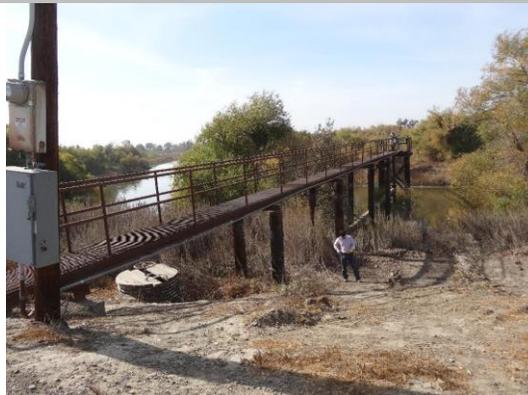
Photo 1 of 3 : UCIP\_SP\_2020\_24629\_43943.jpg

WS view: power pole, walkway to pump, CMP riser, and pipe on waterside slope.

Comment Code					
Inspector Comment					
DS_ID:22109 FS_ID:24629 EP_NO: 13541 Repair Type: Non-Urgent Crossing Status: Found UCIP Comments: 11/06/2013 - erosion around CMP riser on waterside- no U type headwall found on landside.- no pipe found on landside. (P. Amatya - DWR UCIP) FIELD_STRUCT_DESC: 16-inch steel irrigation discharge pipe through the levee, 10 feet below the crown. Pump on the riverbank. Gate valve in a corrugated metal pipe (CMP) riser on the waterside (WS) slope. Concrete U-shaped headwall on the landside (LS) end. Installed by USACE in 1961. (Plans to construct an elevated platform and replace a centrifugal pump with a new vertical pump on the riverbank authorized under Permit No. 13541, 1982 - Joaquin Cabral, 12-inch pipe referenced). [Additional Reference(s): DWR Levee Log, 1992. USACE San Joaquin O&M Manual 6, September 1961, (HLM 7.08), 10-inch pipe referenced]. FS Date: 11/6/2013

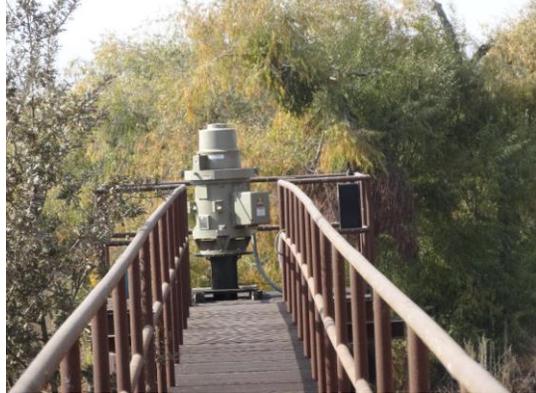
Photo 2 of 3 : UCIP\_SP\_2020\_24629\_43942.jpg

WS view: walkway to pump and pump on pile structure in the stream.

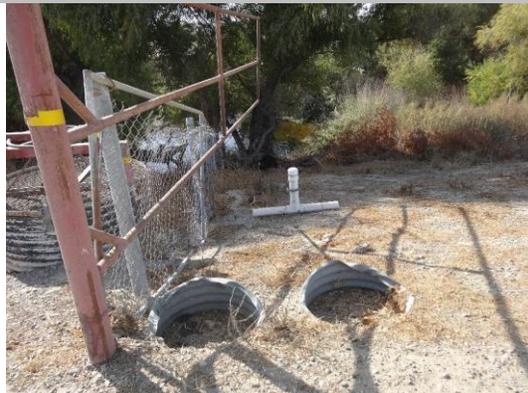
Photo 1 of 3 : UCIP\_SP\_2020\_24651\_44005.jpg

Item	DWR UCIP LMA Responsibility		37.397883 °	37.397883 °	
			-120.972342 °	-120.972342 °	
DWR ID	22124				
Comment Code					
Inspector Comment					
DS_ID:22124 FS_ID:24651 EP_NO: N/A Repair Type: Non-Urgent Crossing Status: Found UCIP Comments: 10/27/2017 This structure is inspected annually under the Structure and Channel Summer Inspection (part of the Levee Inspection Program) conducted by the DWR Flood Project Integrity and Inspection Branch (FPIIB). (DWR UCIP - O. Magana) 11/06/2013 - working during field inspection.- blocked siphon breaker. (P. Amatya - DWR UCIP) FIELD_STRUCT_DESC: 1 of 2: 16-inch steel drainage discharge pipe through the levee, 3.5 feet below the crown. Siphon breaker in a corrugated metal pipe (CMP) riser on the waterside (WS) slope. Flap gate on the WS end. Pump on a timber pile structure on the landside (LS). Timber walkway from levee to pump structure. [Additional Reference(s): DWR Levee Log, 1992. USACE San Joaquin O&M Manual 6, September 1961, (HLM 8.60)]. FS Date: 11/6/2013

WS view: two siphon breakers in CMP risers on levee slope.

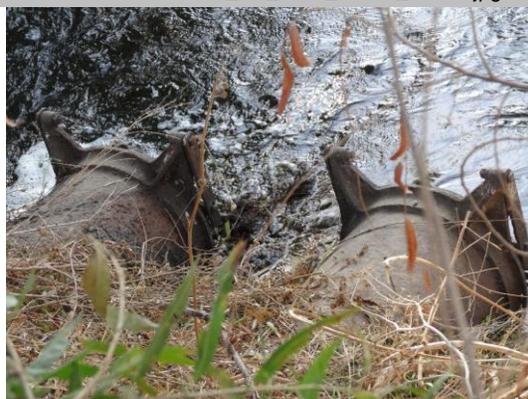
Photo 2 of 3 : UCIP\_SP\_2020\_24651\_44004.jpg

WS view: two flap gates on outfall pipe ends.

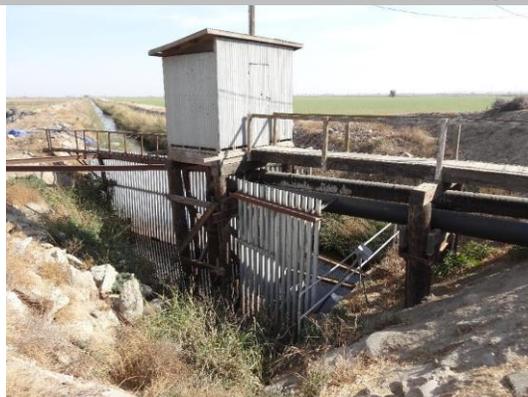
Photo 3 of 3 : UCIP\_SP\_2020\_24651\_44003.jpg

LS view: pipes under walkway to pump house.

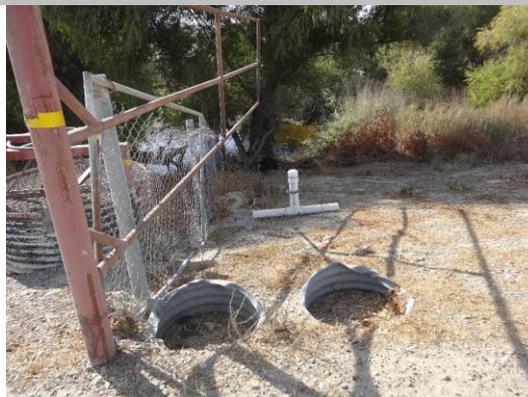
Photo 1 of 3 : UCIP\_SP\_2020\_24652\_44008.jpg

WS view: two siphon breakers in CMP risers on levee slope.

<b>Comment Code</b>					
<b>Inspector Comment</b>					
DS_ID:22112 FS_ID:24652 EP_NO: N/A Repair Type: Non-Urgent Crossing Status: Found UCIP Comments: 10/27/2017 This structure is inspected annually under the Structure and Channel Summer Inspection (part of the Levee Inspection Program) conducted by the DWR Flood Project Integrity and Inspection Branch (FPIIB). (DWR UCIP - O. Magana) 11/06/2013 - working during field inspection.- blocked siphon breaker. (P. Amatya - DWR UCIP) FIELD_STRUCT_DESC: 2 of 2: 16-inch steel drainage discharge pipe through the levee, 3.5 feet below the crown. Siphon breaker in a corrugated metal pipe (CMP) riser on the waterside (WS) slope. Flap gate on the WS end. Pump on a timber pile structure on the landside (LS). Timber walkway from levee to pump structure. [Additional Reference(s): DWR Levee Log, 1992. USACE San Joaquin O&M Manual 6, September 1961, (HLM 8.60)]. FS Date: 11/6/2013

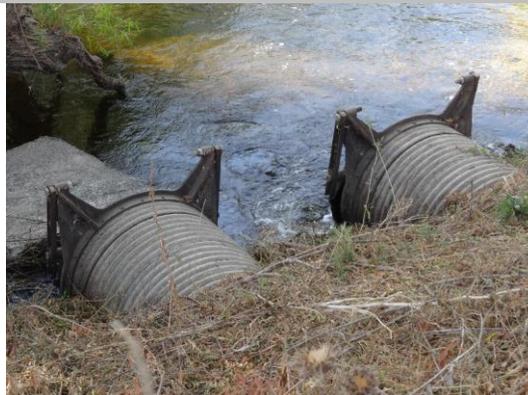
Photo 1 of 3 : UCIP\_SP\_2020\_24650\_44002.jpg

Item	DWR UCIP LMA Responsibility		37.397865 °	37.397865 °	
			-120.972332 °	-120.972332 °	
DWR ID	22113				
Comment Code					
Inspector Comment					
DS_ID:22113 FS_ID:24650 EP_NO: N/A Repair Type: No Action Needed Crossing Status: Found UCIP Comments: 10/27/2017 This structure is inspected annually under the Structure and Channel Summer Inspection (part of the Levee Inspection Program) conducted by the DWR Flood Project Integrity and Inspection Branch (FPIIB). (DWR UCIP - O. Magana) 11/06/2013 Working during field inspection. (P. Amatya - DWR UCIP) FIELD_STRUCT_DESC: [Reclamation District No. 2063 Pumping Plant] 1 of 2: 42-inch corrugated metal gravity drainage pipe through the levee, 18 feet below the crown. Slide gate in a corrugated metal pipe (CMP) riser on the waterside (WS) slope. Flap gate, concrete saddle, and apron on the WS end. Concrete headwall on the landside (LS) end. [Additional Reference(s): DWR Levee Log, 1992. USACE San Joaquin O&M Manual 6, September 1961, (HLM 8.60)]. FS Date: 11/6/2013

WS view: two flap gates on outfall pipe ends.

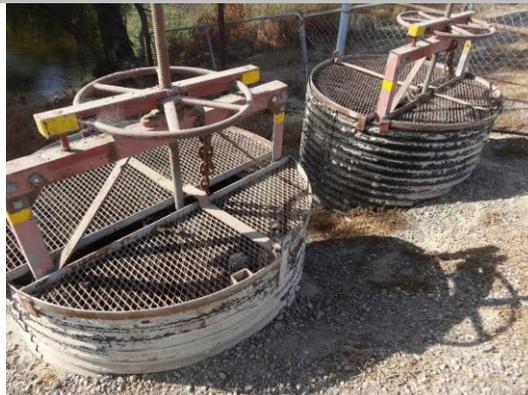
Photo 2 of 3 : UCIP\_SP\_2020\_24650\_44001.jpg

WS view: two slide gates in CMP risers on levee slope.

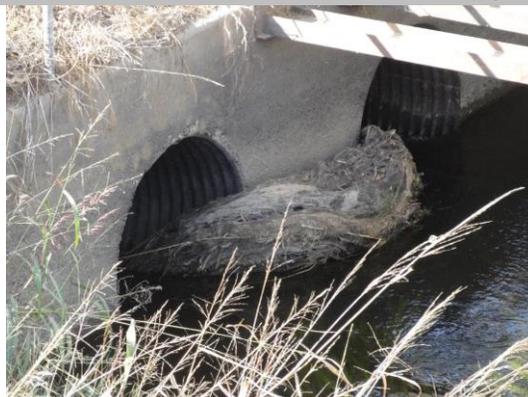
Photo 3 of 3 : UCIP\_SP\_2020\_24650\_44000.jpg

LS view: drainage pipes under walkway in drainage ditch.

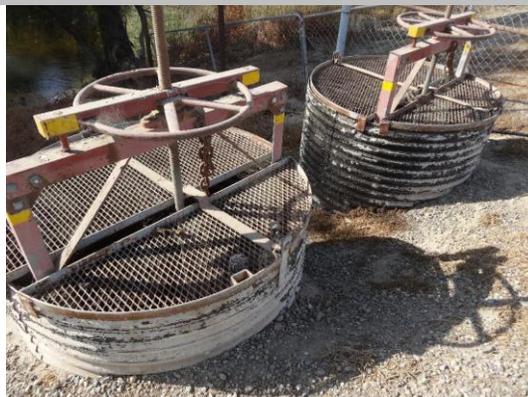
Photo 1 of 3 : UCIP\_SP\_2020\_24636\_43965.jpg

WS view: two slide gates in CMP risers on levee slope

Comment Code					
Inspector Comment					
DS_ID:22125 FS_ID:24636 EP_NO: N/A Repair Type: No Action Needed Crossing Status: Found UCIP Comments: 10/27/2017 This structure is inspected annually under the Structure and Channel Summer Inspection (part of the Levee Inspection Program) conducted by the DWR Flood Project Integrity and Inspection Branch (FPIIB). (DWR UCIP - O. Magana) 11/06/2013 - working during field inspection. (P. Amatya - DWR UCIP) FIELD_STRUCT_DESC: [Reclamation District No. 2063 Pumping Plant] 2 of 2: 42-inch corrugated metal gravity drainage pipe through the levee, 18 feet below the crown. Slide gate in a corrugated metal pipe (CMP) riser on the waterside (WS) slope. Flap gate, concrete saddle, and apron on the WS end. Concrete headwall on the landside (LS) end. [Additional Reference(s): DWR Levee Log, 1992. USACE San Joaquin O&M Manual 6, September 1961, (HLM 8.60)]. FS Date: 11/6/2013

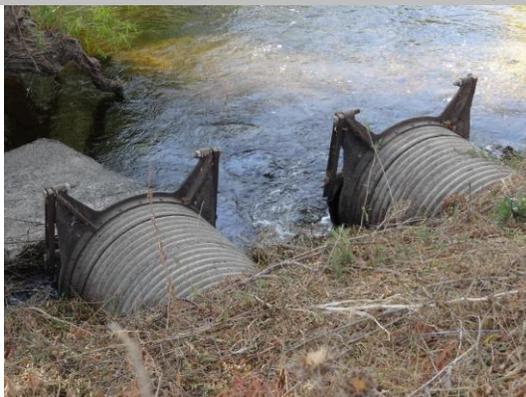
Photo 2 of 3 : UCIP\_SP\_2020\_24636\_43964.jpg

WS view: two flap gates on outfall pipe ends.

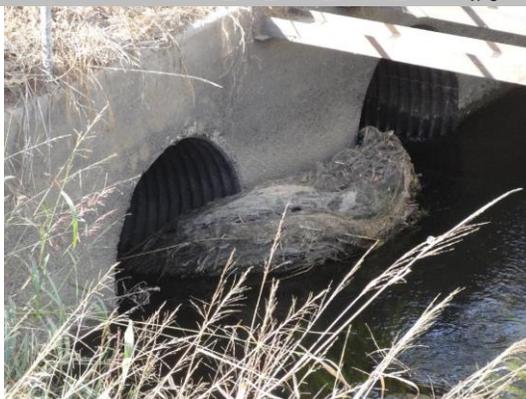
Photo 3 of 3 : UCIP\_SP\_2020\_24636\_43963.jpg

LS view: drainage pipes under walkway in drainage ditch.

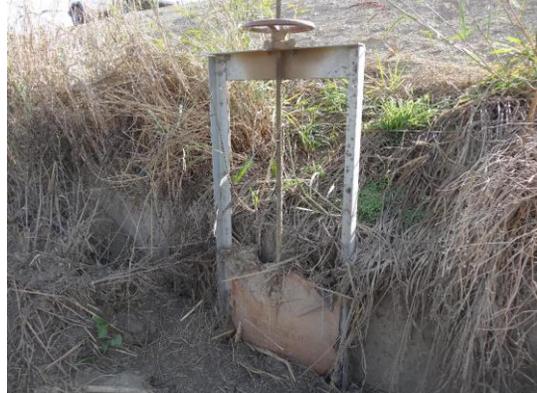
Photo 1 of 2 : UCIP\_SP\_2020\_24638\_43967.jpg

Item	DWR UCIP LMA Responsibility		37.390804 °	37.390804 °	
			-120.966394 °	-120.966394 °	
DWR ID	22114				
Comment Code					
Inspector Comment					
DS_ID:22114 FS_ID:24638 EP_NO: N/A Repair Type: No Action Needed Crossing Status: Found UCIP Comments: 11/06/2013 Flap gate and concrete "U" headwall not visible due to dense vegetation on waterside. (P. Amatya - DWR UCIP) FIELD_STRUCT_DESC: 24-inch corrugated metal gravity drainage pipe through the levee, 12 feet below the crown. Flap gate, concrete U-shaped headwall, and 7-foot-long grouted spillway on the waterside (WS) end. Slide gate and concrete headwall on the landside (LS) end. Installed by USACE in 1961. [Additional Reference(s): DWR Levee Log, 1992. USACE San Joaquin O&M Manual 6, September 1961, (HLM 9.21)]. FS Date: 11/6/2013

WS view: concrete headwall on levee end. Slide gate on pipe end.

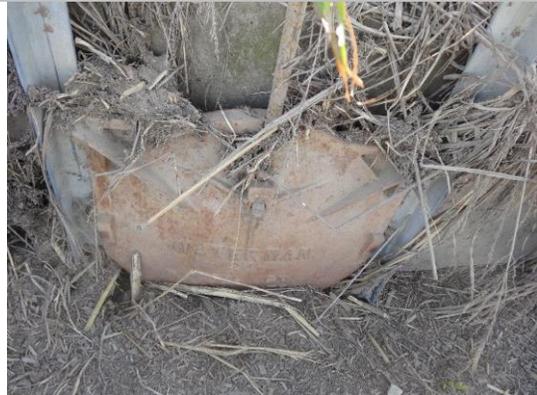
Photo 2 of 2 : UCIP\_SP\_2020\_24638\_43966.jpg

WS view: close view of slide gate on pipe end.

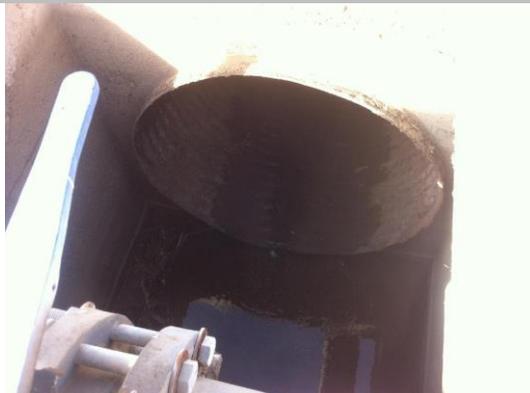
Photo 1 of 3 : UCIP\_SP\_2020\_24644\_43986.jpg

LM Start	<b>9.94</b>	Rating **	A/W	Issue No.	<b>84</b>
LM End	<b>9.94</b>	Issue Type +	Ma	Location *	
Category	Supplemental		GPS Latitude/Longitude		
			Start	End	
Item	DWR UCIP LMA Responsibility		37.390563 °	37.390563 °	
			-120.950329 °	-120.950329 °	
DWR ID	22116				
Comment Code					
Inspector Comment					
DS_ID:22116 FS_ID:24644 EP_NO: N/A Repair Type: No Action Needed Crossing Status: Found UCIP Comments: 11/06/2013 - not very old structure. (P. Amatya - DWR UCIP) FIELD_STRUCT_DESC: 48-inch corrugated metal gravity drainage pipe through the levee and across the drainage ditch on the waterside (WS), 6 feet below the crown. Slide gate and concrete box on the WS end. Concrete box on the landside (LS) end. Installed by USACE in 1961. [Additional Reference(s): DWR Levee Log, 1992. USACE San Joaquin O&M Manual 6, September 1961, (HLM 10.11)]. FS Date: 11/6/2013

WS view: CM pipe on outlet concrete box.

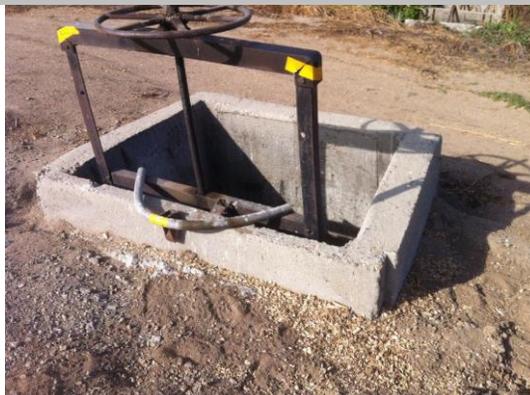
Photo 2 of 3 : UCIP\_SP\_2020\_24644\_43985.jpg

LS view: CM pipe with slide gate on inlet concrete box.

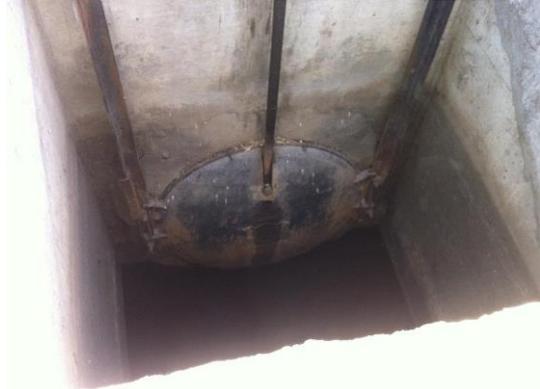
Photo 3 of 3 : UCIP\_SP\_2020\_24644\_43984.jpg

LS view: inside view of slide gate in concrete box.

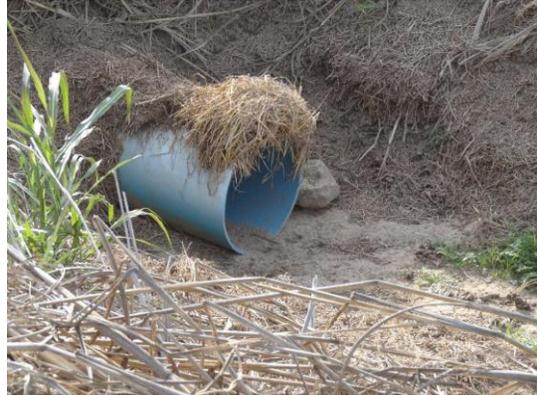
Photo 2 of 3 : UCIP\_SP\_2020\_53095\_43989.jpg

LS view: PVC pipe with open end on levee toe.

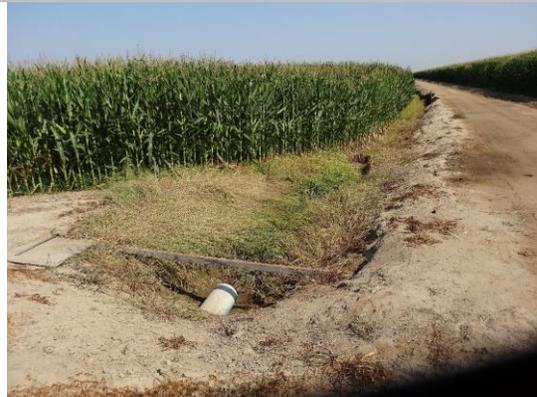
Photo 3 of 3 : UCIP\_SP\_2020\_53095\_76005.jpg

LS view of crossing

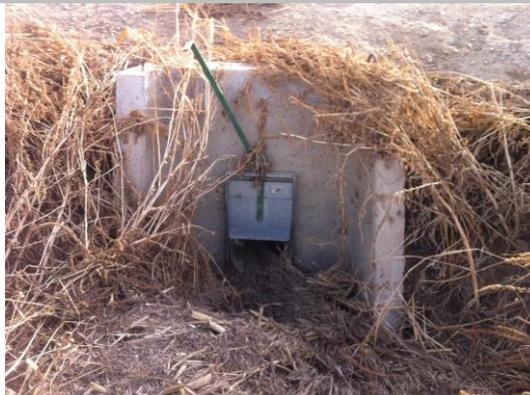
Photo 1 of 3 : UCIP\_SP\_2020\_53096\_43993.jpg

DS\_ID:24731  
FS\_ID:53096  
EP\_NO: 11631  
Repair Type: Urgent  
Crossing Status: Found  
UCIP Comments: 10/19/2018 Pipe size was field measured and updated to a 12-inch pipe instead of an 8-inch pipe as previously reported. Additional notes found in permit file indicate that a 10-inch to 12-inch corrugated metal pipe (CMP) was authorized in 1976 and a USACE letter showed no objection for approval of Application No. 11631. Inspector's notes from 7/27/1976 indicate that a new 12-inch steel, coated and wrapped, with 6 feet of cover at the levee centerline was installed. This means that the 12-inch PVC is a pipe replacement. Need to contact owner to find out if the new pipe replacement was authorized through the CVFPB. Erosion is still visible on the LS slope near the concrete headwall. Levee height at this crossing location is about 6-feet tall. Unable to find the WS outlet due to dense vegetation. Need to address the following outstanding issues with the CVFPB and the owner for this crossing: pipe replacement without proper CVFPB documentation, dense vegetation on the WS slope, and erosion is still present on the LS toe near the headwall. Crossing remains Urgent due to the LS erosion behind the headwall. (O. Magana - DWR UCIP)

09/29/2017 Received updated photos from DWR levee inspector, D. Torres, and photos show erosion behind wing wall on LS and WS pipe end still remains opened. Pipe still needs to conform with Title 23. Crossing has been upgraded from Non-Urgent to Urgent, crossing remains opened on the WS. Unable to find permit authorizing pipe replacement through the levee. (DWR UCIP - O. Magana)

08/23/2016 Same as last inspection. Pipe looks to be relatively newer than 1976. Appears there is no permit for this newer PVC pipe so recommend LMA contact owner to bring crossing into compliance with Title 23. Crossing has been upgraded from No Action Needed to Non-Urgent. (K. Fazel - UCIP)11/05/2013: Pipe not visible on waterside. Dense vegetation on waterside. (P. Amatya - DWR)  
FIELD\_STRUCT\_DESC: 12-inch polyvinyl chloride (PVC) gravity drainage pipe (field measured) through the levee, 4 feet below the crown. Metal slide gate in a concrete U-shaped headwall on the landside (LS). (12-inch drainage pipe through the levee and into project ditch on the riverbank authorized under Permit No. 11631, 1976 - A. W. Barcellos).  
FS Date: 10/19/2018 11:09:00 AM

LS view: U type concrete headwall, slide gate, and pipe on levee toe.

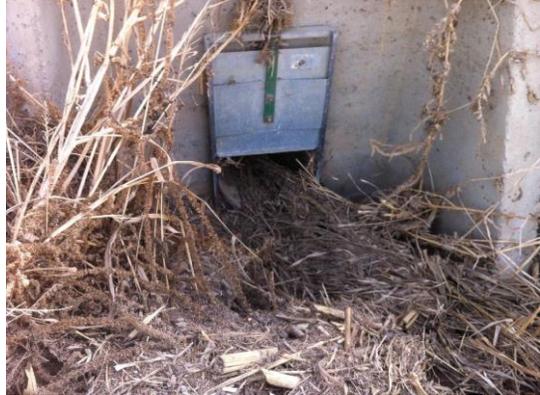
Photo 2 of 3 : UCIP\_SP\_2020\_53096\_43992.jpg

LS view: closer view of U type concrete headwall, slide gate, and pipe on levee toe.
