**Flood Control Project Maintenance
Levee Inspections**

Fall 2019 Levee Maintenance Deficiency Summary Report

San Joaquin River Basin

| RD2089 Reclamation District No. 2089 Stark | Overall LMA Rating | Total LMA Miles | | | | | | |

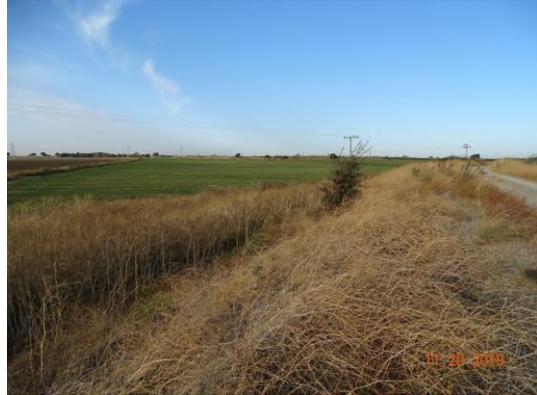
Photo 2 of 2 : FA_2019_RD2089_316_24_20191121_00061.jpg

| Vegetation on landside slope needs to be maintained to allow access and visibility. | | | | | |

View of vegetation on landside slope. Fall 2019

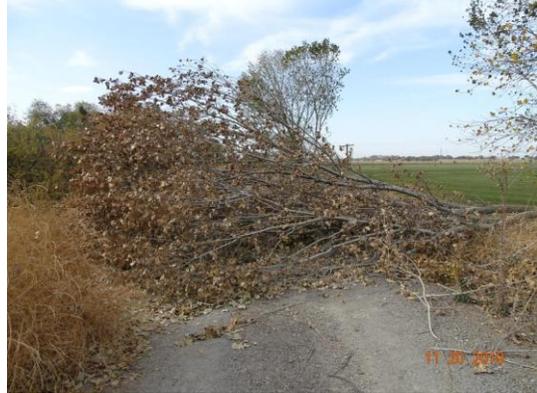
Photo 1 of 2 : FA_2019_RD2089_316_29_20191121_00057.jpg

View of downed tree limb on crown surface. Fall 2019

| Remove downed tree limb that is across the levee and blocking crown access. | | | | | |

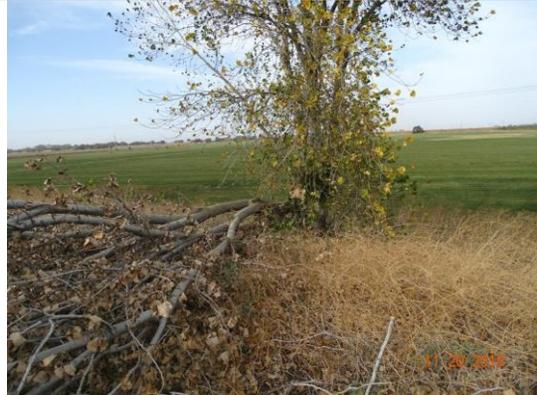
Photo 2 of 2 : FA_2019_RD2089_316_29_20191121_00058.jpg

View of downed tree limb on crown surface. Fall 2019

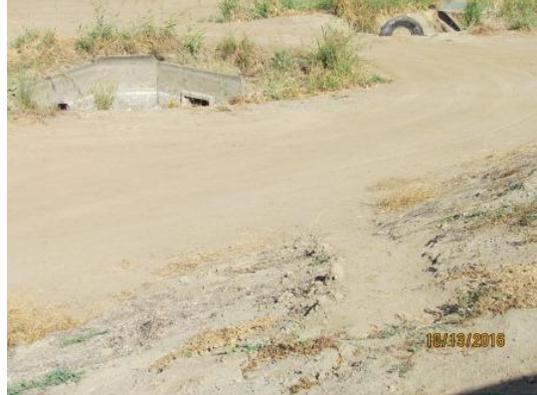
Photo 2 of 2 : FA_2019_RD2089_316_22_20190830_00022.jpg

View of the footpath on the landside levee slope.

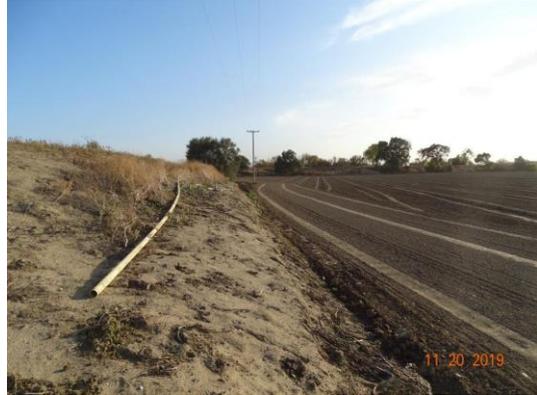
Photo 1 of 2 : FA_2019_RD2089_316_17_20191121_00060.jpg

| The landside levee toe is cut due to farming. | | | | | |

View of vertical cut along the landside toe. (Fall 2019)

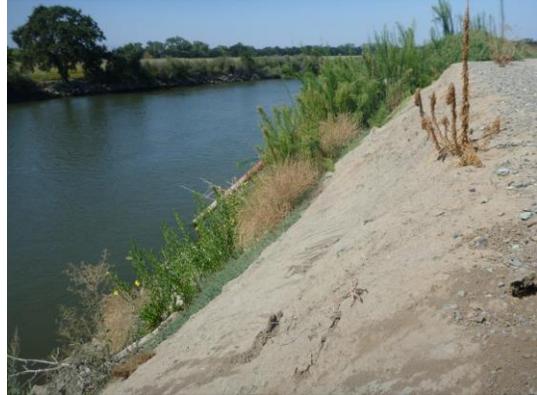
Photo 1 of 3 : LEVAL_FA_2019_511_4301.jpg

| LM Start | 1.16 | Rating ** | A/W | Issue No. | 30 |
|---|---|---|---|---|---|
| Description:Slope protection repairs are needed along the waterside slope due to erosion and riprap displacement from high water. Based upon levee inspections, it was determined the waterside levee slope is eroding, deteriorating, and degrading. The eroded levee sections need to be restored back to design standards to prevent further deterioration and damage. | | | | | |

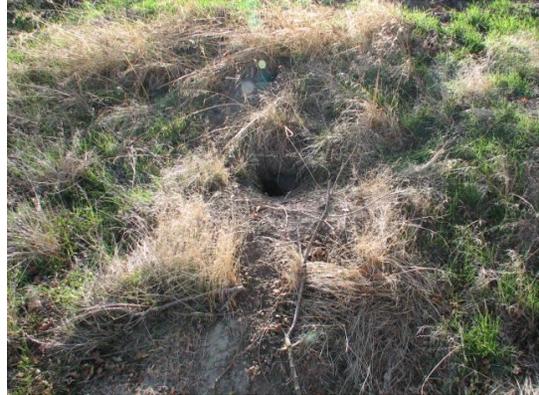
Photo 1 of 1 : FA_2019_RD2089_316_47_20190830_00036.jpg

View of active rodent burrow on landside slope. 11/10/2011

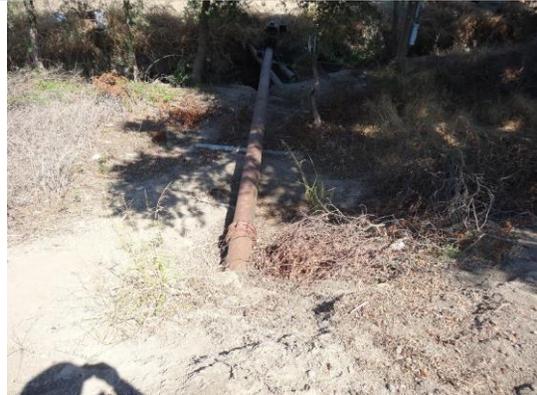
Photo 3 of 3 : UCIP_FA_2019_21585_36622.jpg

LS view: exposed steel pipe on levee slope.

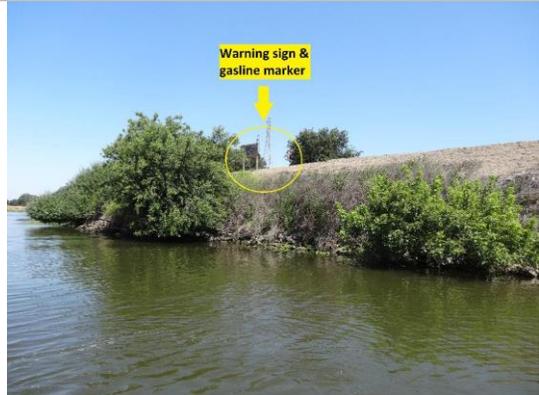
Photo 2 of 3 : UCIP_FA_2019_53182_74508.jpg

Gasline marker (for crossing with DS ID 25121) appr. 100 ft west of crossing.

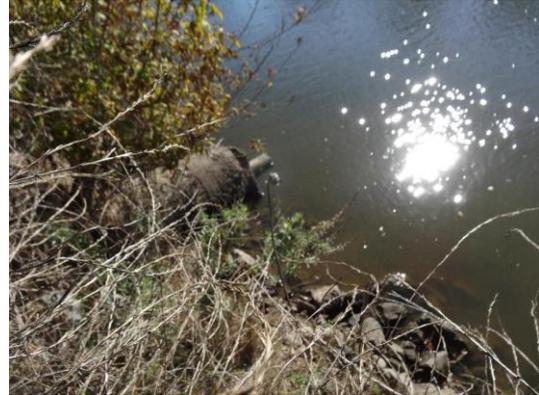
Photo 3 of 3 : UCIP_FA_2019_53182_76207.jpg

| DS_ID:23046 FS_ID:53182 EP_NO: N/A Repair Type: Non-Urgent Crossing Status: Found UCIP Comments: 10/12/2018 Same as last inspection; downgrading to Non-Urgent due to no visual pipe or levee threat (D. Sanoski - DWR UCIP). 11/15/2016 Pipe found on WS only. Same as last inspection. (K. Fazel - UCIP)06/25/2015 Crossing appears abandoned; if so, should be done so properly. Pipe open on WS. Holes and cracks visible on pipe. (K. Fazel - UCIP) FIELD_STRUCT_DESC: *ABANDONED* 12-inch reinforced concrete pipe of an unknown purpose possibly through the levee, approximately 8 feet below the crown. Smaller steel pipe sleeved through the 12-inch pipe with annular space grouted. Pipe does not cross channel and may not cross levee. May be related to the gas line crossing with DS ID 25121. Discovered from boat on 2015 DWR Erosion Survey. FS Date: 10/12/2018 5:22:43 PM | | | | | |

WS view of pipe

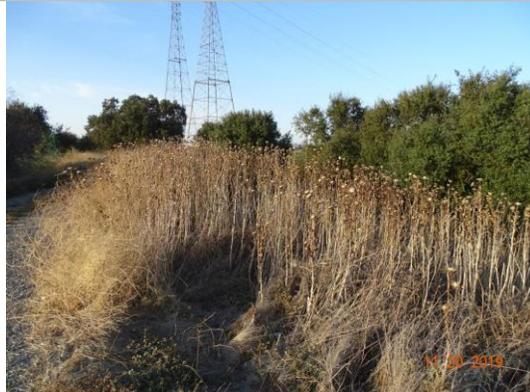
Photo 1 of 1 : FA_2019_RD2089_317_60_20191121_00071.jpg

View of vegetation on landside slope. Fall 2019

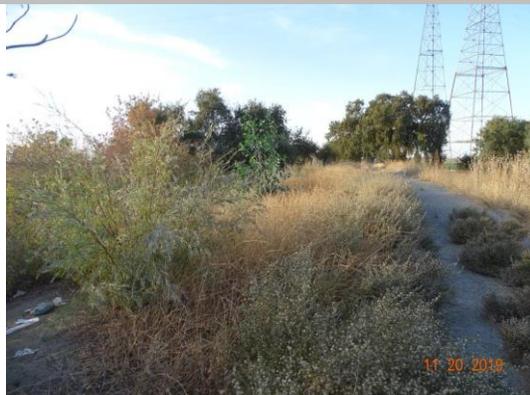
Photo 1 of 2 : FA_2019_RD2089_317_58_20191121_00072.jpg

View of vegetation on waterside slope. Fall 2019

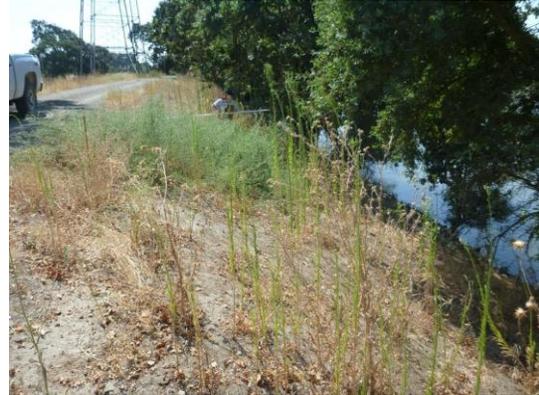
Photo 3 of 3 : LEVAL_FA_2019_509_4317.jpg

| Levee Evaluation Comments Description: Slope protection repairs are needed along the waterside slope due to erosion and riprap displacement from high water. Based upon levee inspections, it was determined the waterside levee slope is eroding, deteriorating, and degrading. The eroded levee sections need to be restored back to design standards to prevent further deterioration and damage. Site ID No: 509 Site Designation: LMA-415 Repair Type: Erosion Rating: Area of Concern Field Date: 8/16/2017 Notes: Displaced riprap at toe. | | | | | |

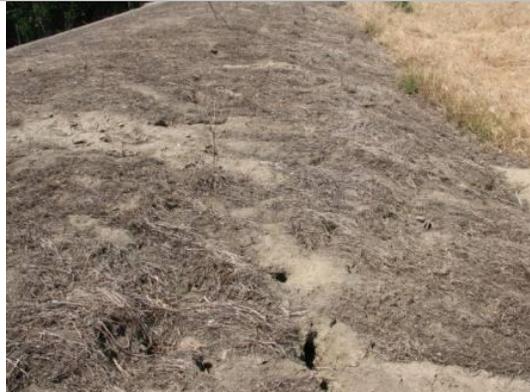
Photo 1 of 1 : FA_2019_RD2089_317_24_20190830_00026.jpg

View of active burrows, ground squirrel sighted in area. 05/24/2011

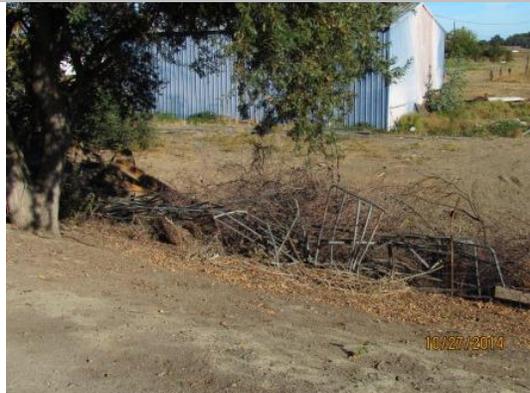
Photo 1 of 1 : FA_2019_RD2089_317_52_20190830_00057.jpg

View of the tree branches on the landside levee toe obstructing access.

| Remove prunings and other debris from the levee toe. | | | | | |

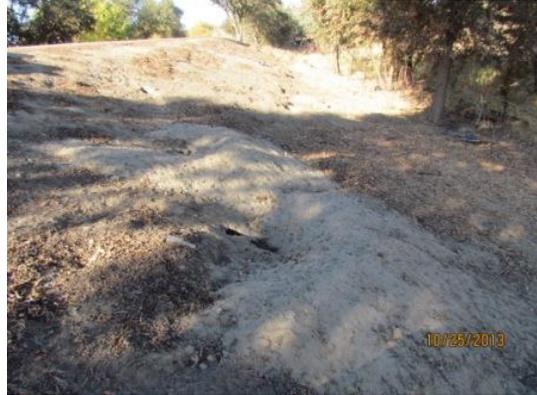
Photo 1 of 3 : FA_2019_RD2089_317_53_20190830_00058.jpg

View of the multiple rodent burrows on the landside levee slope.

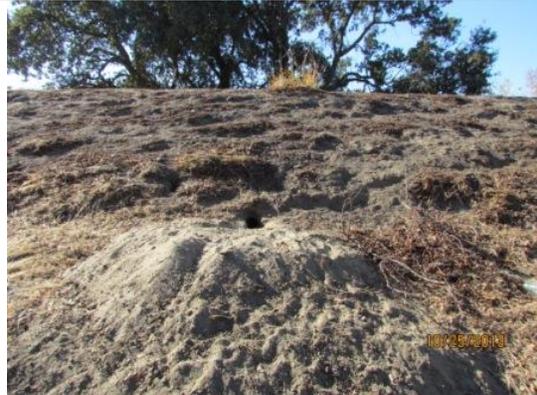
Photo 2 of 3 : FA_2019_RD2089_317_53_20190830_00059.jpg

View of the rodent burrow on the landside levee slope.

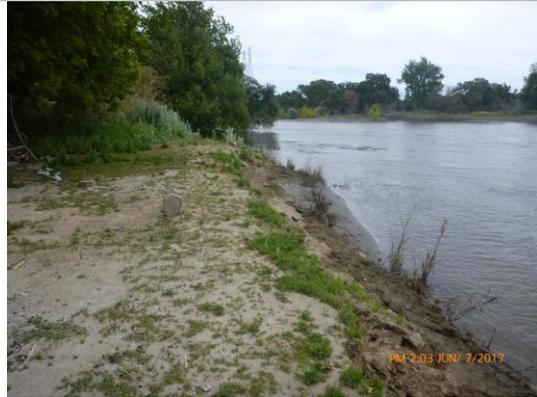
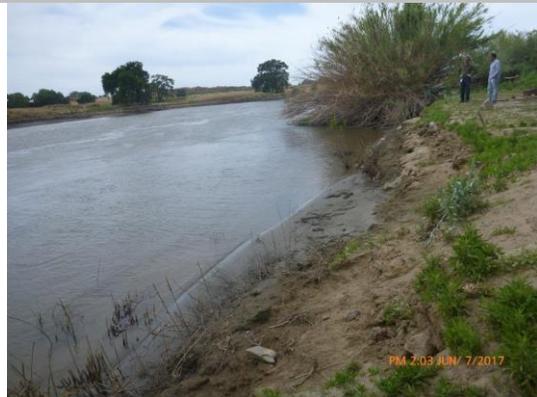
| Notes: vegetation too dense for evaluation | | | | | |

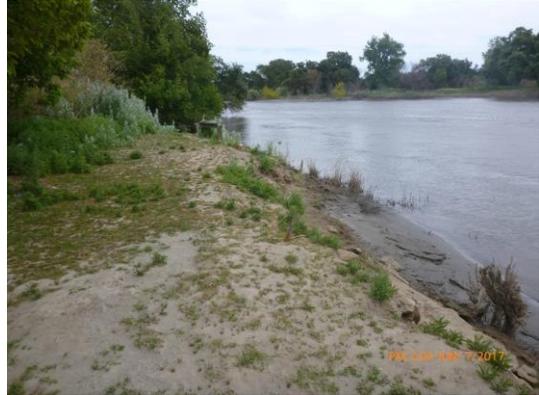
Photo 3 of 3 : LEVAL_FA_2019_109_1300.jpg

| Notes: vegetation too dense for evaluation | | | | | |

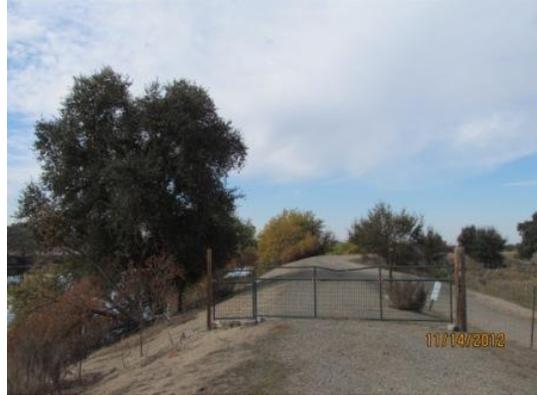
Photo 1 of 1 : FA_2019_RD2089_317_2_20190830_00004.jpg

| There is a gate across levee crown. | | | | | |

View of gate across levee crown.

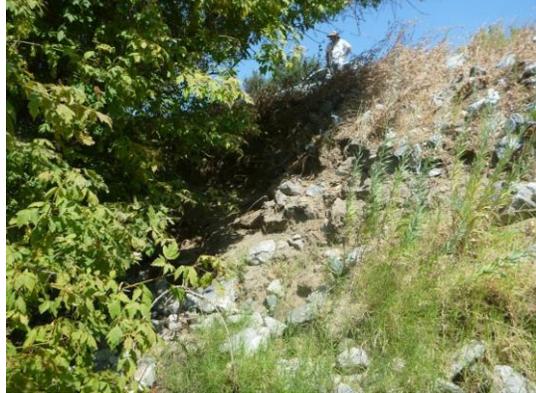
Photo 3 of 3 : LEVAL_FA_2019_508_4325.jpg

| Notes: Large erosion around tree with a 12' vertical cut. | | | | | |

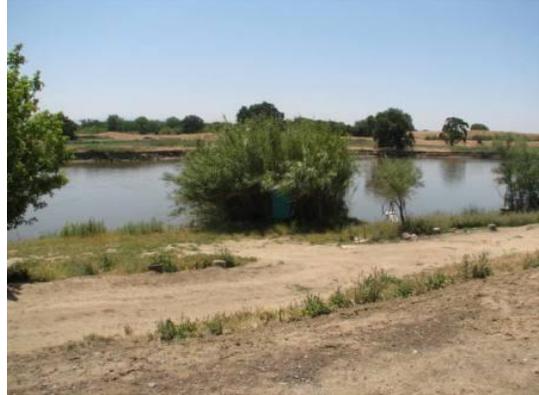
Photo 1 of 3 : FA_2019_RD2089_317_27_20190830_00028.jpg

| There is a portable toilet on the bank at the water's edge. | | | | | |

View of portable toilet is in the shadows in the center of the photo at the water's edge. 05/24/2011

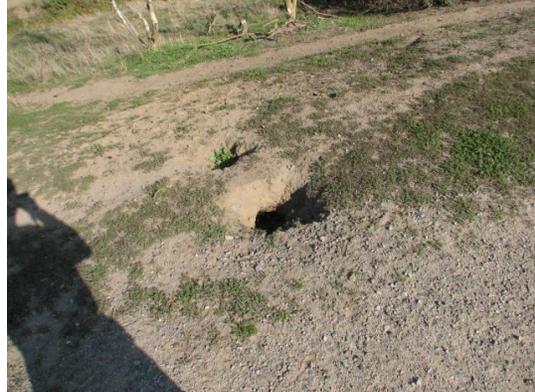
Photo 1 of 1 : FA_2019_RD2089_317_13_20190830_00015.jpg

View of two large burrows on crown, need to be filled. 11/10/2011

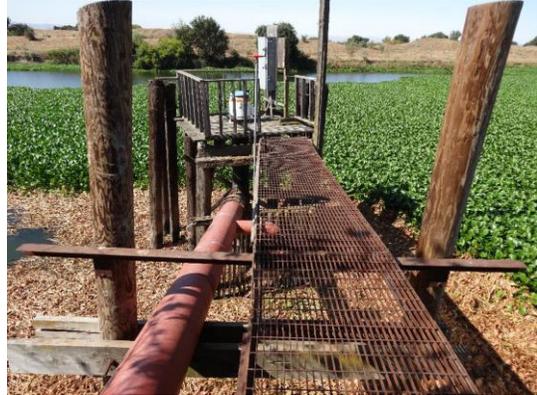
Photo 3 of 3 : UCIP_FA_2019_21676_36859.jpg

| LM Start | 0.54 | Rating ** | M | Issue No. | 62 (cont) |
|---|---|---|---|---|---|
| DS_ID:23047 FS_ID:21676 EP_NO: N/A Repair Type: Non-Urgent Crossing Status: Found UCIP Comments: - air relief valve on waterside. Needs repair.- concrete standpipe on landside. FIELD_STRUCT_DESC: 14-inch irrigation discharge pipe of an unknown material through the levee, 8 feet below the crown. Pump on a pile structure in the stream. Timber walkway to the pump. Air relief valve on the waterside (WS) slope. Concrete distribution standpipe on the landside (LS) toe. [Additional Reference(s): DWR Levee Log, 1991. USACE San Joaquin O&M Manual 8, 1968, (HLM 0.55)]. FS Date: 9/12/2013 | | | | | |

WS view: pipe (left) and steel walkway to pump on piling structure in the channel.

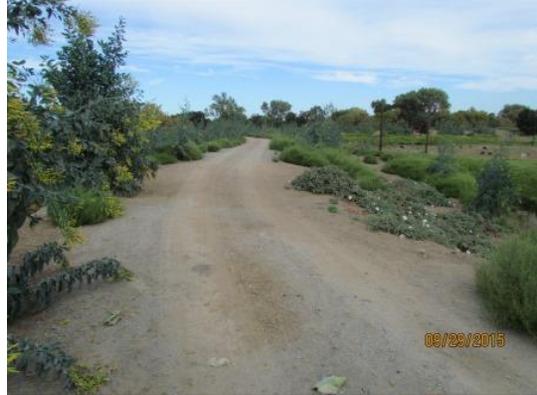
Photo 2 of 4 : FA_2019_RD2089_317_35_20190830_00035.jpg

View of the levee crown depression looking downstream.

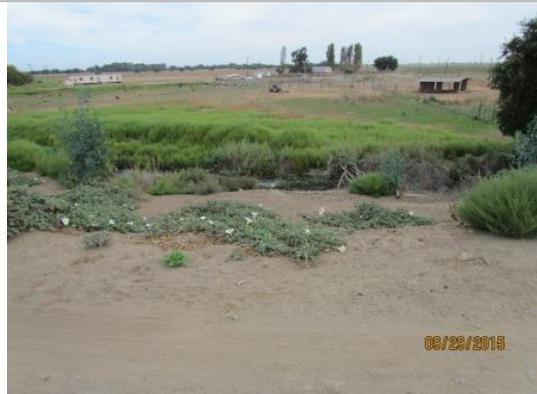
Photo 3 of 4 : FA_2019_RD2089_317_35_20190830_00036.jpg

View of the levee crown depression looking to the landside.

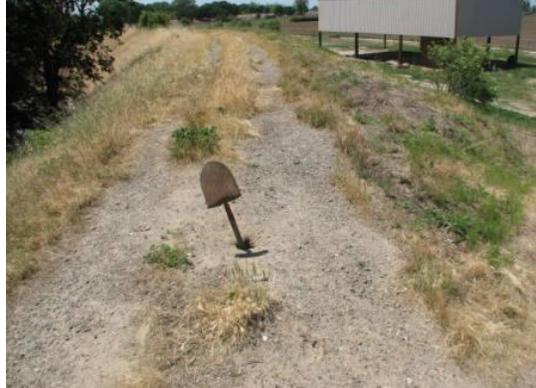
Photo 2 of 3 : FA_2019_RD2089_317_40_20190830_00041.jpg

View of deep vertical burrow in levee crown. 05/24/2011

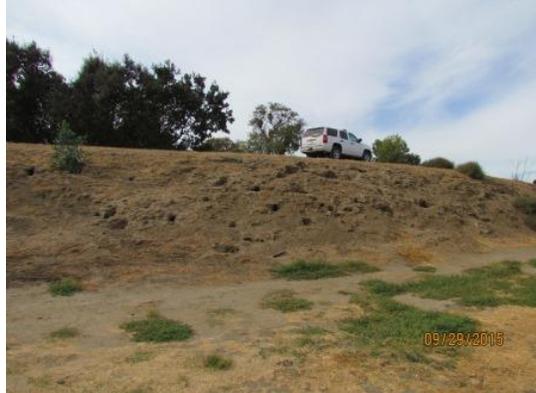
Photo 3 of 3 : FA_2019_RD2089_317_40_20190830_00042.jpg

View of the multiple rodent holes on the landside levee slope.

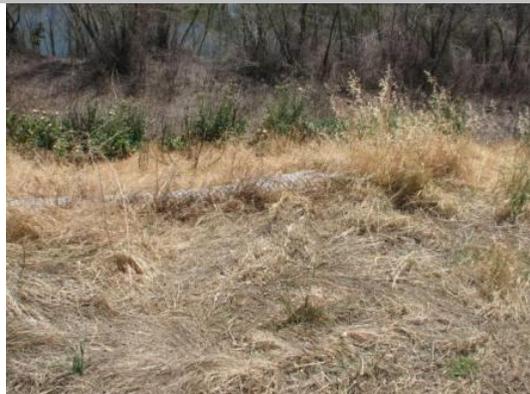
Photo 1 of 1 : FA_2019_RD2089_317_41_20190830_00043.jpg

| Debris/CMP are on levee slope and needs to be removed. | | | | | |

View of old CMP left on waterside levee slope, needs to be removed.
05/24/2011

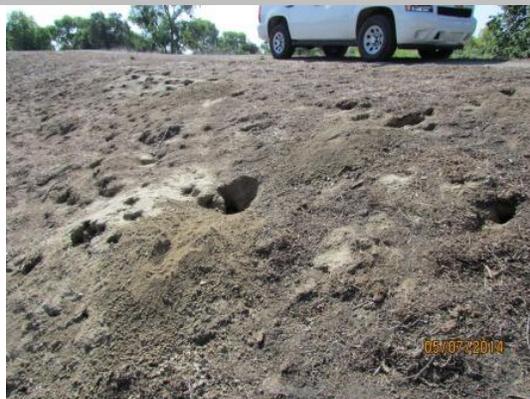
Photo 1 of 1 : FA_2019_RD2089_317_5_20190830_00005.jpg

View of the rodent holes on the landside levee slope.

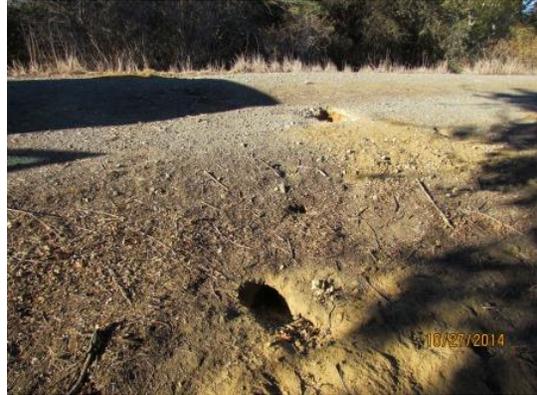
Photo 2 of 2 : FA_2019_RD2089_317_12_20190830_00014.jpg

View of several rodent burrows on landside levee hinge and crown.

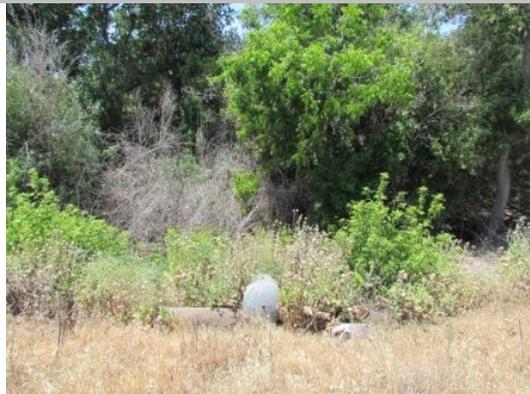
Photo 1 of 1 : FA_2019_RD2089_317_17_20190830_00019.jpg

| Water tanks disposed of on levee are obstructive. | | | | | |

View of water tanks disposed on waterside slope.

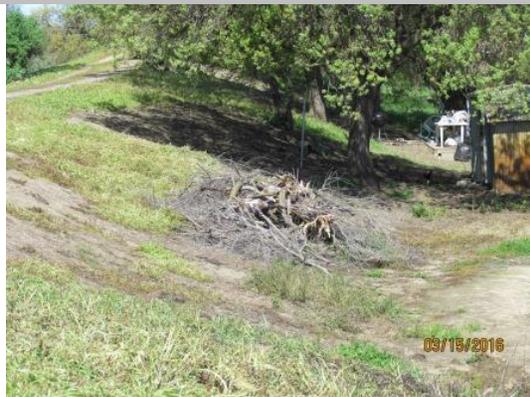
Photo 1 of 1 : FA_2019_RD2089_317_37_20190830_00039.jpg

View of the prunings on the landside levee slope.

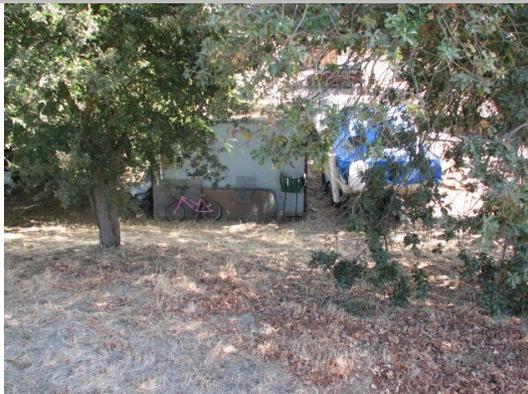
Photo 1 of 1 : FA_2019_RD2089_317_23_20190830_00025.jpg

| Buildings and equipment encroach within 10-ft of landside toe. | | | | | |

View of buildings and patio decks within 10-ft of the levee slope. Fall 2009

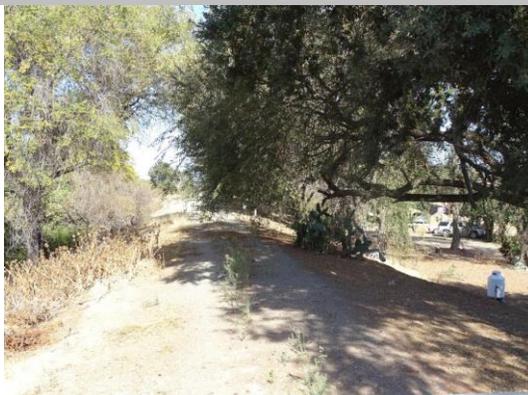
Photo 1 of 1 : FA_2019_RD2089_317_33_20190830_00033.jpg

Looking west at trees overhanging crown of levee. (Fall 2018)

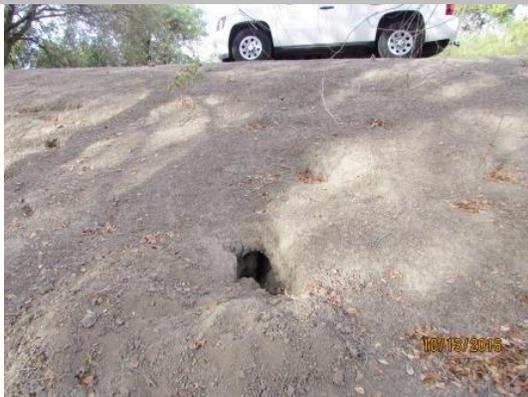
Photo 1 of 1 : FA_2019_RD2089_317_19_20190830_00021.jpg

View of the rodent burrow in the landside levee slope.

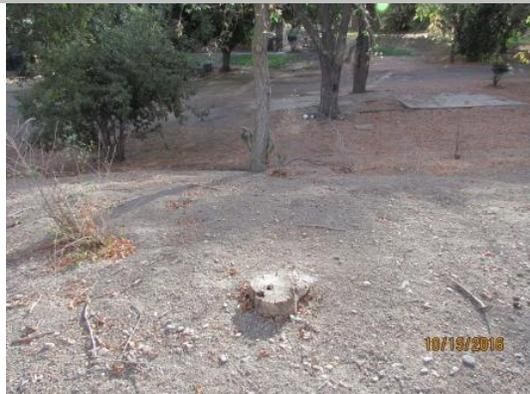
Photo 1 of 1 : FA_2019_RD2089_317_18_20190830_00020.jpg

View of the tree stump from the levee crown.

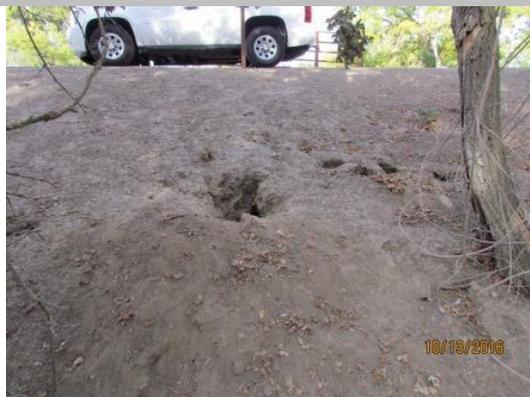
Photo 1 of 1 : FA_2019_RD2089_317_16_20190830_00018.jpg

View of the rodent burrow in the landside levee slope.
